**Our Reference**  
60693486

## **Unauthorized Wastewater Containment Structure - Update on Remedial Measures**

**Attachment 1**  
**Wastewater Containment Structure Photos**

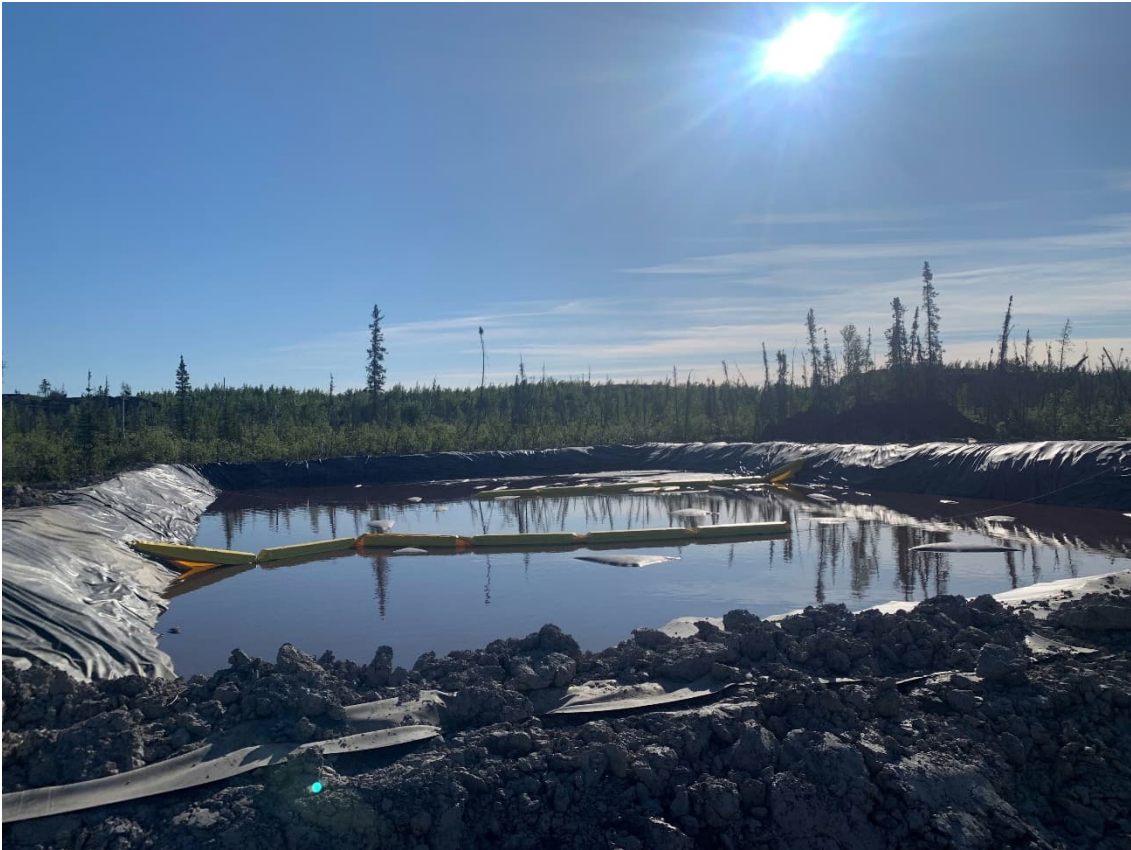
**June 17, 2024**

The of wastewater containment structure currently contains camp wastewater plant effluent and the contractor is awaiting confirmation of achieving the required effluent quality criteria. The liner remains in place, there is no evidence of erosion around the containment facility, nor has there been any incidents involving wildlife related to the facility. The water level in the containment facility has decreased due to evaporation. Please see the attached photos showing the current condition of the containment structure (Attachment 1).

The plan for water removal and decommissioning of the containment structure is in development and will be provided to the Inspector when complete. If the wastewater in the containment cell meets the required Environmental Quality Criteria (EQC), the wastewater will be discharged to the drainage field. If the water does not meet EQC, it will be directed to the camp wastewater treatment plant for further treatment prior to discharge.
