**Re: Land Use Permit W2020X0005
Miscellaneous - Remediation
Rayrock Remediation Project, NT**

ENVIRONMENTAL INSPECTION REPORT

Location(s) Inspected:	Sun Main Winter Road and Camp.
------------------------	--------------------------------

Current Stage of Operation:	Construction of the Sun Main Winter Road is complete and hauling of gravel was half completed. The camp is active at approximately 14km into the road.
-----------------------------	--

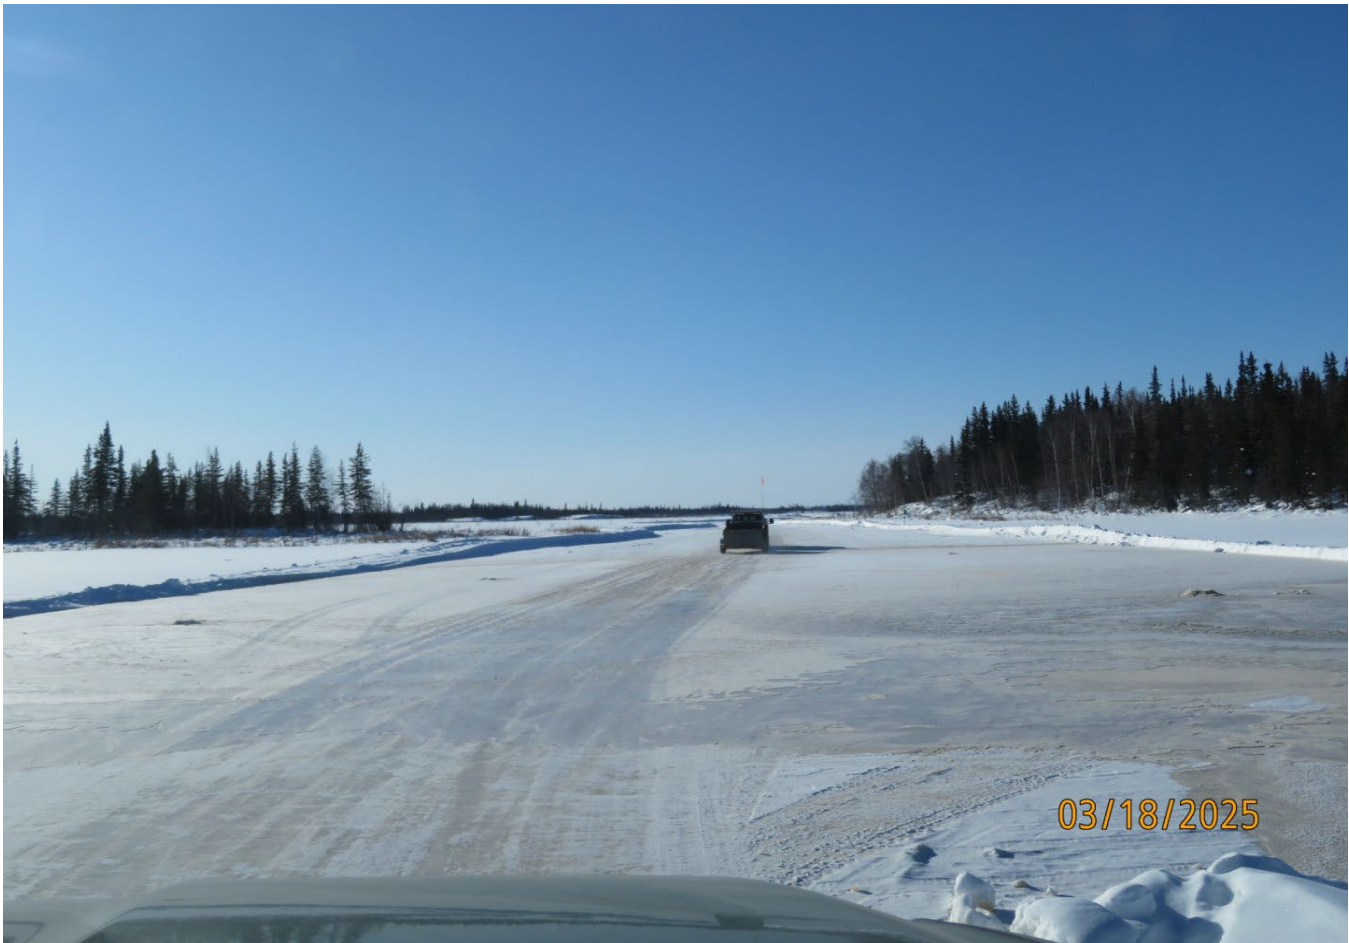
Figure 1

- The road was in good condition and sufficient ice coverage was observed (Figures #1 & 2),
- No damage to ground or signs of deterioration was observed and the Permittee was reminded to pay particular attention to the shoulders for any signs of softening or deterioration.

Example of a lake section of the Sun Main winter road.

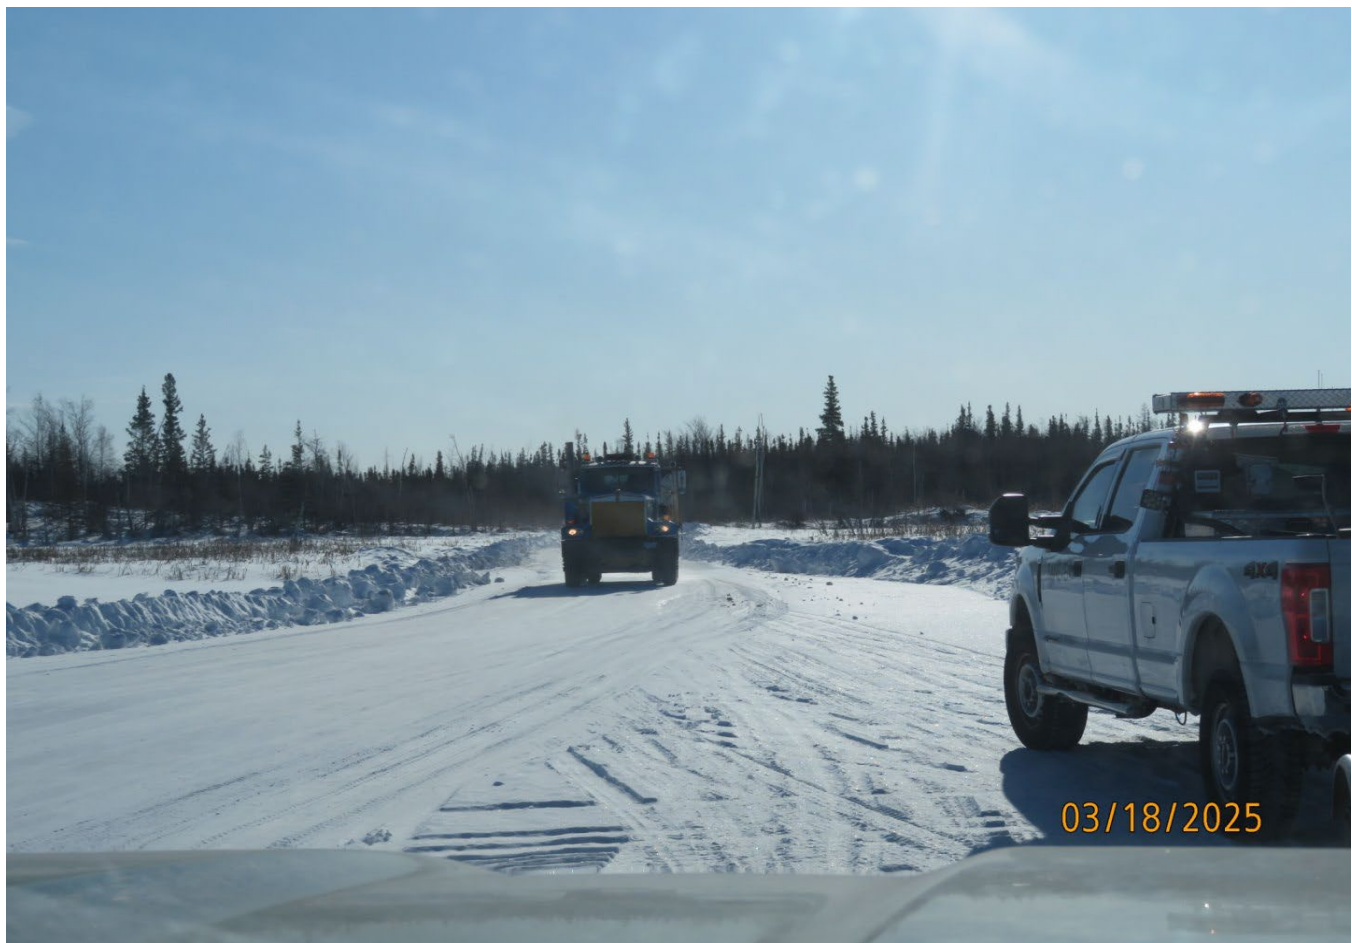
Figure 2

Hauling of gravel on the Sun Main winter road.

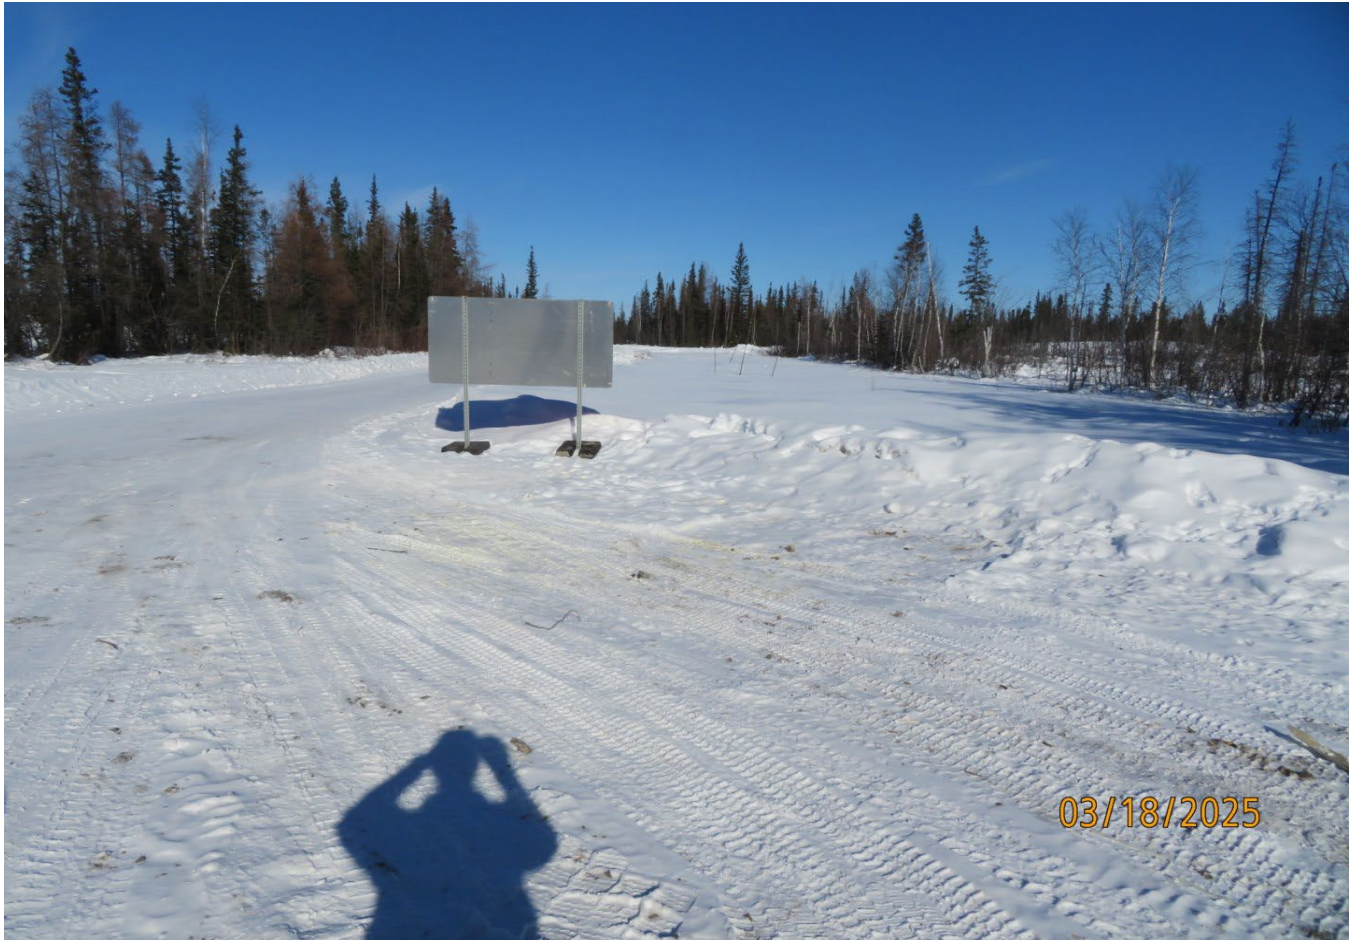
Figure 3

- What appears to be a fuel spill was observed at the previous camp location (start of the road near the Wekweeti Winter Road junction (Figures #3 & 4). The Permittee was notified of the findings and a clean-up of the spill was completed shortly thereafter. At the time of writing this report, the Inspector had received photo confirming the clean-up was complete and update to the small spill log made,

Hydrocarbon spill on the Sun Main winter road (original camp location near the Wekweeti winter road junction)

The Permittee is reminded to provide the Inspectors with notification once the date is known for the closure of the road and the demobilization of the camp. At the closure of the camp, a thorough inspection of the surface used must be conducted and any hydrocarbon impacted snow must be scrapped, the snow/impacted material containerized and sent for proper off-site disposal.

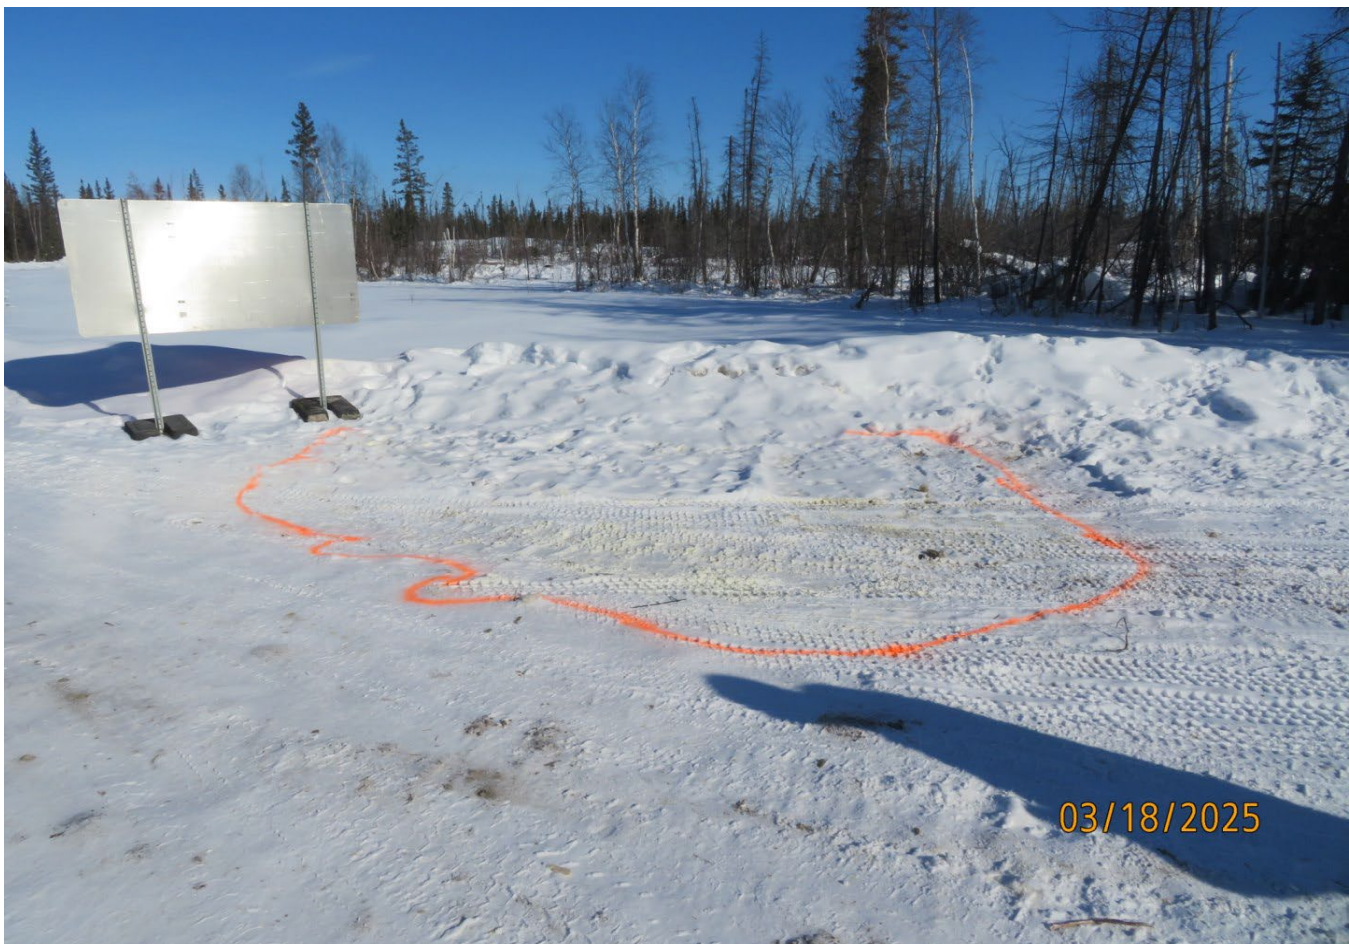
Figure 4

The area of hydrocarbon impacted snow at the original camp location.

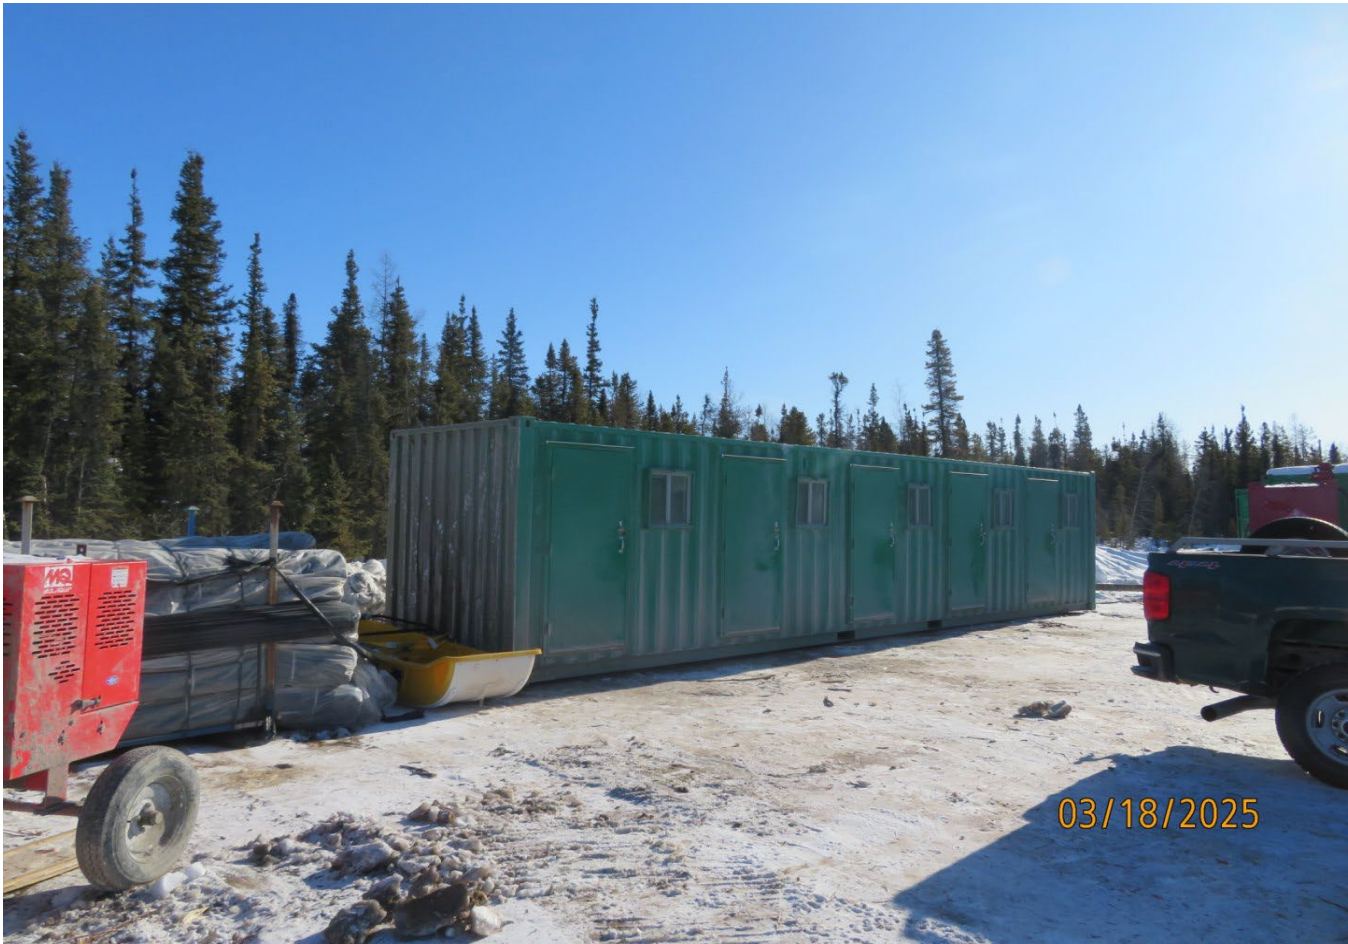
Figure 5
Camp units.

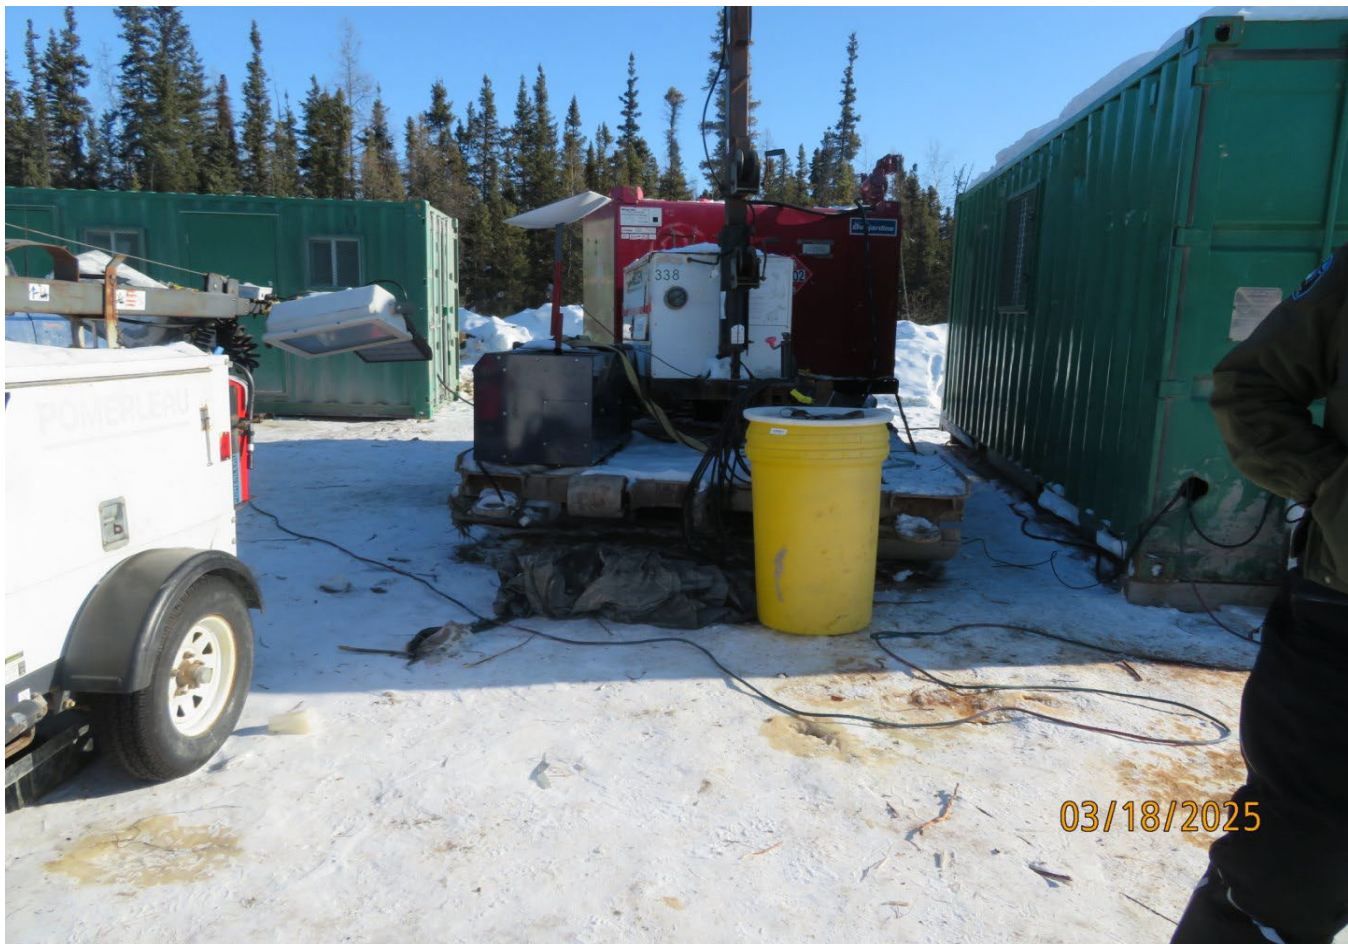
- Sewage management is done using honey bags et off-site disposal at an approved facility,
- Drip trays and/or boards are used underneath equipment parked, and secondary containments is used in areas of fuel handling (Figures #6 to 9),

Figure 6
Spill response material is readily available and visible in areas of fuel handling.

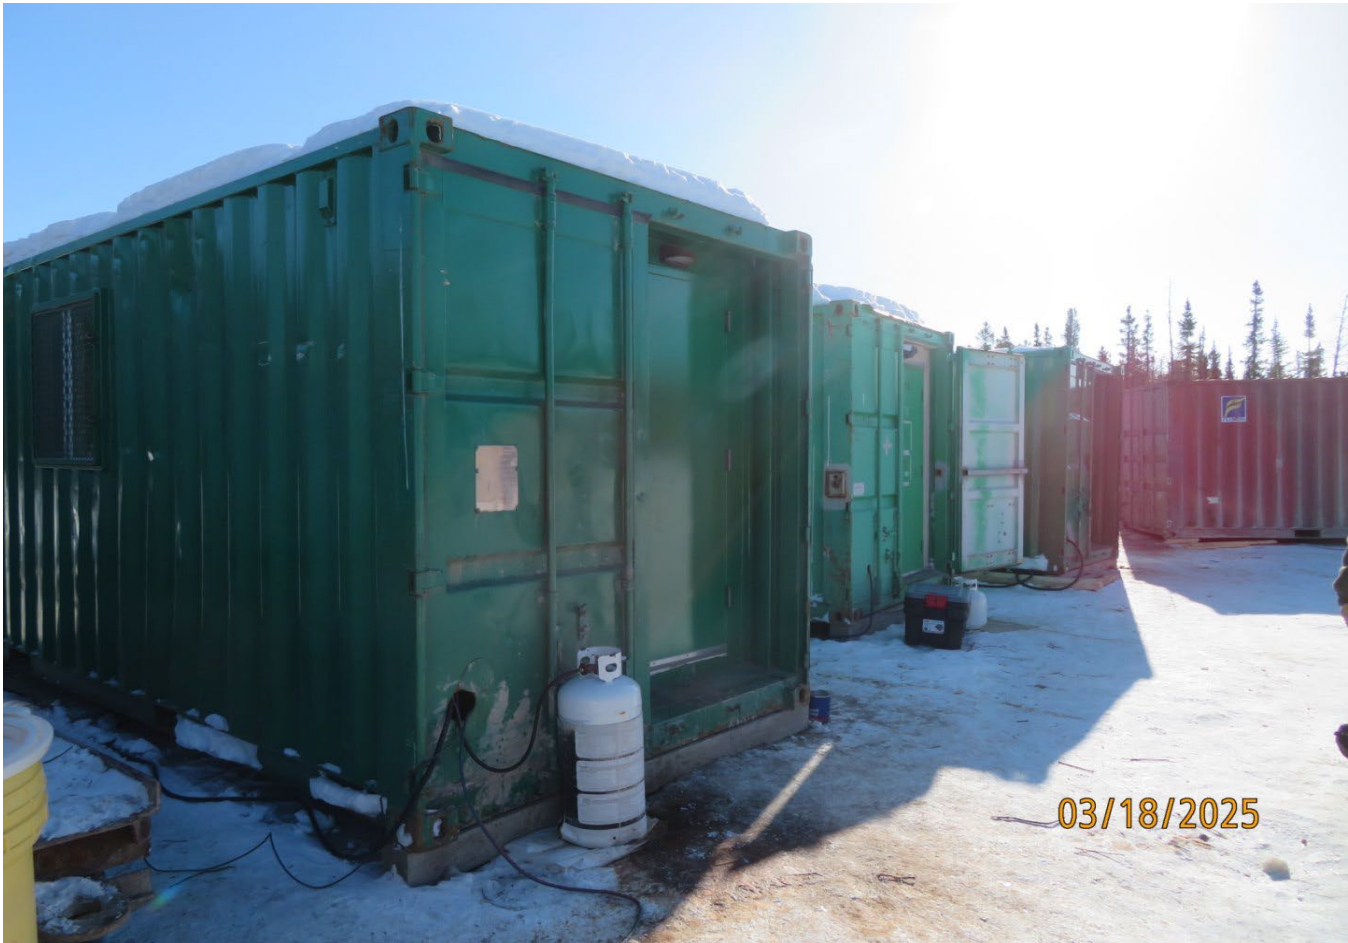
Figure 7

Overview of the camp laydown.

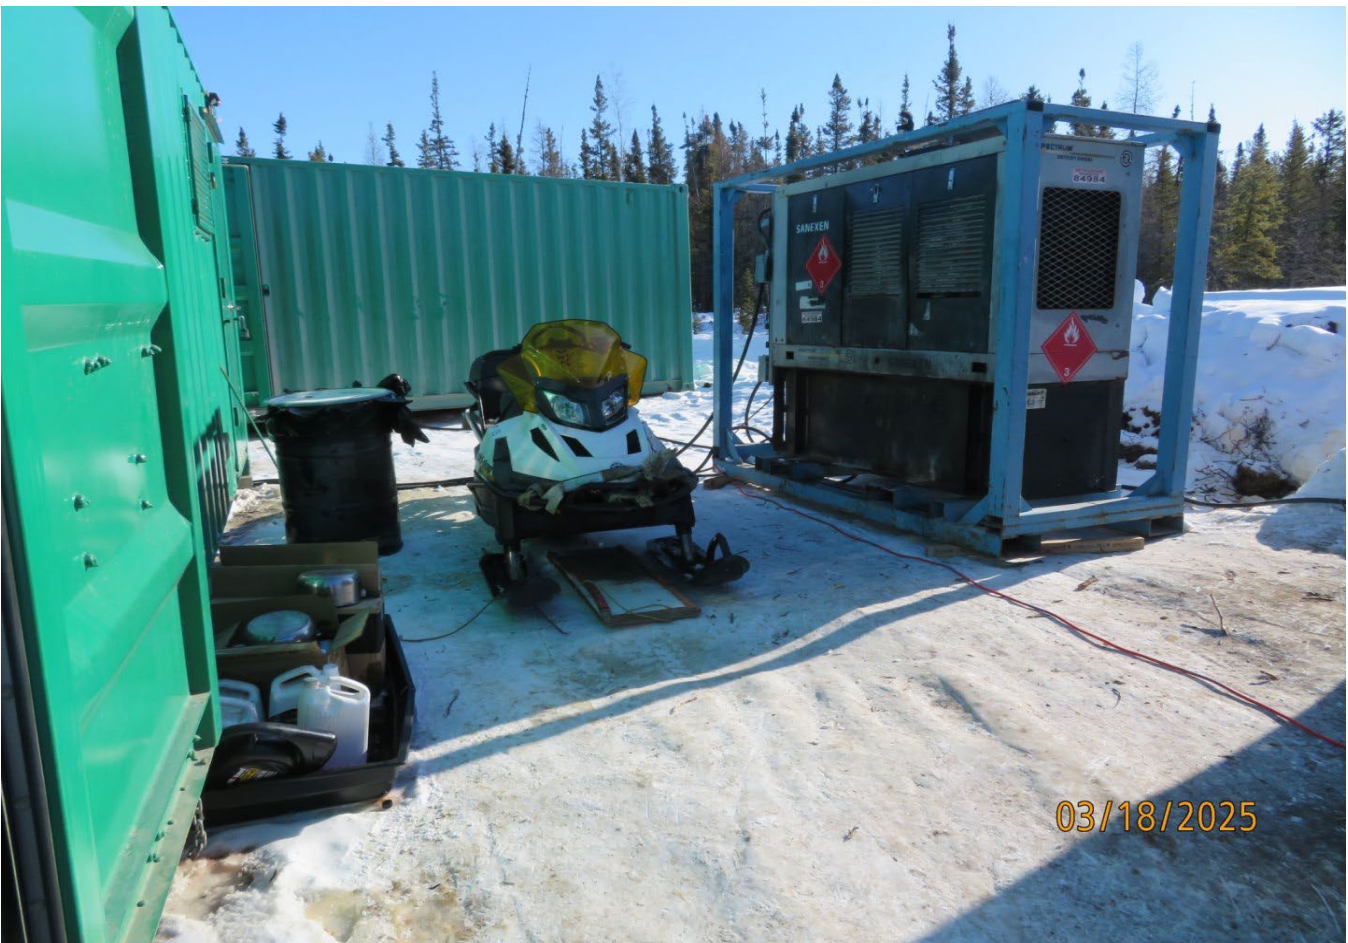
Figure 8

Drip boards / trays, and secondary containments are used throughout the site where required or where potential risk of hydrocarbon impacting the grown may be present.

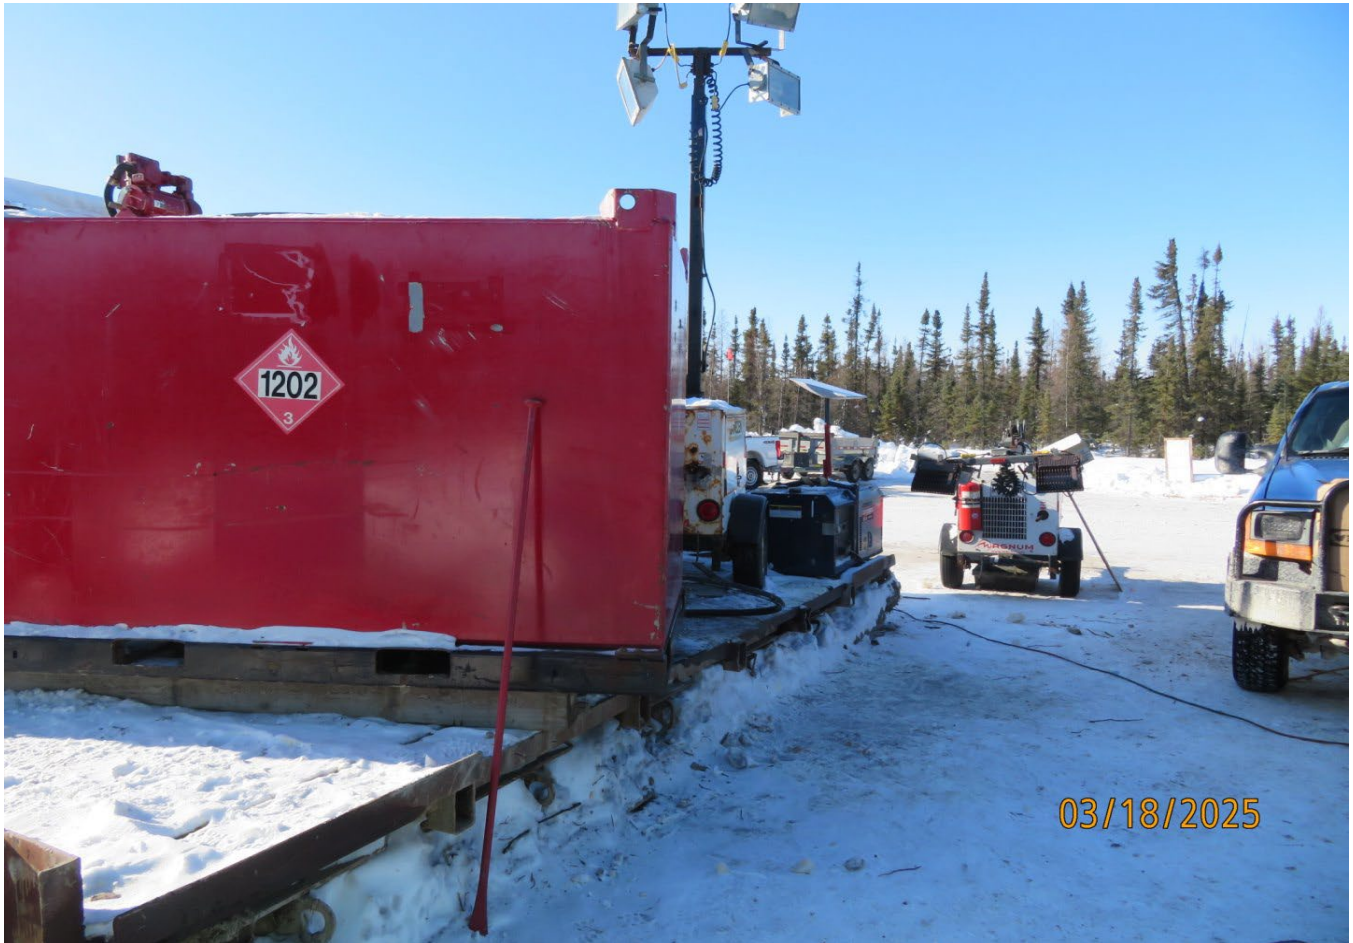
Figure 9

Generator and refueling area.

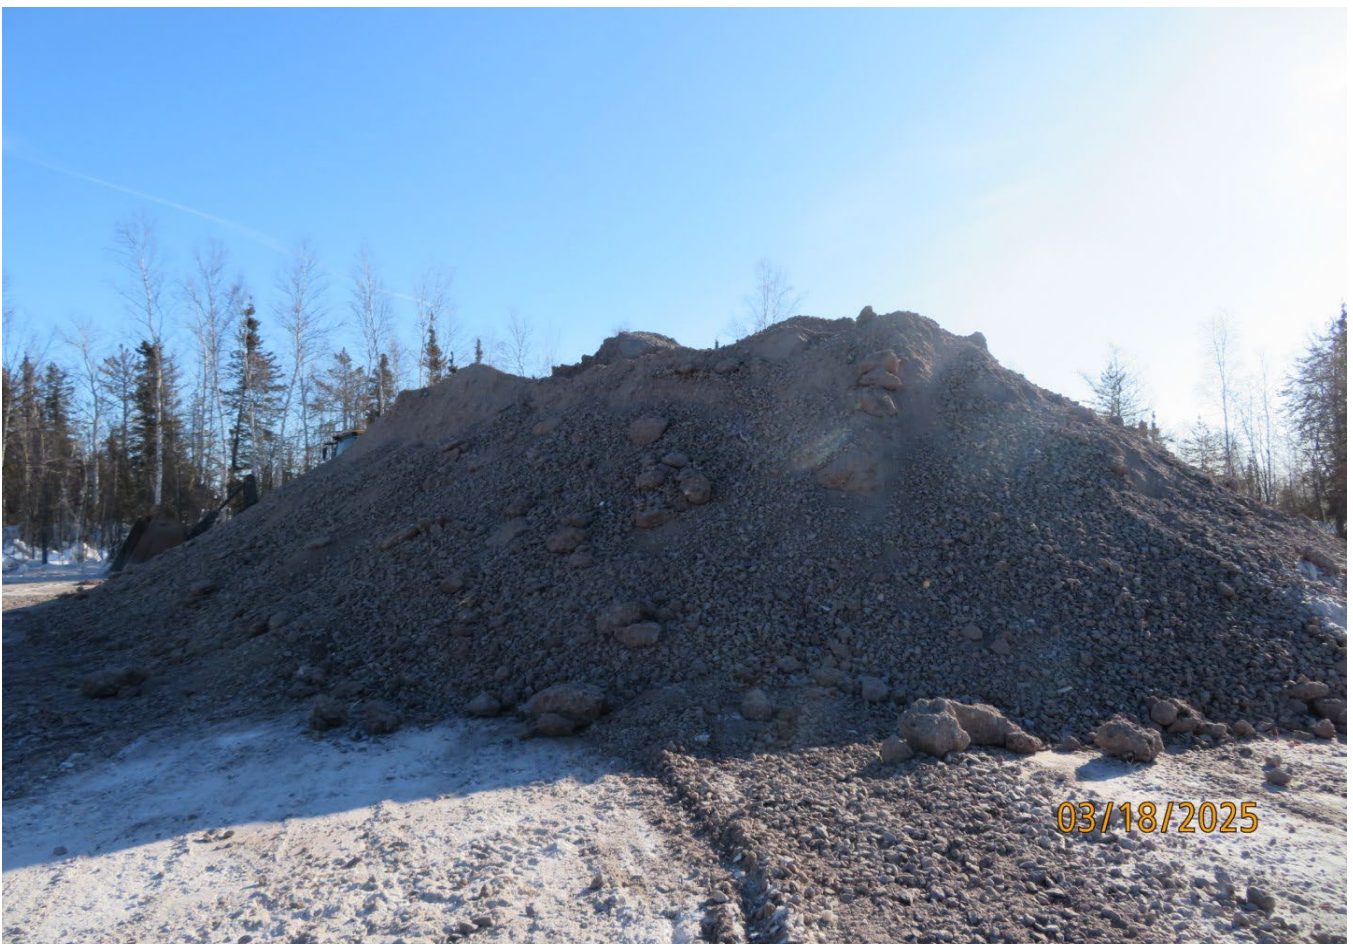
Figure 10

The hauled gravel is deposited temporary at the end of the winter road, then reloaded into smaller hauling equipment that can navigate safely the narrower stockpiling area at Sun Main.
