**Re: Land Use Permit W2021F0010  
Winter Road & Campsites  
Whati/Gamètì Junction to Wekweètì, NT**

## ENVIRONMENTAL INSPECTION REPORT

Location(s) Inspected:	Snowcat breakthrough location on the Emile River at ~Km 30.3 of the Wekweètì Winter Road.
------------------------	-------------------------------------------------------------------------------------------

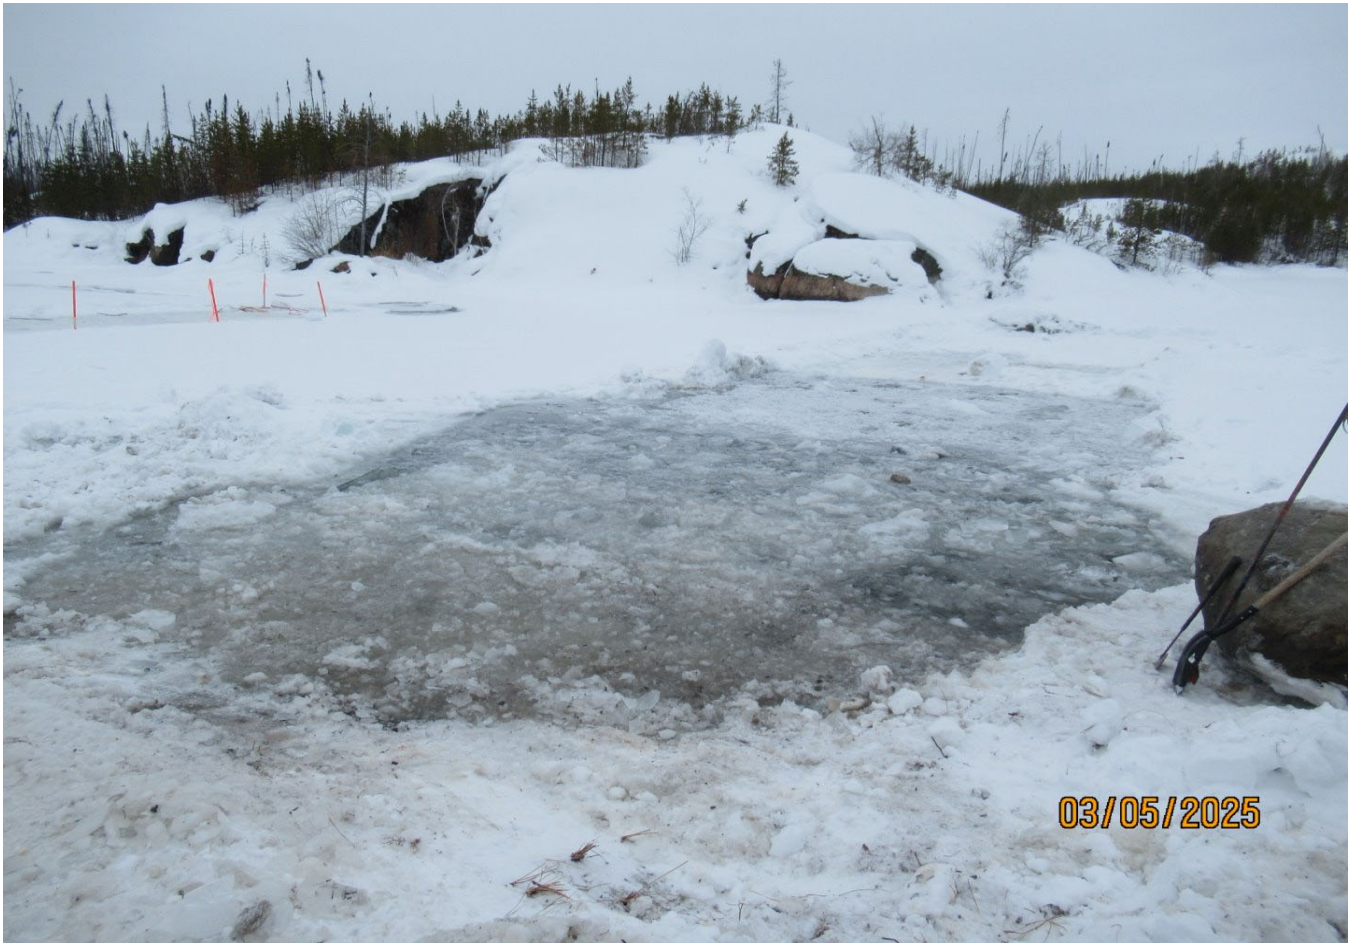
**Figure 1**

On Tuesday March 4<sup>th</sup>, 2025 equipment was mobilized to the land use area, tandem dump trucks and an excavator. Ice overtop of the submerged snowcat (Figure 1) was cut with chain saws and the excavator used to load it into trucks for removal & disposal at KBL's facility in Yellowknife. **The Permittee/Contractor must provide the Inspectors Bill of Ladings for all material taken offsite for disposal.**

**Ice between the submerged snowcat and the shoreline of the Emile River was removed and taken offsite for disposal at a licensed facility in Yellowknife.**

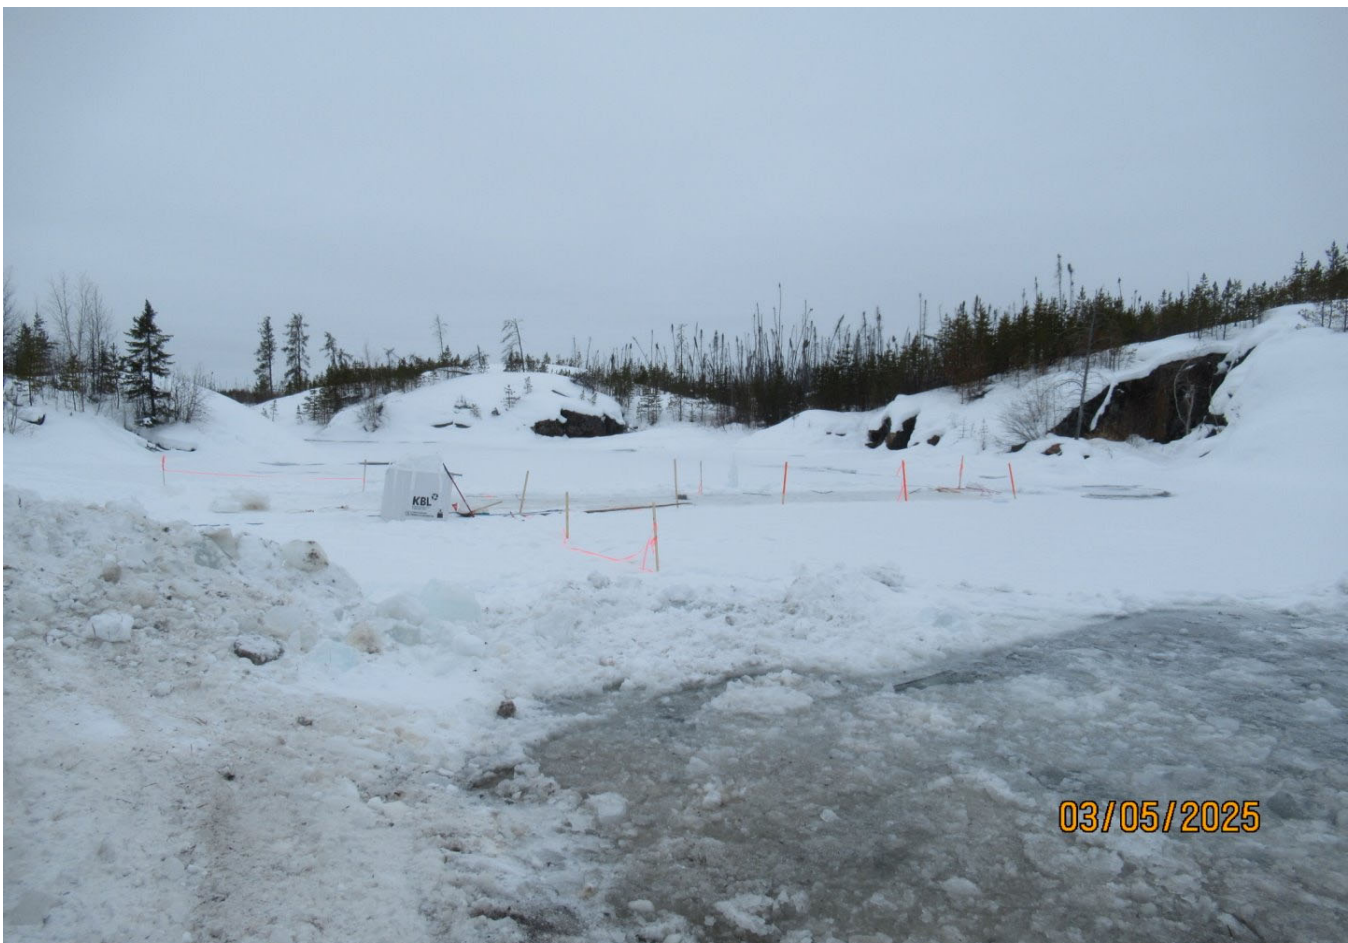
**Figure 2**

The use of the ice slot (Figure 2 & 3) for the collection of hydrocarbons during the snowcat extraction was kept ice free and active throughout this operation. Monitoring and mopping with hydrocarbon absorbent matting & booms must continue until it is confirmed that no further hydrocarbons are present in the watercourse.

**The ice slot down stream of the snowcat breakthrough location has been diligently monitored since the previous inspection of February 20<sup>th</sup>, 2025.**

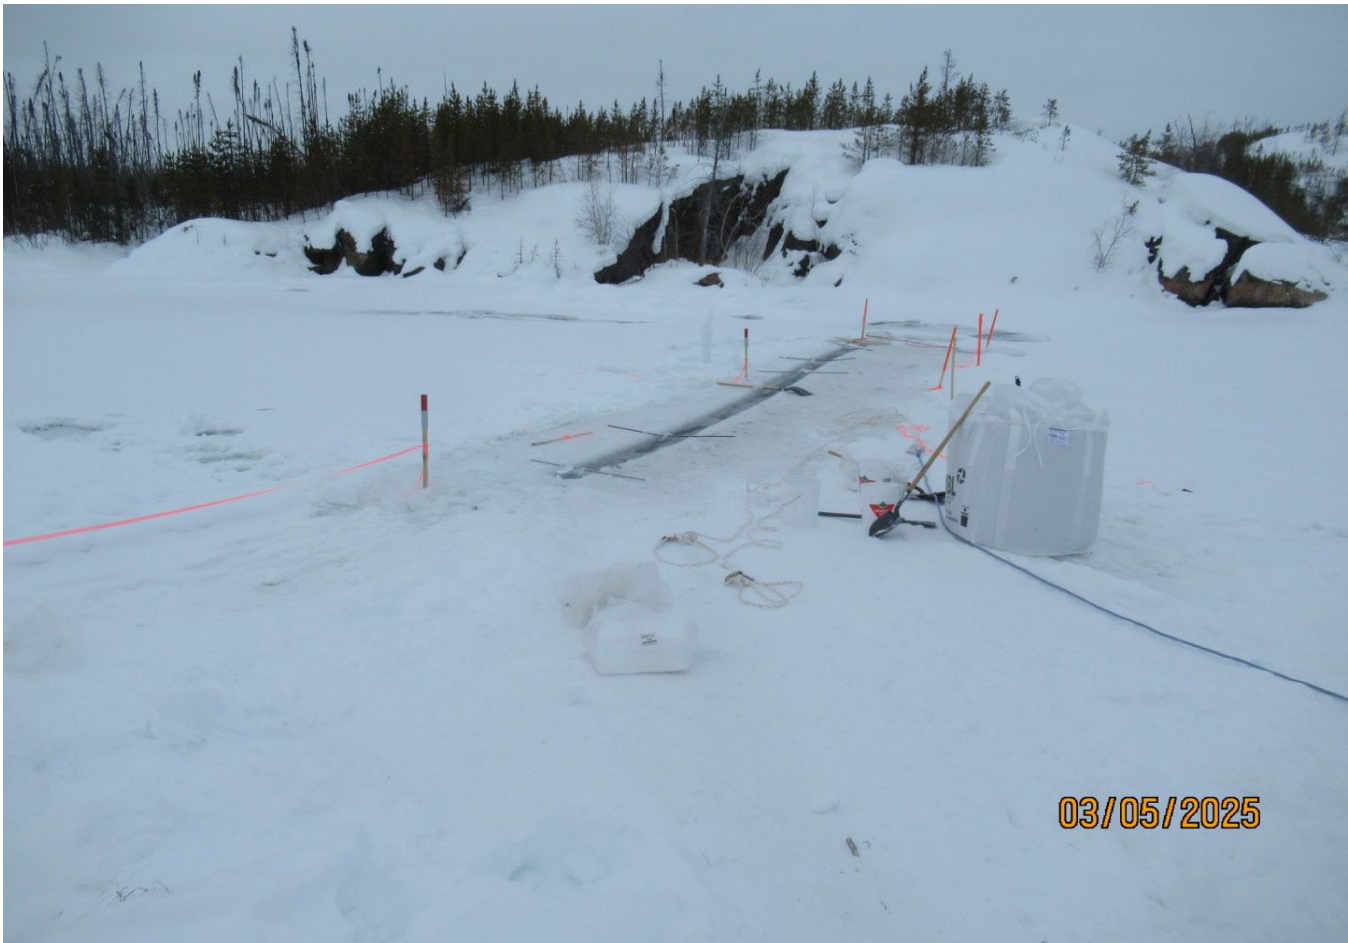
**Figure 3**

**Hydrocarbon absorbent booms were installed in the ice slot and changed out regularly.**

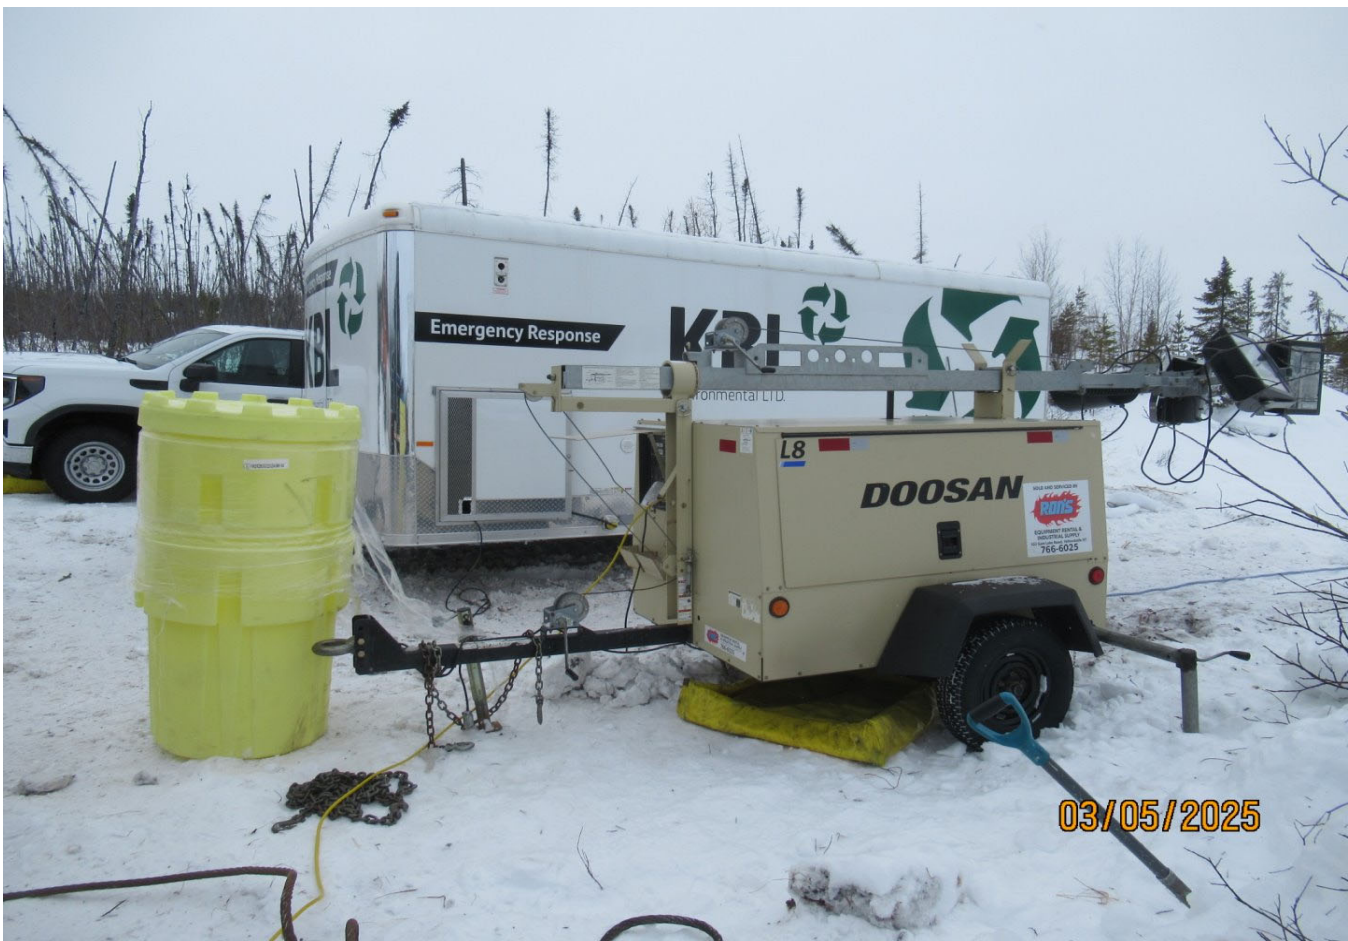
**Figure 4**

Other best practices observed during the inspection were the placement of the light plant in secondary containment, positioning an Emergency Response Trailer at the breakthrough location (Figure 4), and securely storing all potentially hydrocarbon impacted ice in poly lined mega bags (Figure 5) until offsite disposal occurs.

**The light plant has secondary containment present and spill response materials are readily available.**

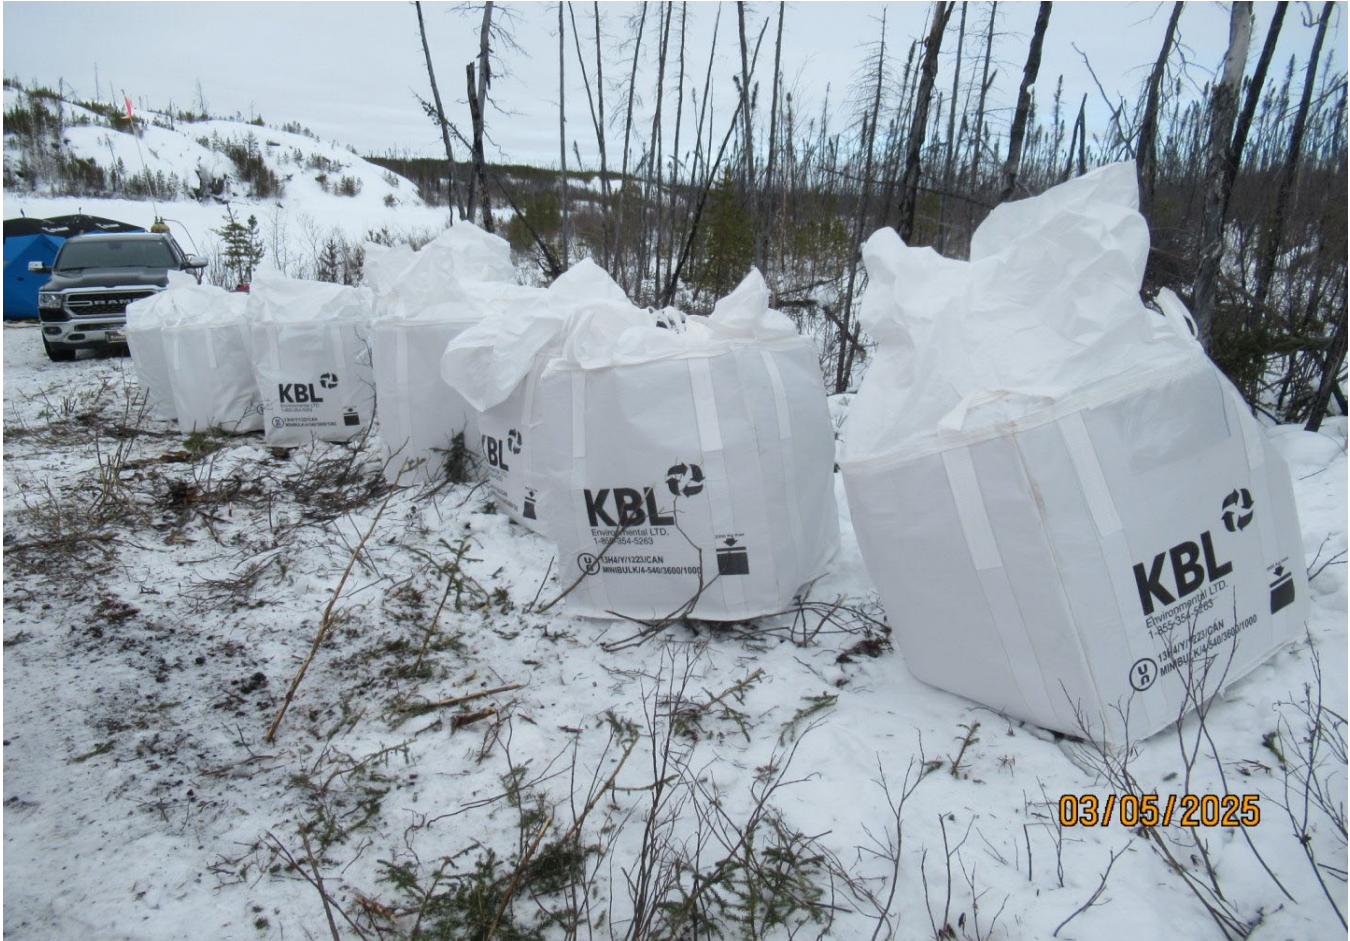
**Figure 5**

**Poly lined mega bags are being used for the secure storage of impacted ice and spent absorbent pads until proper offsite disposal occurs.**

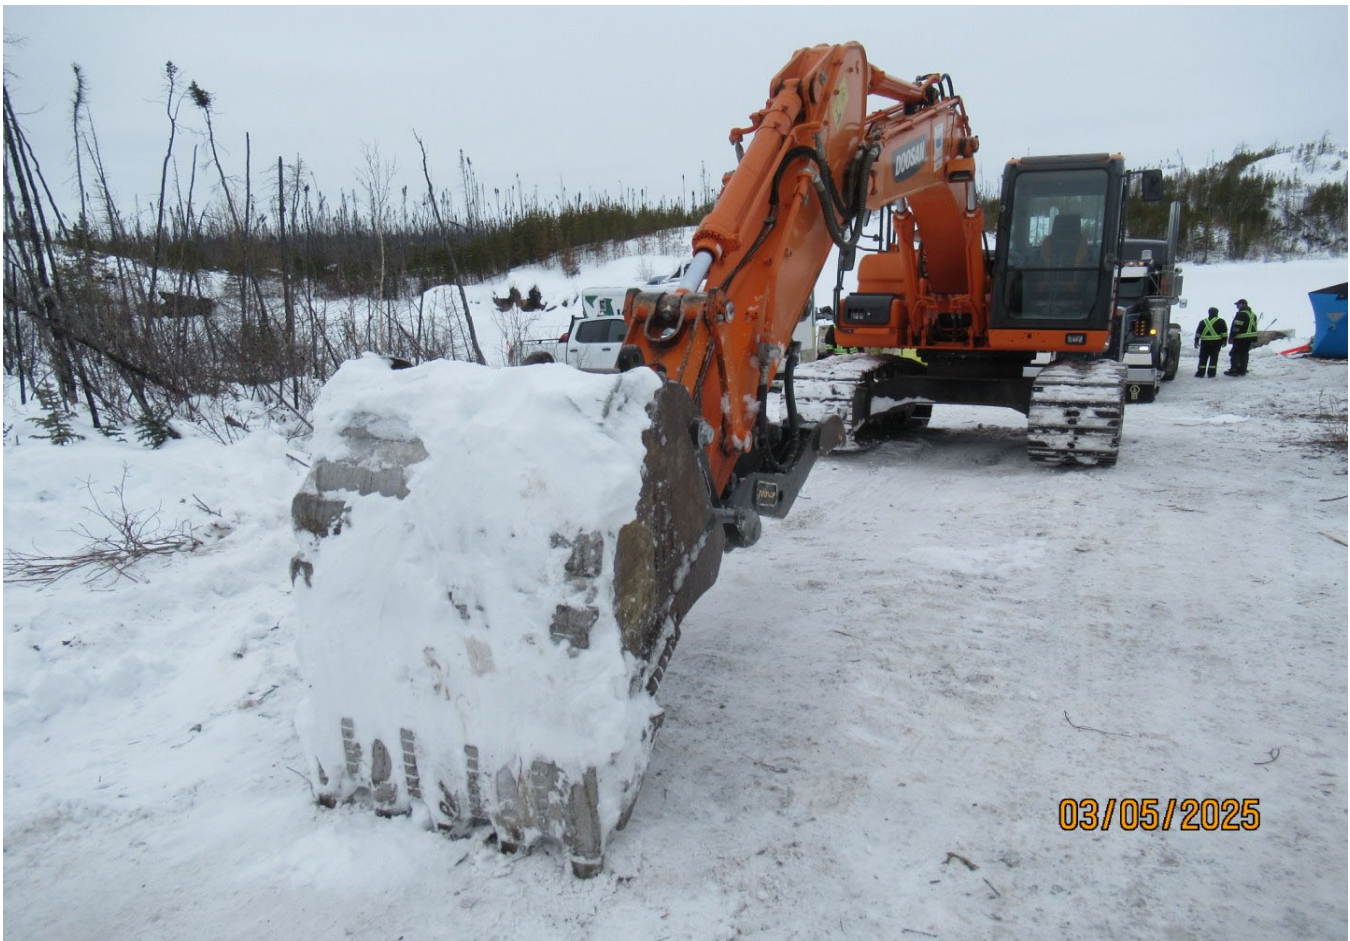
**Figure 6**

**An excavator was used to remove ice blocks from the river and to function as an anchor for the winching of the snowcat.**

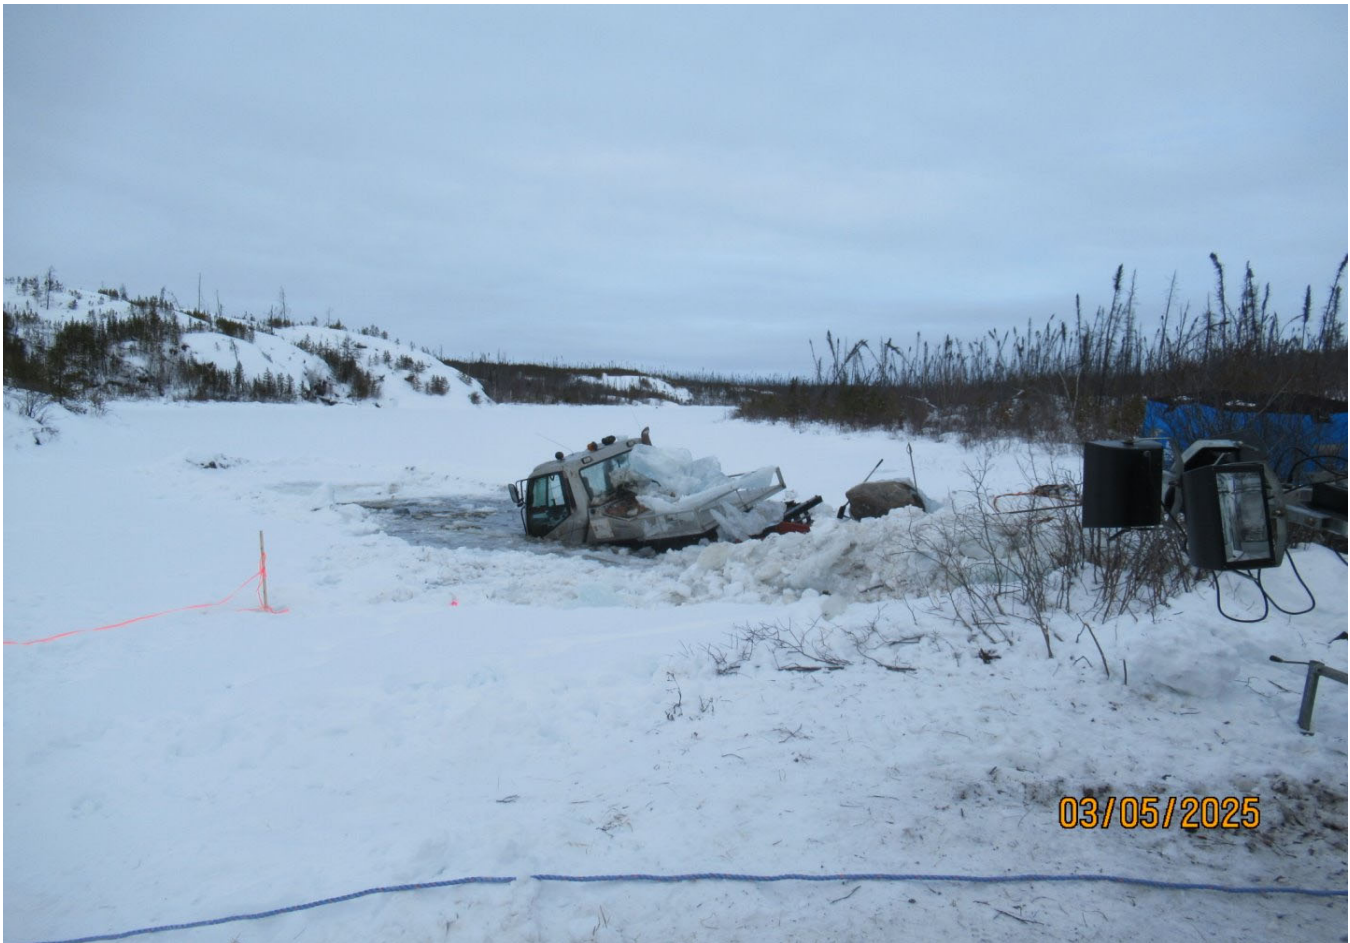
As seen in Figure 7, the snowcat was winched to shore and upon inspection of the water surface, the Inspector is pleased to report that minimal hydrocarbons were present. Figure 8 shows "clear" water without a sheen and the only areas of concern can be viewed in Figure 9 & 10. The requirement to remove hydrocarbon impacted snow & ice and to mop the surface of the water was discussed with Mr. Snyder and Mr. Purchase.

**Figure 7**  
**Snowcat being winched out of the Emile River.**

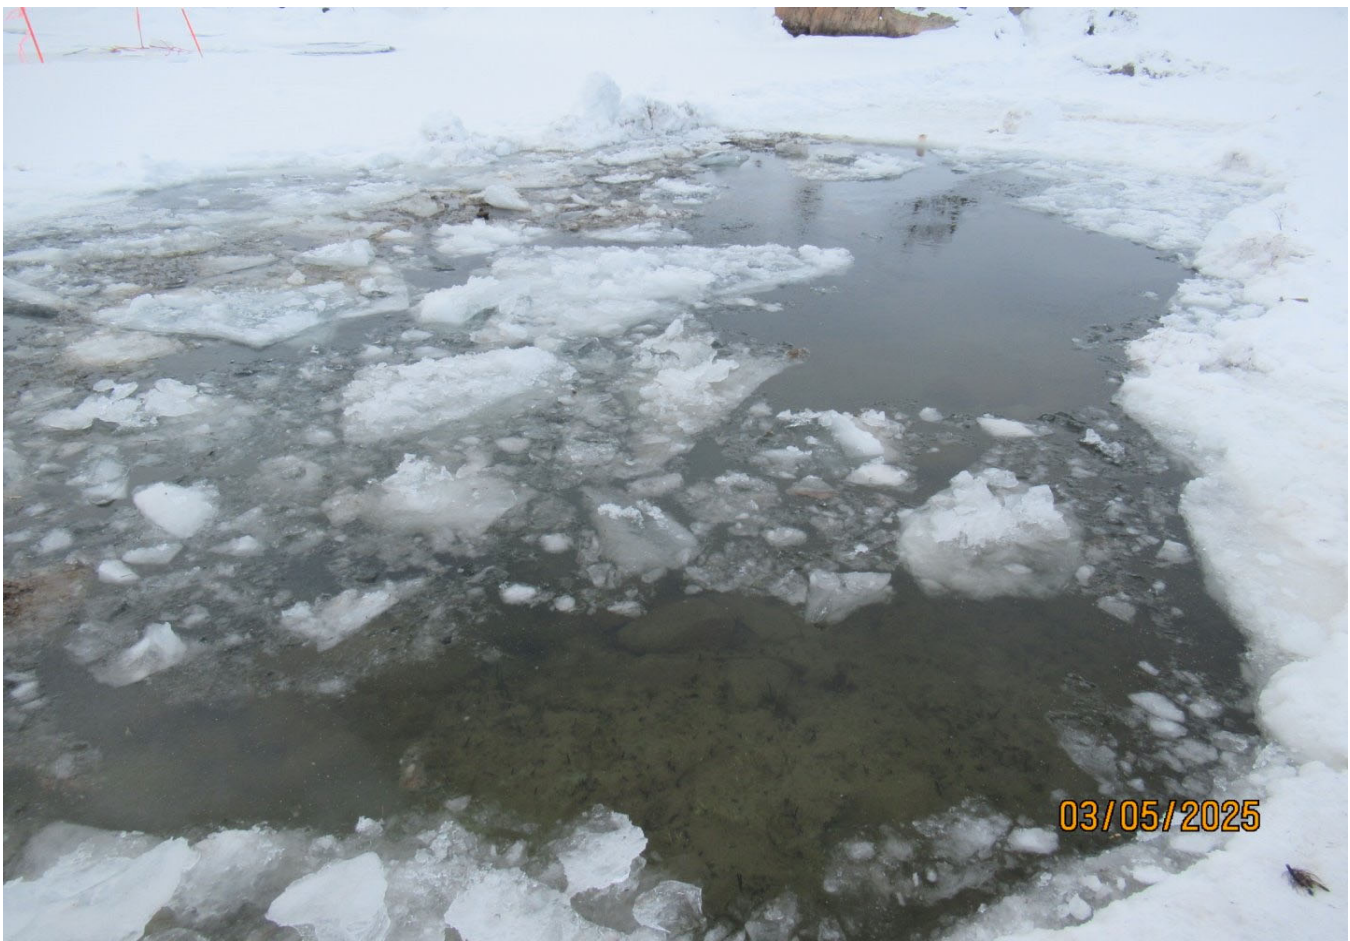
**Figure 8**  
**No hydrocarbon sheen was observed on the upstream side of the excavated hole in the Emile River.**

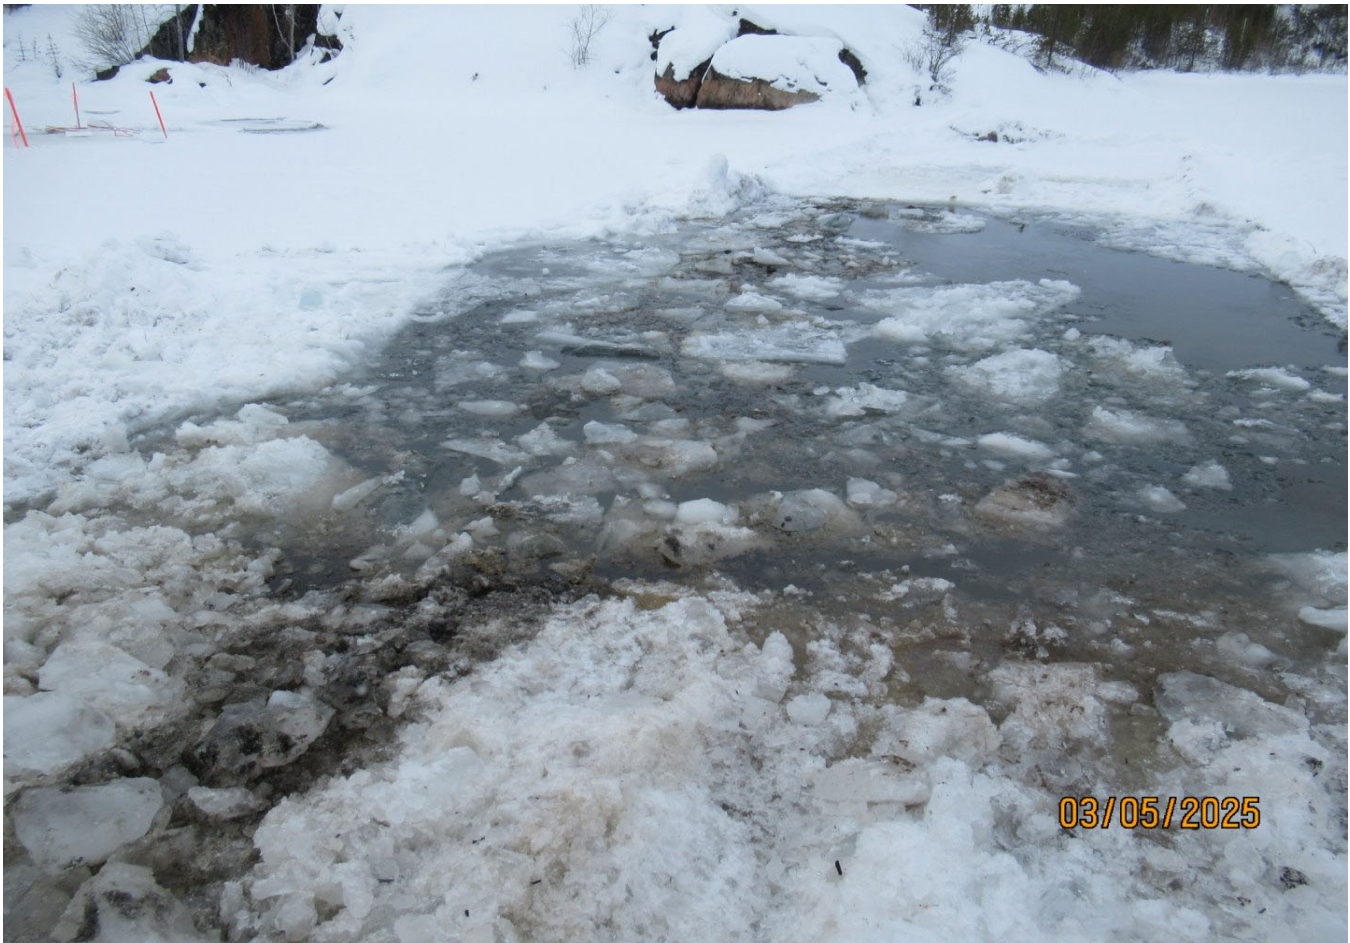
**Figure 9**

**Engine oil and other hydrocarbons were observed. A thorough cleanup must be undertaken.**

The Inspectors were assured that the excavator would not be demobilized until full restoration was complete, and photographs taken. As per Condition #63 of the land use permit, a detailed report must be provided to the Inspector within 30 days of initially reporting the incident and therefore due **no later than 17:00 HRS on March 14<sup>th</sup>, 2025.** It is anticipated that photographs of the final mop will be included in this report, if not provided sooner.

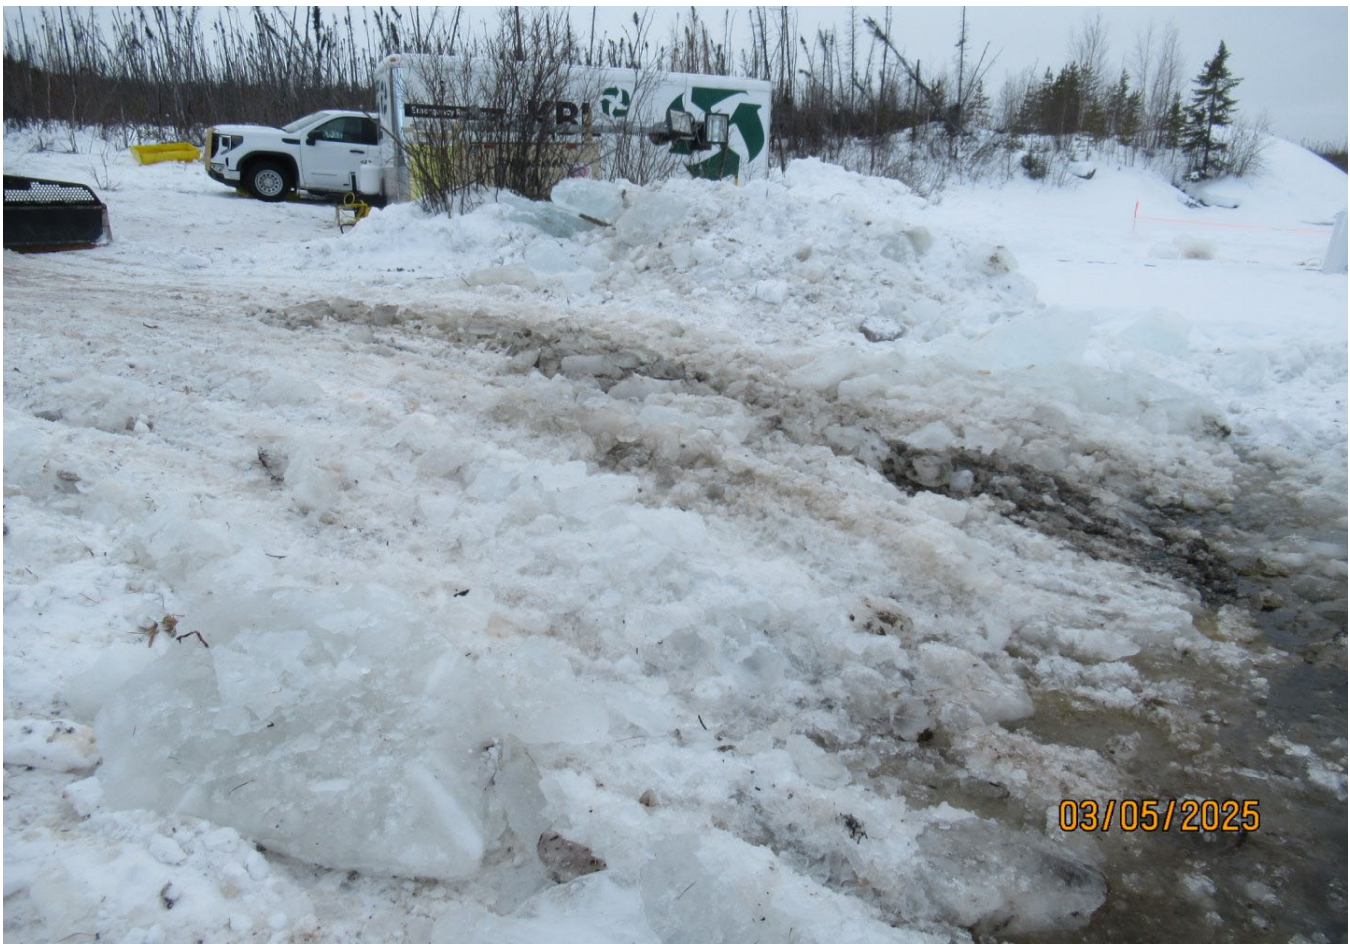
**Figure 10**

**Hydrocarbon impacted snow and potential soils require excavation for offsite disposal at a licensed facility in Yellowknife.**
