File Number W2021Q0011
Type of Operation QUARRY SITE – Winter Road
Location From km12 of the Wekweeti Winter Road to the Snare Forks Hydro Facility.

ENVIRONMENTAL INSPECTION REPORT

Location(s) Inspected:	The 12.3km winter road from the Wekweèti (Km 12) to the Snare Forks Hydro Facility
------------------------	--

Current Stage of Operation:	Winter road construction with final grooming to be completed.
-----------------------------	---

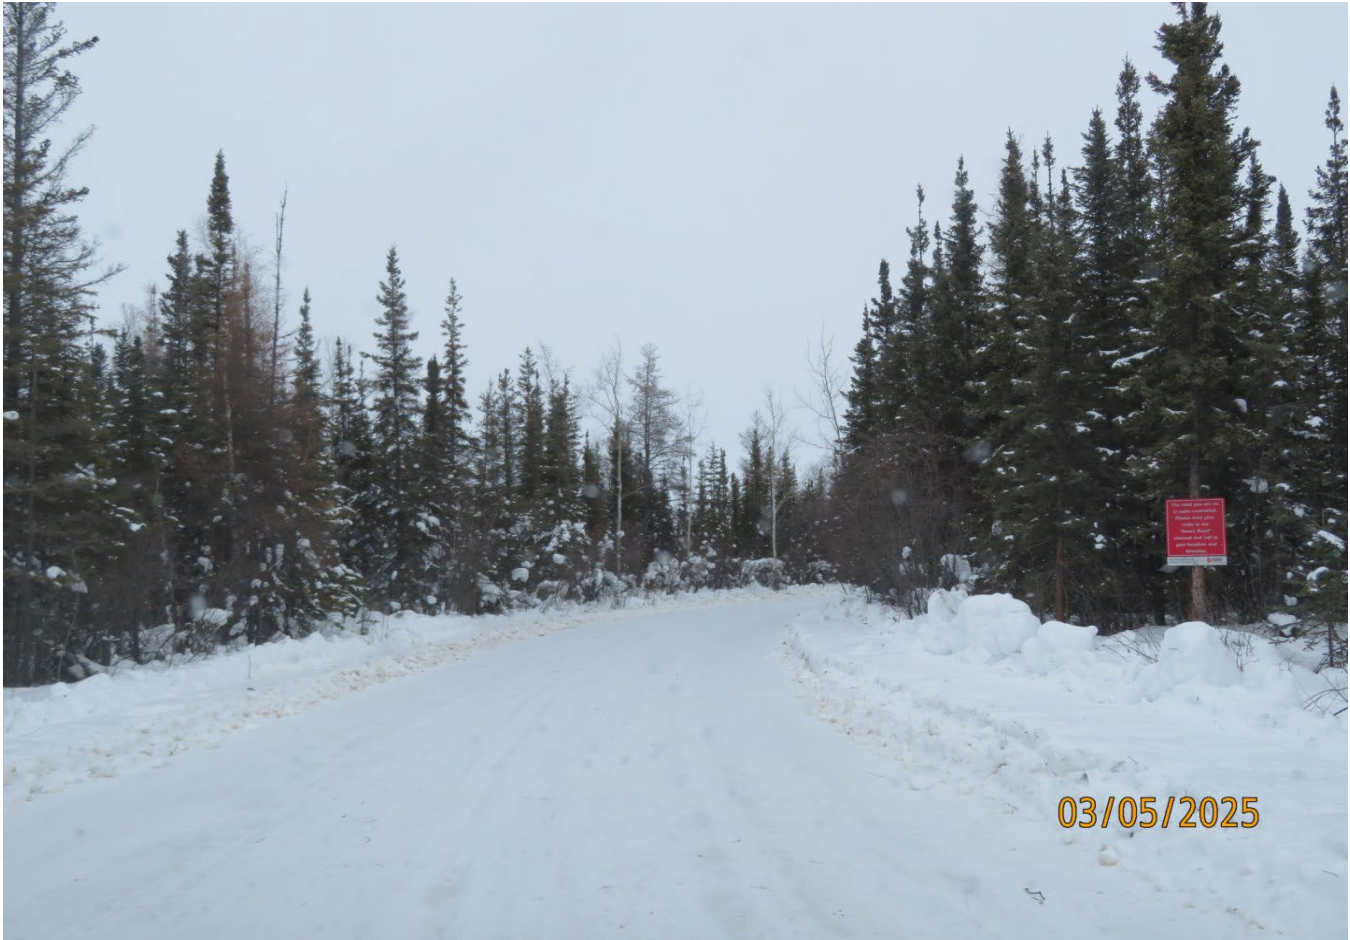
Figure 1

View from the start of the Snare Hydro Facility winter road from the km 12 junction of the Wekweèti Winter Road.

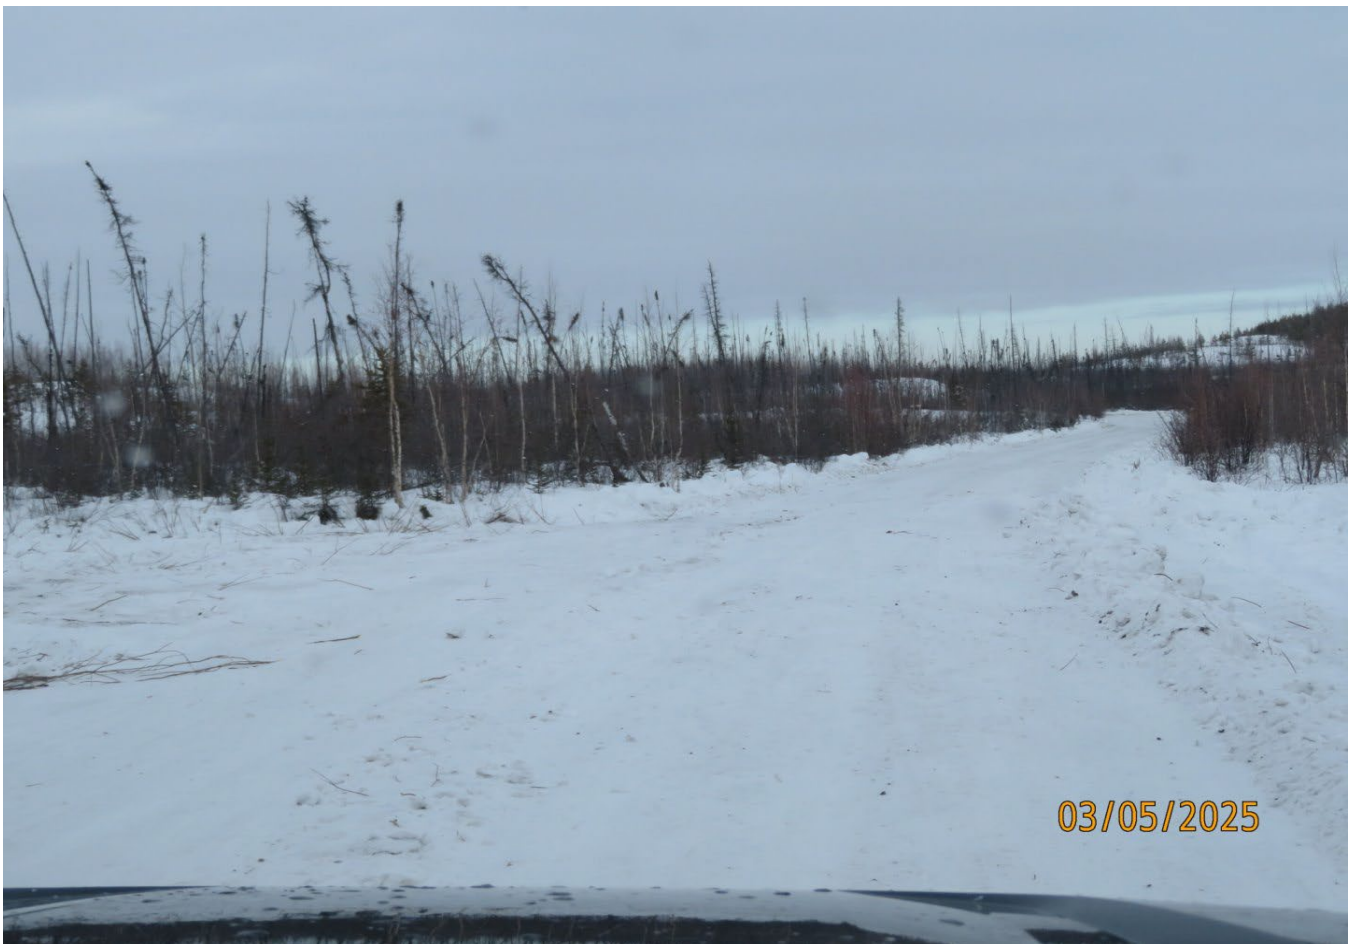
Figure 2

Section of the Snare Hydro Facility winter road. Icing is completed shoulder to shoulder and the road is ready for final grooming.

At the time of the inspection, the road was nearing completion, and no equipment was observed working on the road. No gouging or rutting was observed during the inspection, and adequate ice coverage was observed on the road. Final grooming must be completed to ensure the 10cm ground protection is met for all sections of the road. Notification is to be provided once final grooming is done confirming the completion of the road construction.

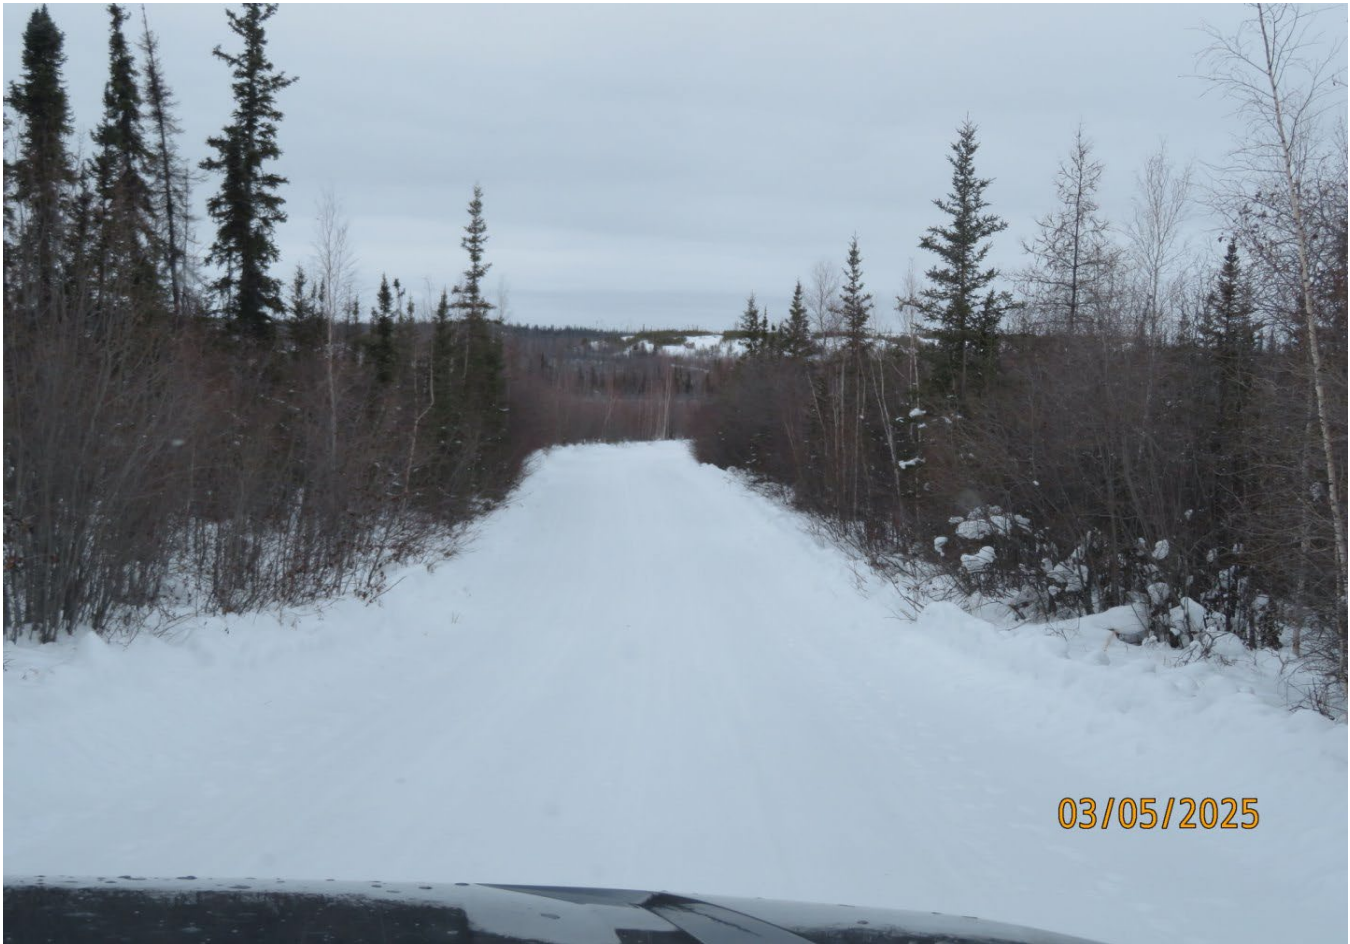
Figure 3

Another example of a section of the Snare Hydro Facility winter road.

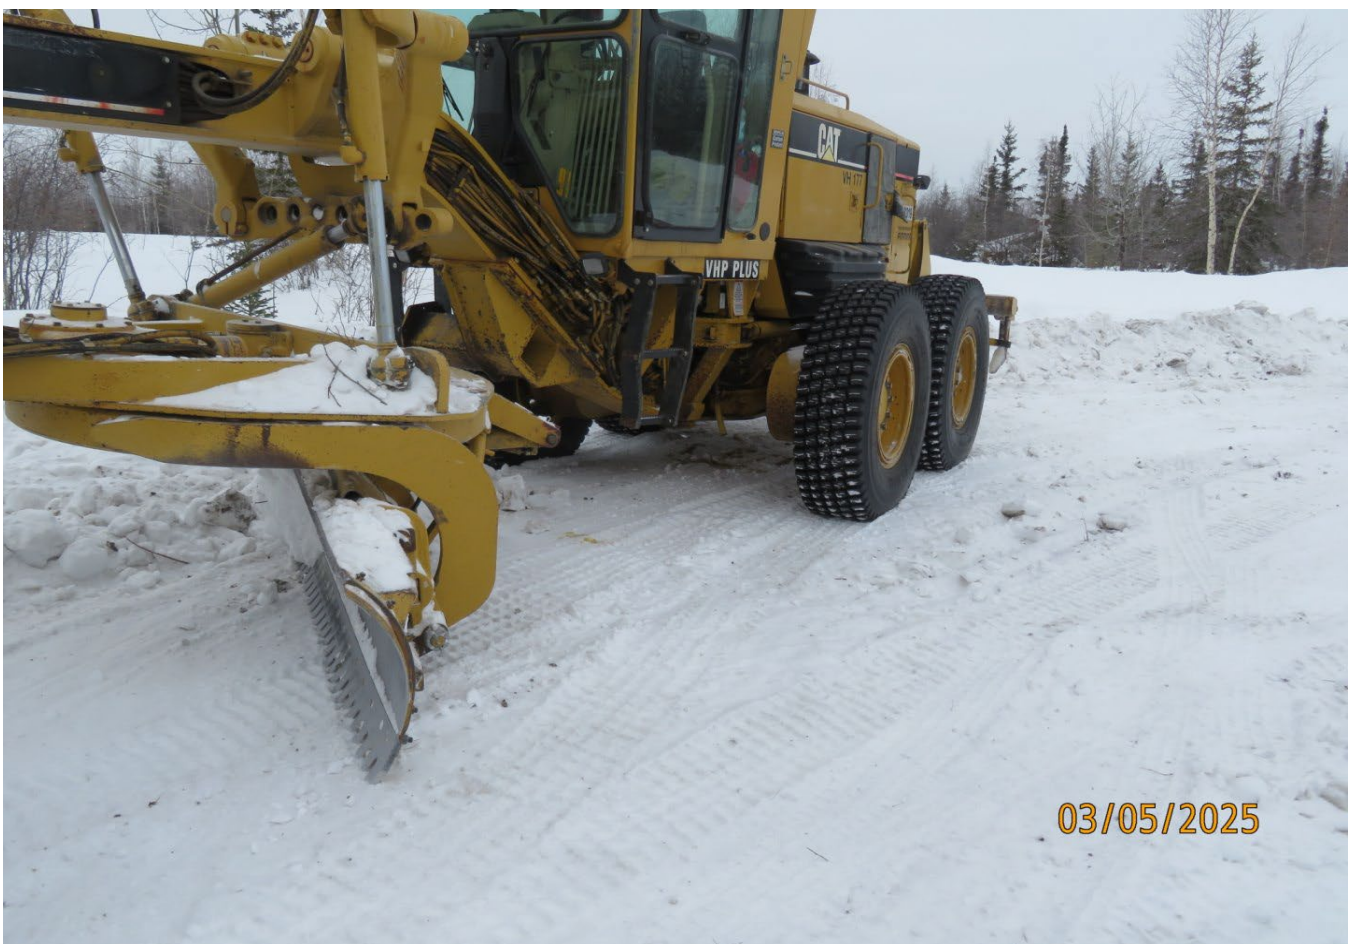
Figure 4

Grader parked at the end of the winter road at the Snare Hydro Facility Forks. There is no drip tray underneath, and a small drip of oil was observed. The spill must be cleaned up and the leak repaired.
