**File Number** G20H006  
**Type of Operation** CAMPS - < 50 Man Camp  
**Location** James Creek Highway Maintenance Camp

### ENVIRONMENTAL INSPECTION REPORT

**James Creek Km 14.2:**

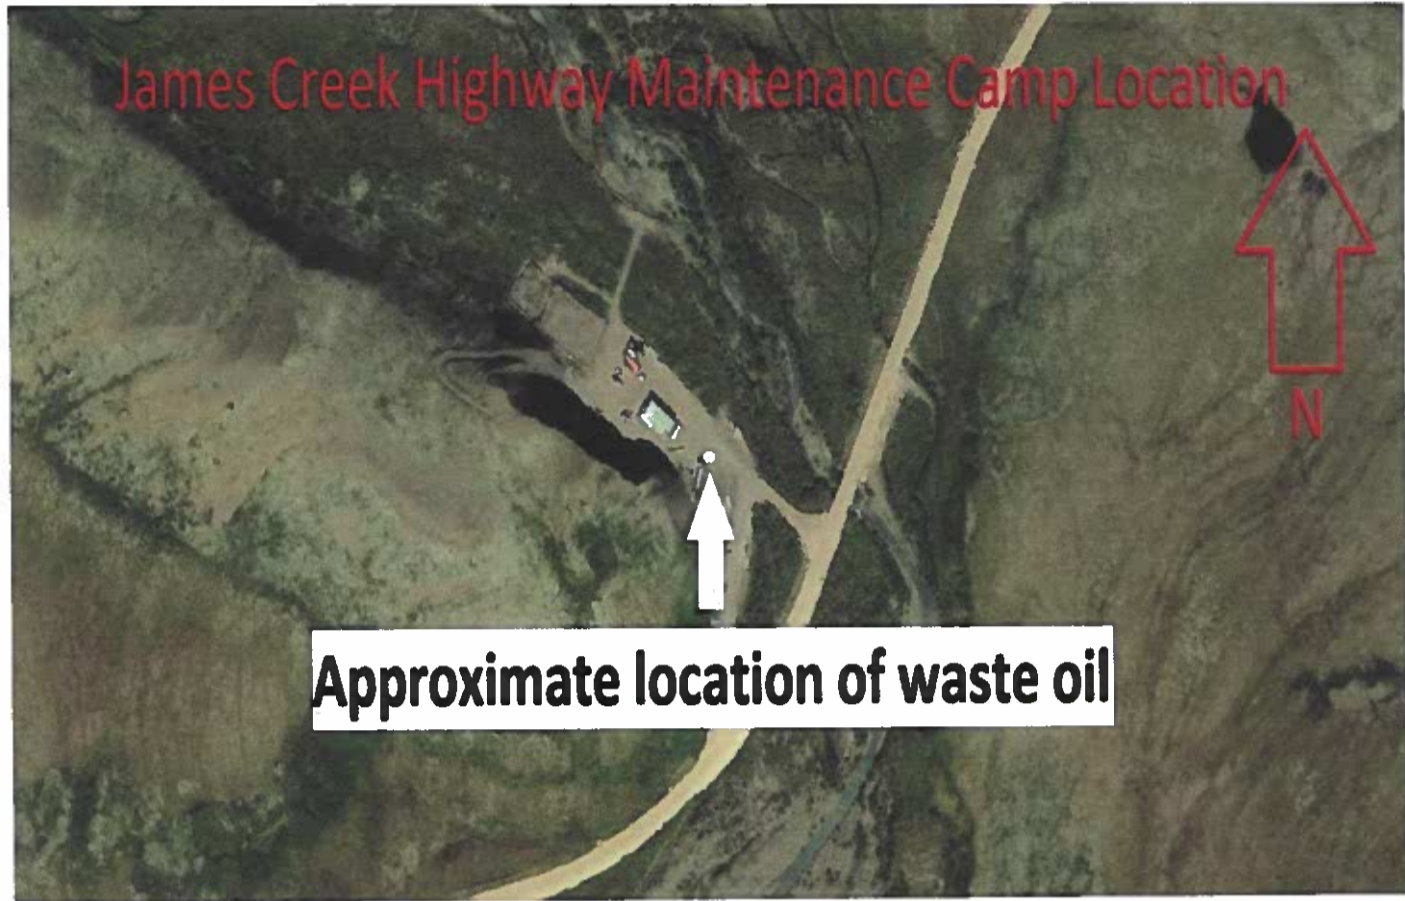
**Figure 1**

**Aerial view of the site, taken from the Government of the Northwest Territories Administration of the Territorial Lands Act System or GNWT ATLAS.**

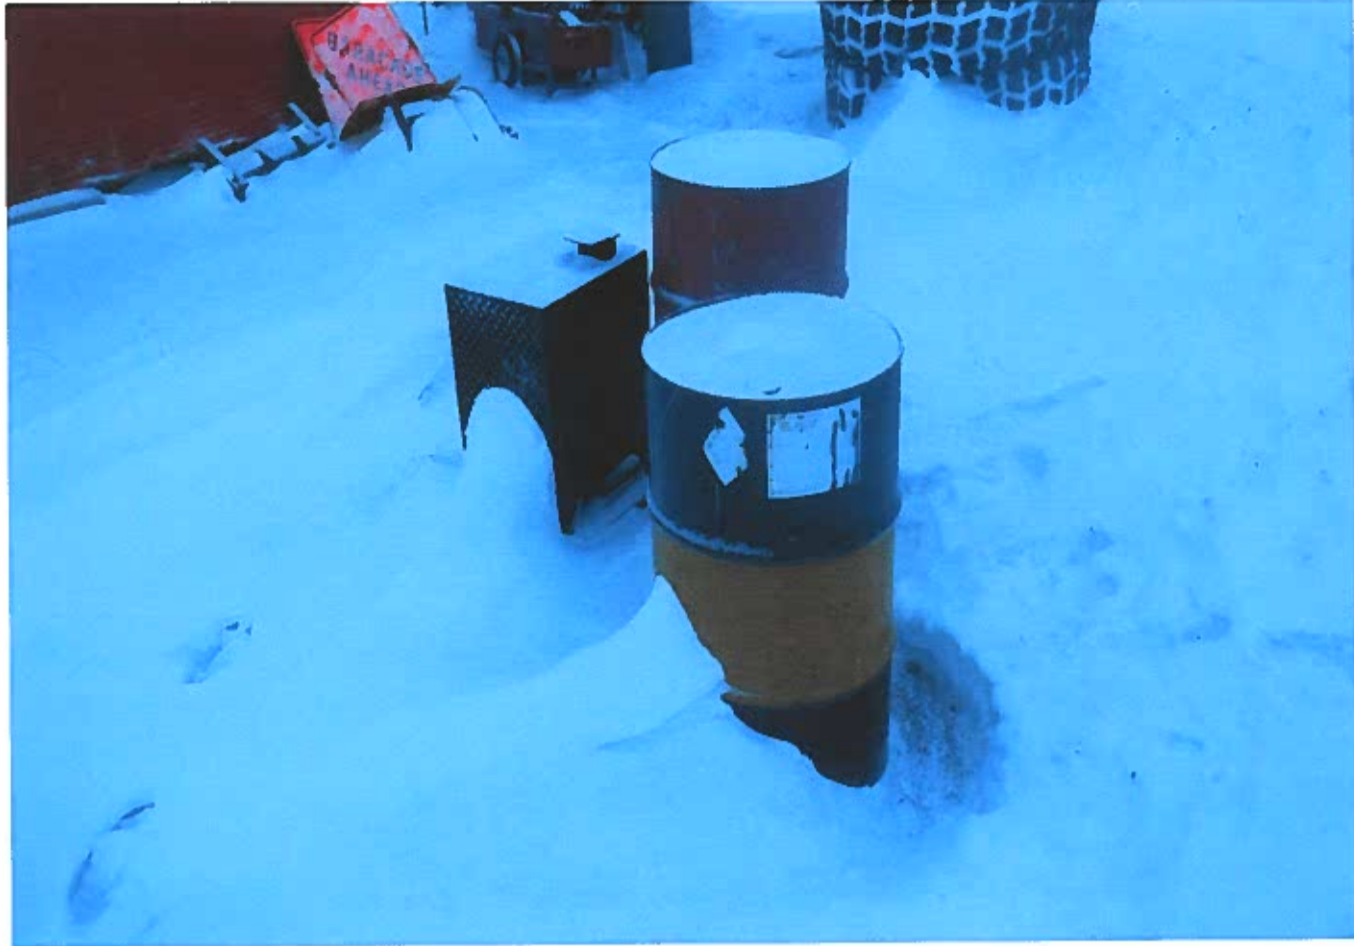
**Figure 2**

During the inspection it was observed that there was one unacceptable condition related to the operation. Near the entrance there were two 205-liter drums and one smaller container that had waste oil/hydrocarbon (see figure 1). The Highway Maintenance operation and Terms and Conditions of the permit do not allow for any waste oil storage on-site.

The waste oil drums referred to in the comments section of this report.

Waste oil observed on December 14, 2022 inspection.

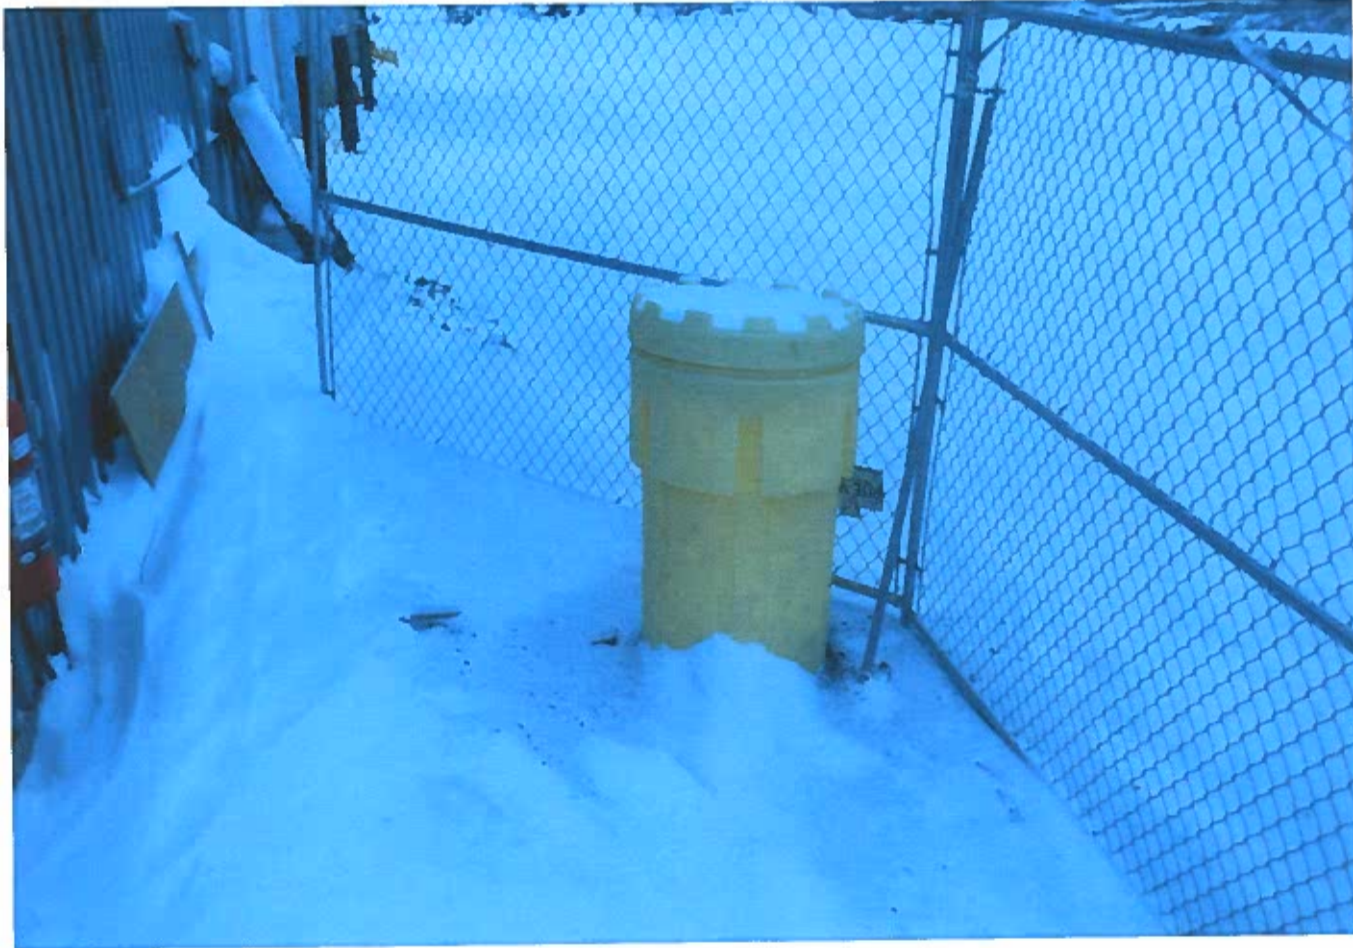
**Figure 3**

Spill kit near the fuel storage tanks.
