**Inspection: Emile Lake A-77 (WID 1964) Well – ACW-2019-010-CNRL-A-77-WID1964**

# OROGO Operations Inspection Summary Report

Well name: Emile Lake A-77

Nature of activity: Abandonment

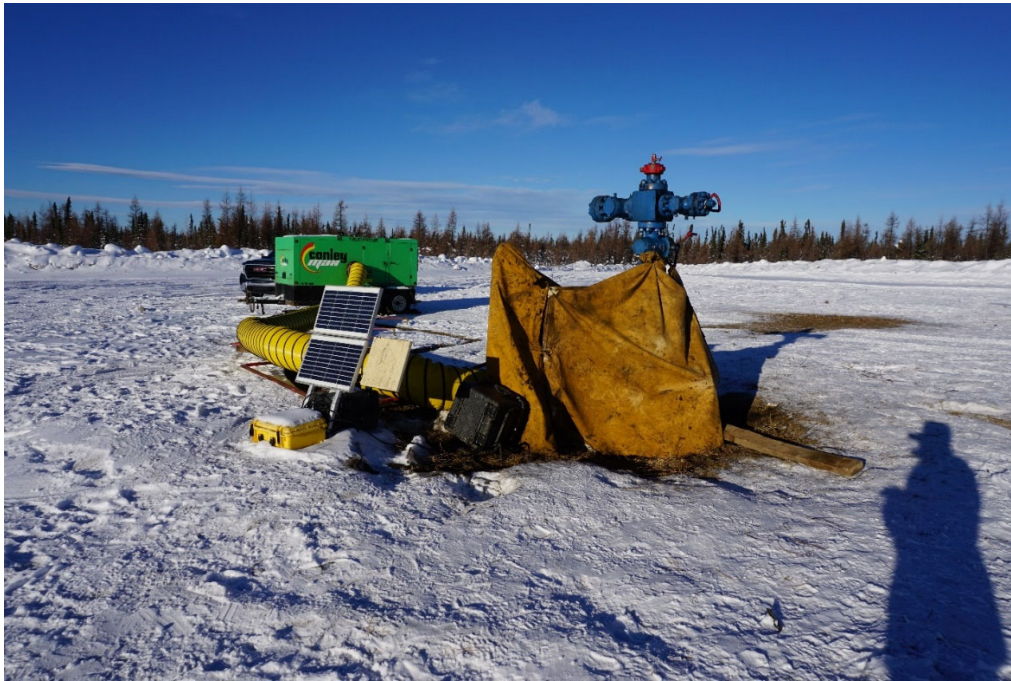
PHOTO #1: View of the A-77 wellhead monitoring for surface casing vent flow after completing the casing expansion intervals.

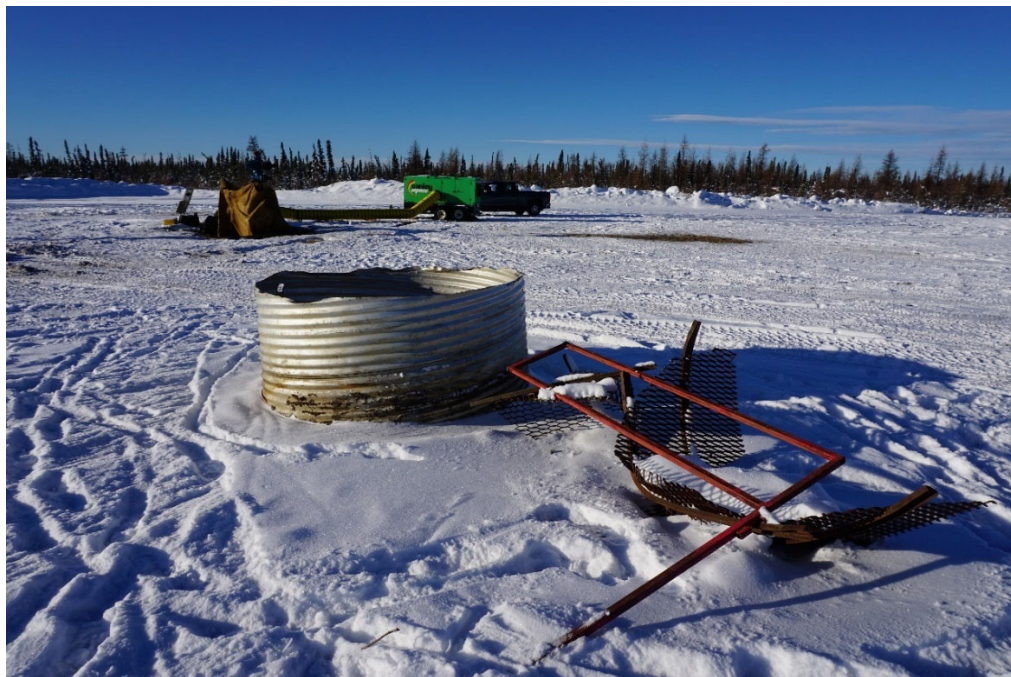
PHOTO #2: Waste metals must be removed for proper offsite disposal at an authorized disposal facility.

Although no concerns were noted during the inspection, CNRL personnel must ensure the ground surface over the wellhead is mounded after cut and cap operations to ensure no ponding of water occurs above the abandoned well. All waste items seen in Photo #2 must also be removed for proper offsite disposal at an authorized disposal facility.

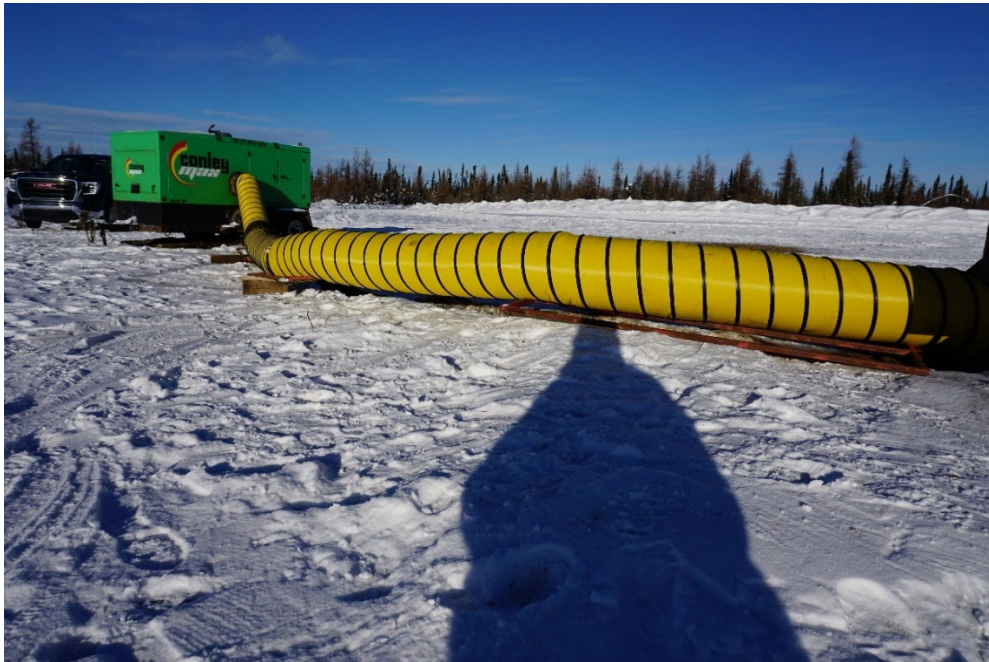
PHOTO #3: Heated air tubing was elevated off the ground surface and no concerns were noted.

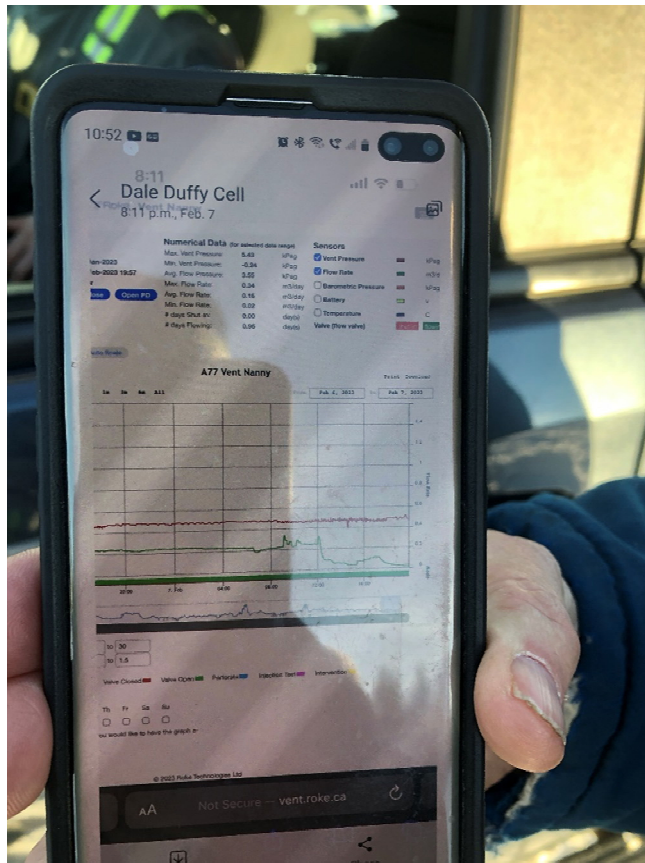
At the time of the inspection, the Emile Lake A-77 wellhead had a 'Vent Nanny' installed to monitor the effectiveness of the casing expansion on repairing the SCVF. The February 7, 2023 'Vent Nanny' report (Photo #4) showed a continuing decrease in the SCVF following the casing expansion operations.

PHOTO #4: 'Vent Nanny' monitoring report for Emile Lake A-77 showing a steady decrease in the SCVF following the casing expansion on February 7, 2023.
