WELLSITE SUMMARY INSPECTION REPORT

Well/Facility Name:	Arrowhead River O-38	Operator:	Canadian Natural Resource Ltd.
Location of Inspection:	60° 37' 51" N 123° 51' 25" W	Access method:	Helicopter
Site Contractor:	N/A	Status:	Non-compliant suspended
Approval Info	ACW-2019-013-CNRL-O-38-WID1983 Variation # 2	WID:	1983
Date of Inspection	23-FEB-2022	H2S Site:	Yes

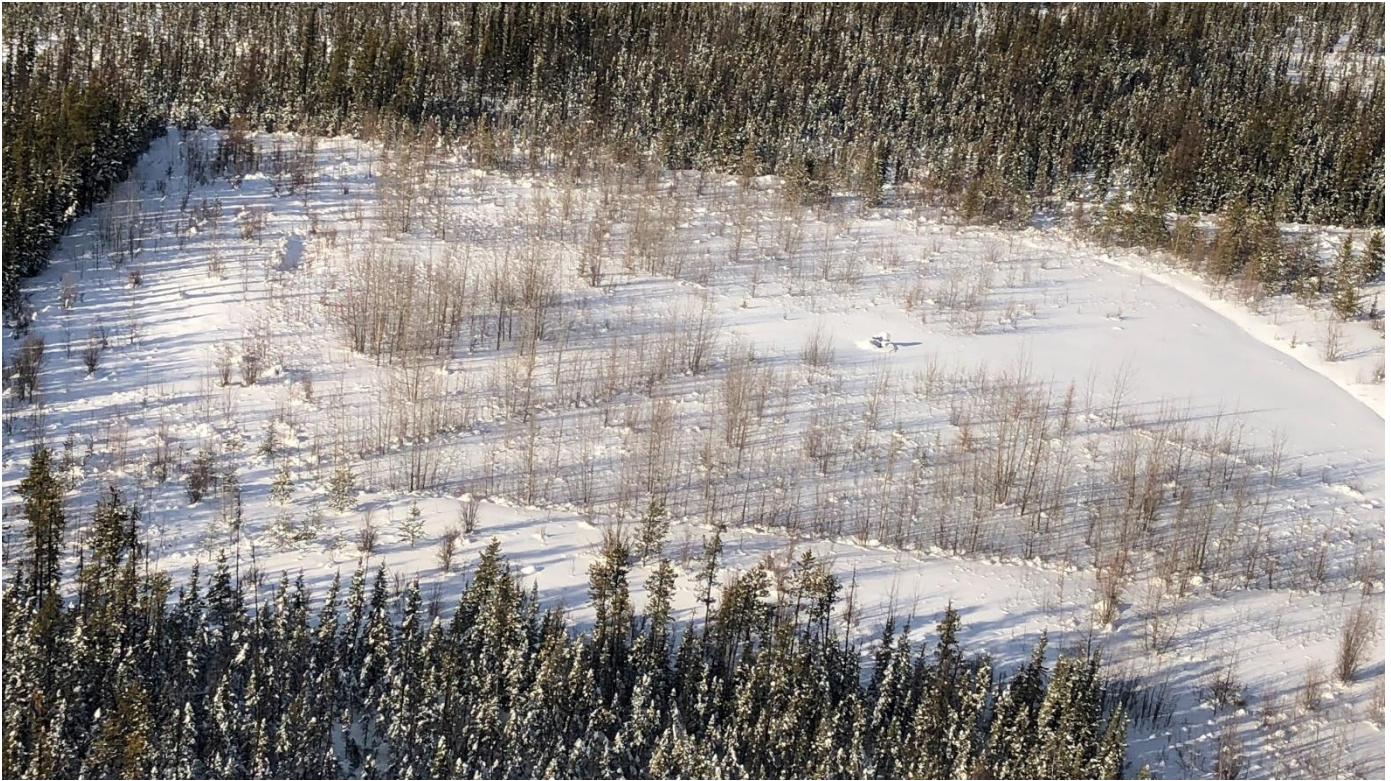
Activity on site	N/A		
Conditions	Satisfactory (Y/N)	Comments	
Site Access	N	Site access is restricted by encroachment of brush (See Photo #1). No wind indicator installed at the site (See Photo #2)	
Well Head Access	N/A		
Signage	N/A	Well identification sign installed. Unable to confirm compliant signage in place. (See Photo #2)	
General Housekeeping	Y	No debris noted on site above snow cover.	
SCV Open and dead	N/A

At the time of the inspection there was brush encroachment onsite restricting site access and sight lines from some directions limiting safe access to the site. There was no wind indicator installed on the site.

Photo #1: Aerial view of Arrowhead River O-38.

Section 5A of the *Well Suspension and Abandonment Guidelines and Interpretation Notes* states "All wellheads must be safely accessible for inspection and monitoring".

The well site must allow for year-round access to inspect and monitor including winter months when there may be significant snow depth on the ground. This includes the requirements to:

- Maintain the wellsite to allow rotary wing aircraft to land at a safe distance upwind of the well head;
- Ensure safe ingress, egress and access to the well head and valves for inspection and monitoring; and
- Install a wind indicator.

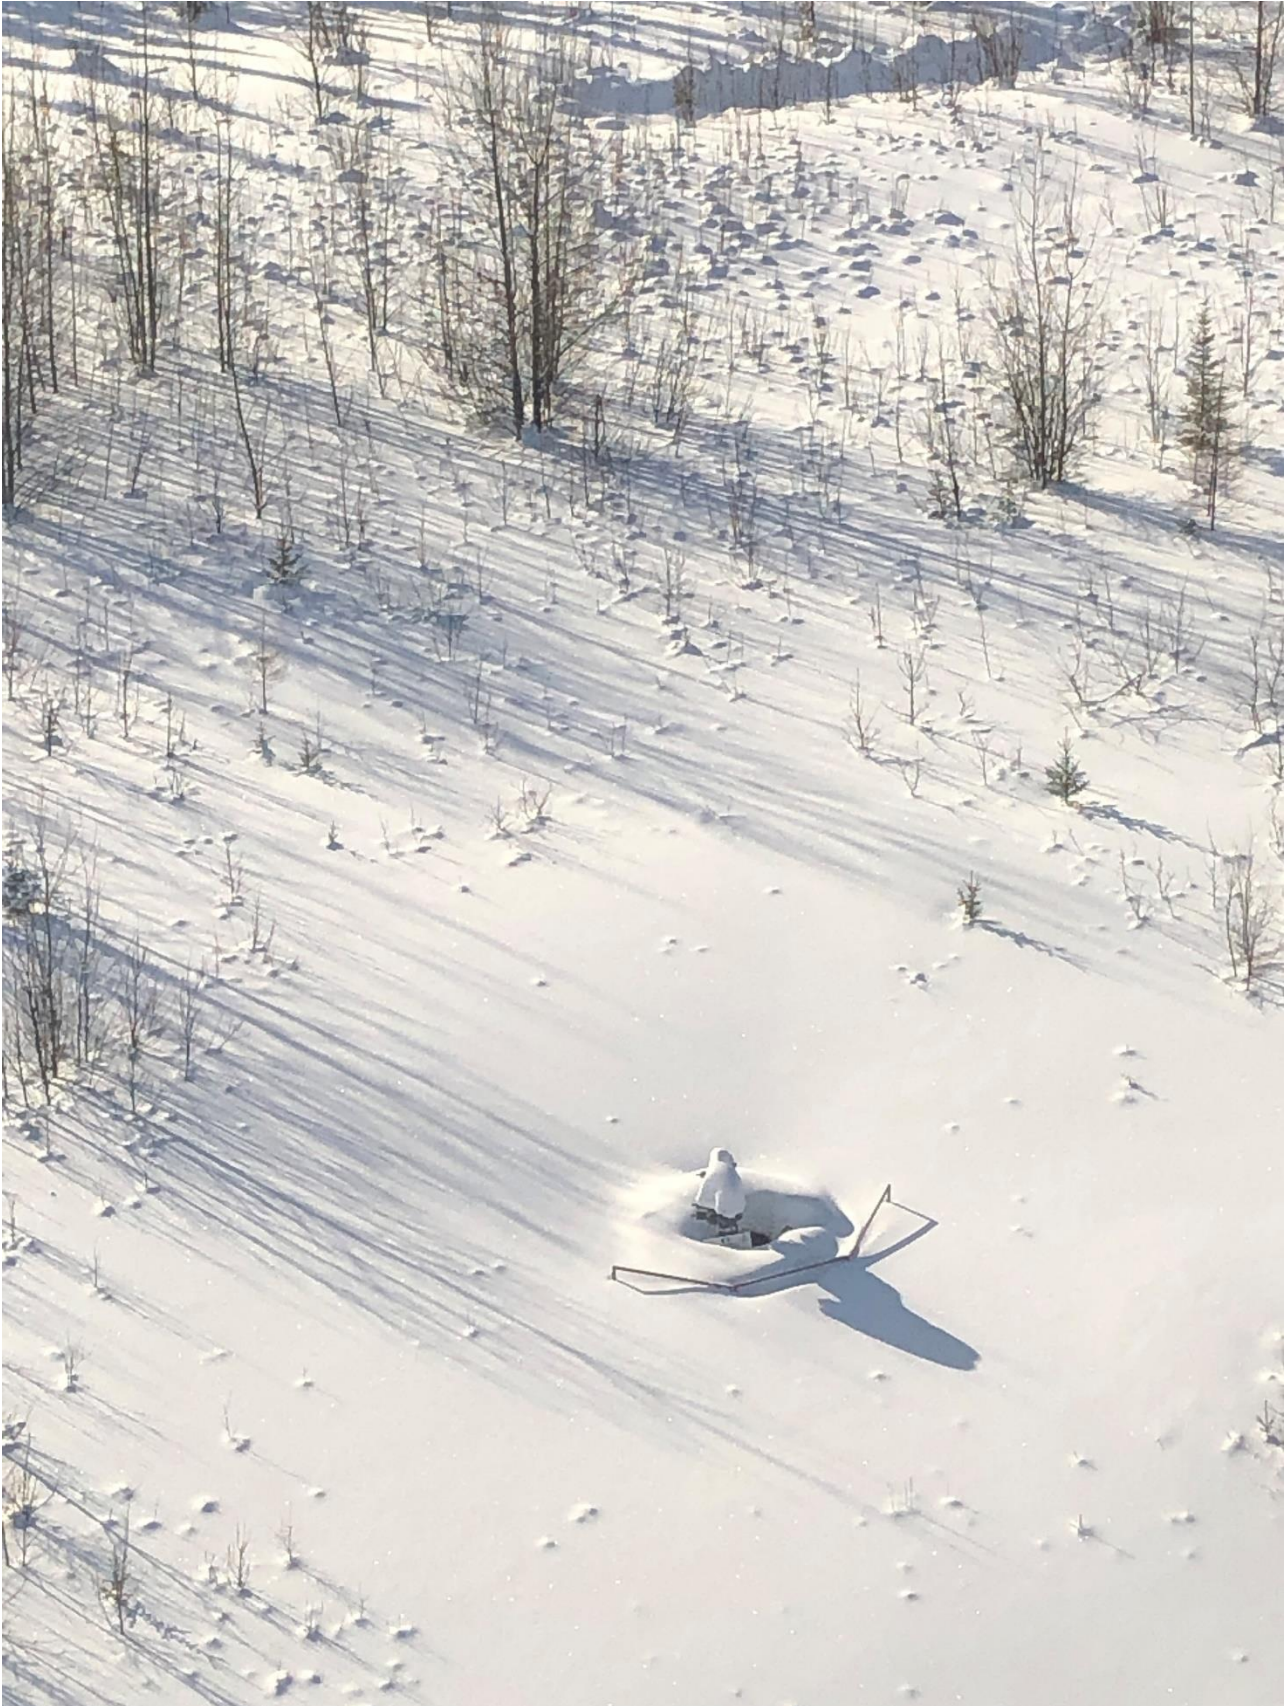
Photo #2: Aerial view of Arrowhead River O-38 Well Head – No wind indicator
