OROGO Well Inspection Summary Report

Well name: Nogha K-14

Operator: MGM Energy

Date of inspection: 2026-03-03

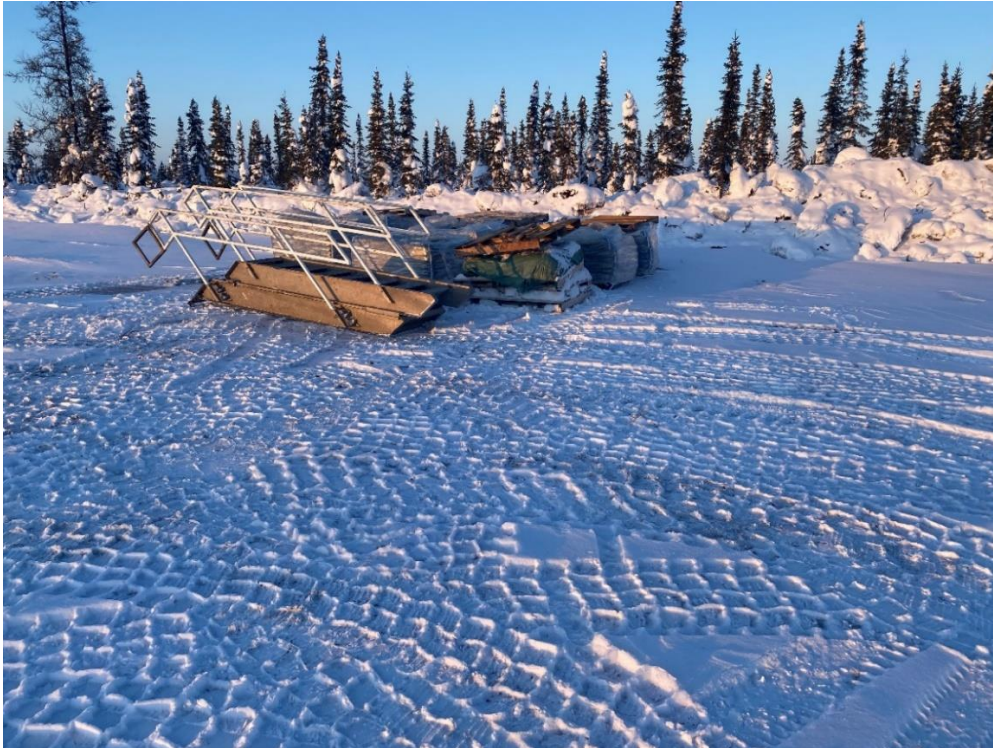
9 pallets of G class cement and metal frame stairs were observed on site to support abandonment operations (photo 1).

Photo 1: Pallets of G class cement and metal stairs on site to support abandonment operations.

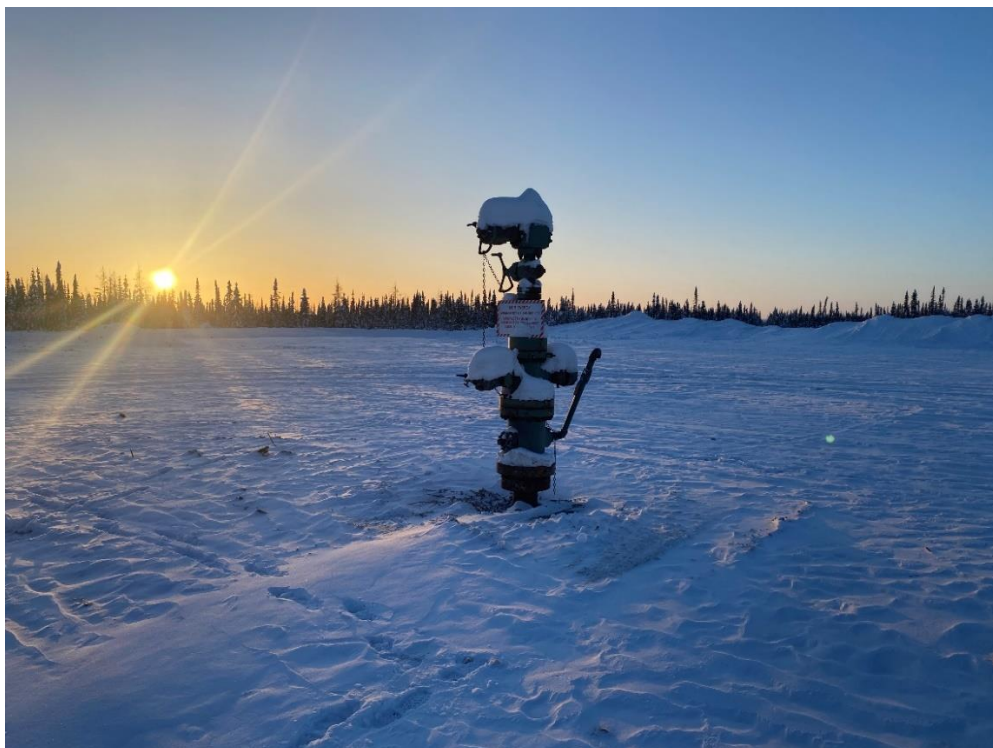
Abandonment of the Nogha K-14 well will take place upon completion of downhole operations at the Nogha B-23 well. All valves were chained and locked and well identification sign in place (Photo 2). The OROGO inspectors ensured the surface casing vent was open and placed a nitrile glove over the vent to see if there were any indications of flow (Photo 3). No indication of a surface casing vent flow was observed. As a reminder wind indicators need to be present on all well heads until commencement of surface abandonment operations.

Photo 2: Nogha K-14 (WID 2006) Wellhead with valves chained and well identification signage in place.
