OROGO Well Inspection Summary Report

Well name: Nogha C-49

Operator: MGM Energy

Date of inspection: 2026-03-03

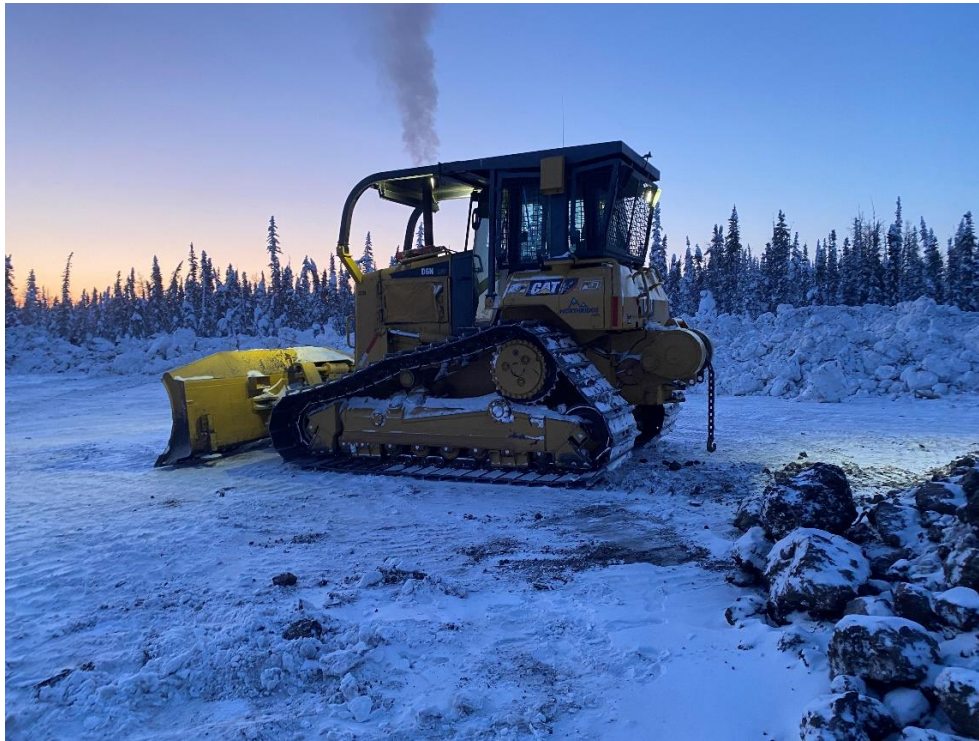
Photo 1: Caterpillar D6N Crawler Dozer

Caterpillar D6N Crawler Dozer (Photo 1) was on site staged to backfill the excavation around the wellhead.

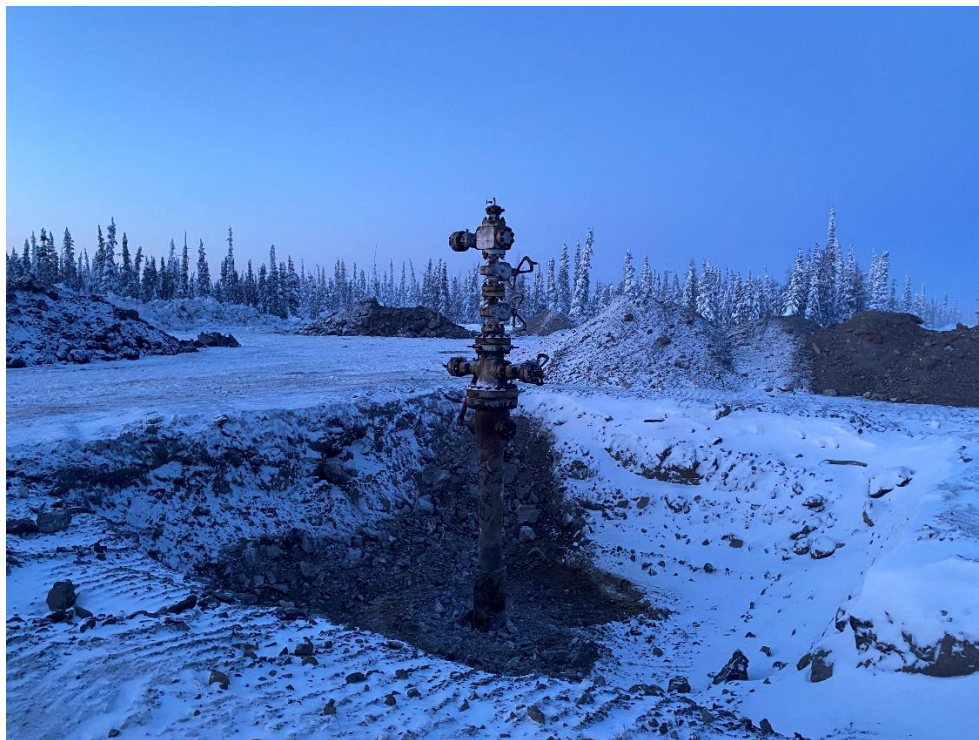
Photo 2: Nogha C-49 (WID1934) wellhead prepared for surface abandonment

Soil around the wellhead was excavated (Photo 2) in preparation for cut and cap operations in compliance with the Well Suspension and Abandonment Guidelines and Interpretation Notes surface abandonment requirements.

Zonal abandonment was completed on February 24, 2026. Site was being prepared for surface abandonment. OROGO has no concerns with the absence of valve chains and wind indicators as the well was being prepared for surface abandonment operations.
