Inspection: North Arrowhead River C-55 (WID 1979) Well – ACW-2020-003-CNRL-C-55-WID1979

OROGO Operations Inspection Summary Report

Well name: Arrowhead River C-55

Nature of activity: Abandonment

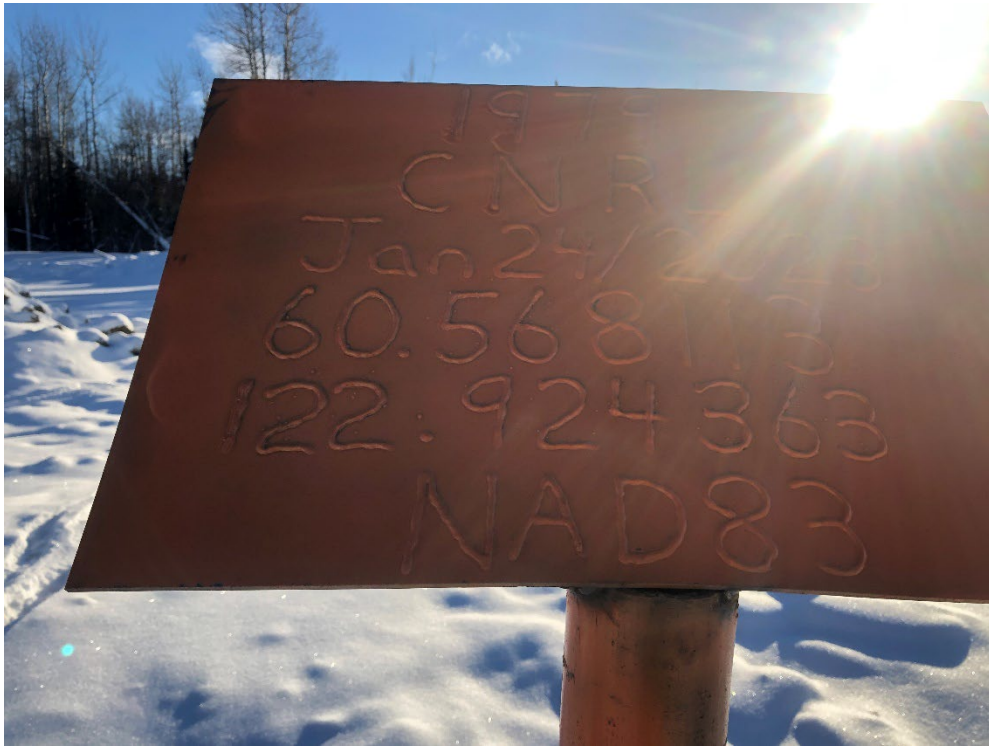
PHOTO #1: Well abandonment sign

The well head and associated infrastructure has been removed from the lease area and cut and cap operations were completed on January 24, 2023. High visibility signage was placed 1 meter to the North of the well and therefore no major concerns were noted.

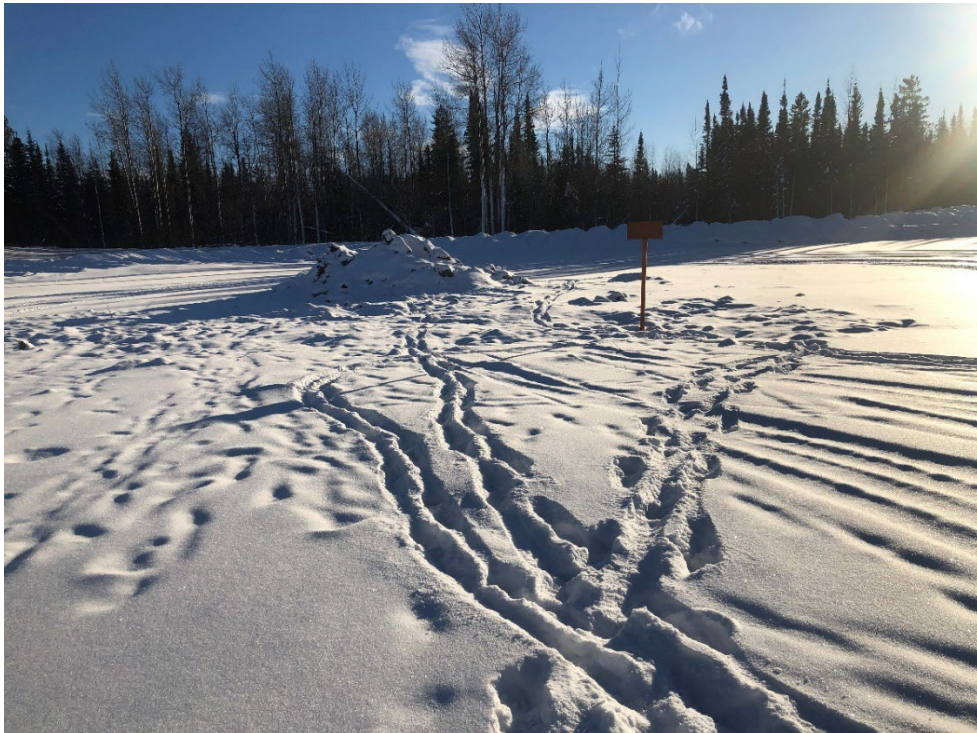
PHOTO #2: C-55 lease site looking East

Although no concerns were noted during the inspection, CNRL personnel must ensure the ground surface over the well is properly mounded after cut and cap operations to ensure no ponding of water occurs above the abandoned well. All waste items appear to have been removed from site
