WELLSITE SUMMARY INSPECTION REPORT

Well/Facility Name:	Jean Marie B-48	Operator:	Imperial Oil Limited
Location of Inspection:	62° 27' 10" N 120° 38' 16" W	Access method:	Helicopter
Site Contractor:	N/A	Status:	Non-compliant suspended
Approval Info	ACW-2021-IMP-B-48-WID 0448	WID:	0448
Date of Inspection	22-FEB-2022	H2S Site:	No

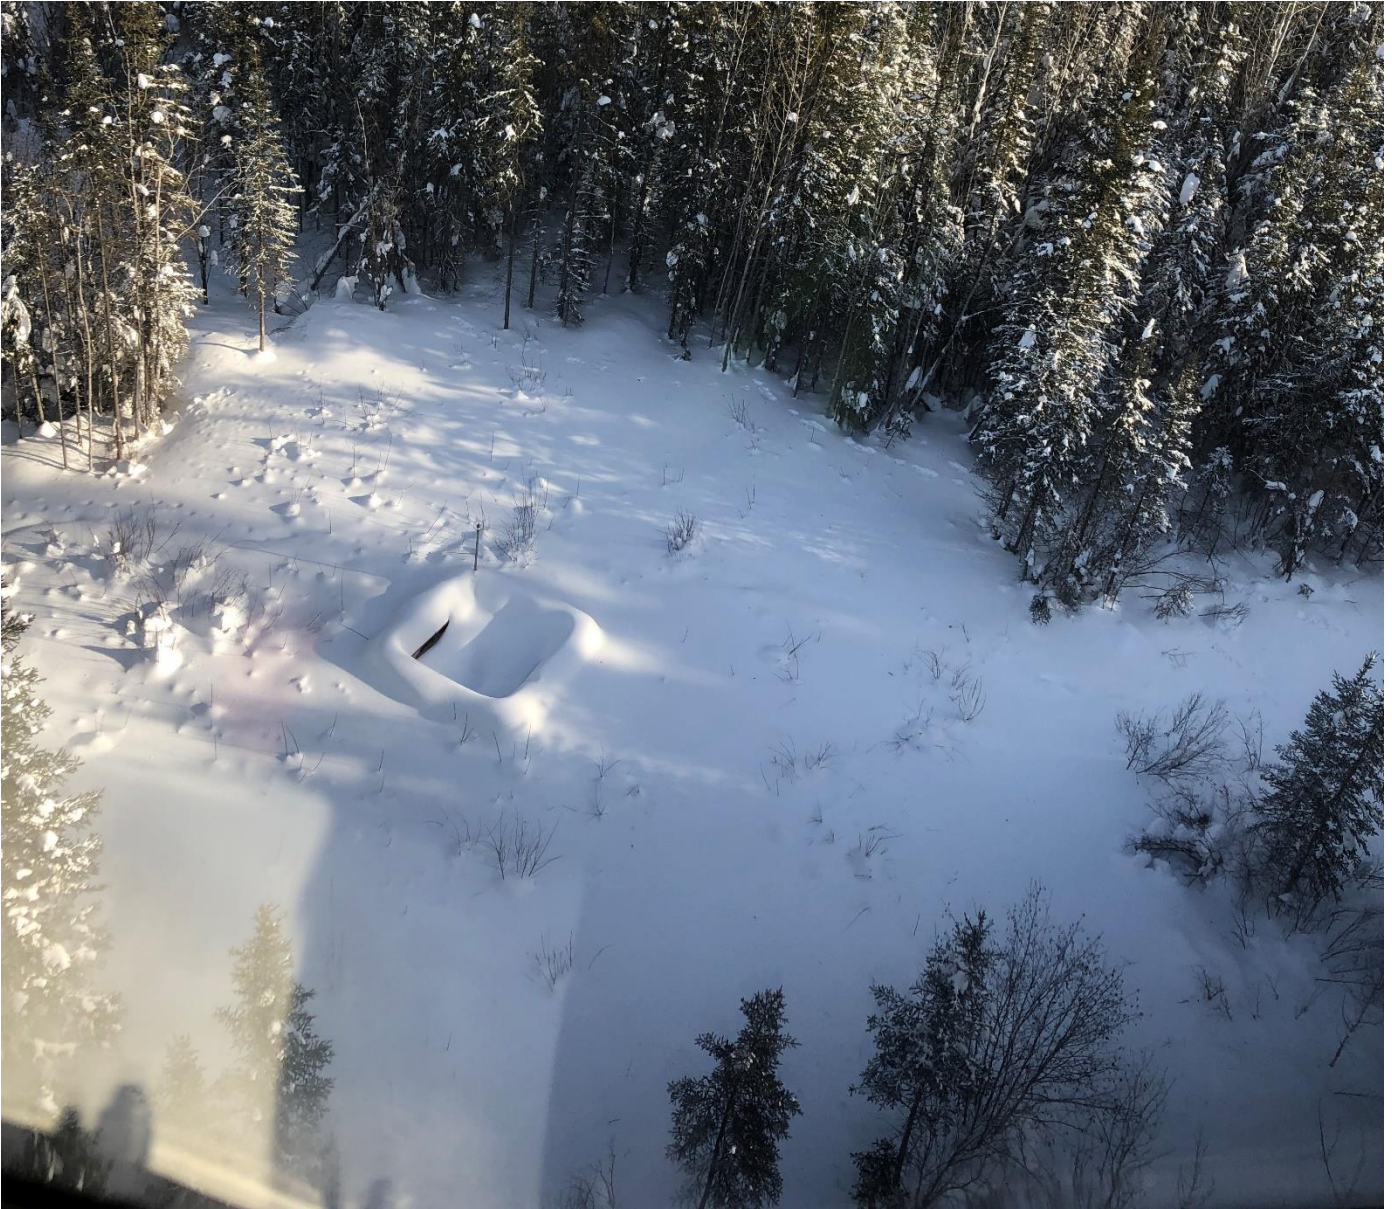
Activity on site	N/A		
Conditions	Satisfactory (Y/N)	Comments	
Site Access	N	Site access is restricted by limited size of cleared area at the wellsite (See Photo #1) Wind indicator post and frame installed at the site, however, wind indicator not functional as no windsock present. (See Photo #1)	
Well Head Access	Y	Encroachment of brush near the well. (See Photo #1)	
Signage	N/A	Unable to confirm well identification signage in place due to snow cover.	
General Housekeeping	Y	No debris noted on site above snow cover.	
SCV Open and dead	N/A

At the time of the inspection the size of the cleared area around the well along with some brush encroachment is restricting site access. The alternate landing site is a significant distance from the well site with no sight lines between the two.

There was no functional wind indicator installed on the site.

Photo #1: Aerial view of Jean Marie B-48.

The well site must allow for year-round access to inspect and monitor including winter months when there may be significant snow depth on the ground. This includes the requirements to:

- Maintain the wellsite to allow rotary wing aircraft to land at a safe distance upwind of the well head;
- Ensure safe ingress, egress and access to the well head and valves for inspection and monitoring; and
- Install a wind indicator.
