WELLSITE SUMMARY INSPECTION REPORT

Well/Facility Name:	S. Pointed Mountain L-68	Operator:	Prairie Provident Resources Canada Ltd.
Location of Inspection:	60° 11' 34" N 123° 31' 9" W	Access method:	Helicopter
Site Contractor:	N/A	Status:	Non-compliant suspended
Approval Info	ACW-2021-PPR-L-68-WID1207	WID:	1207
Date of Inspection	23-FEB-2022	H2S Site:	No

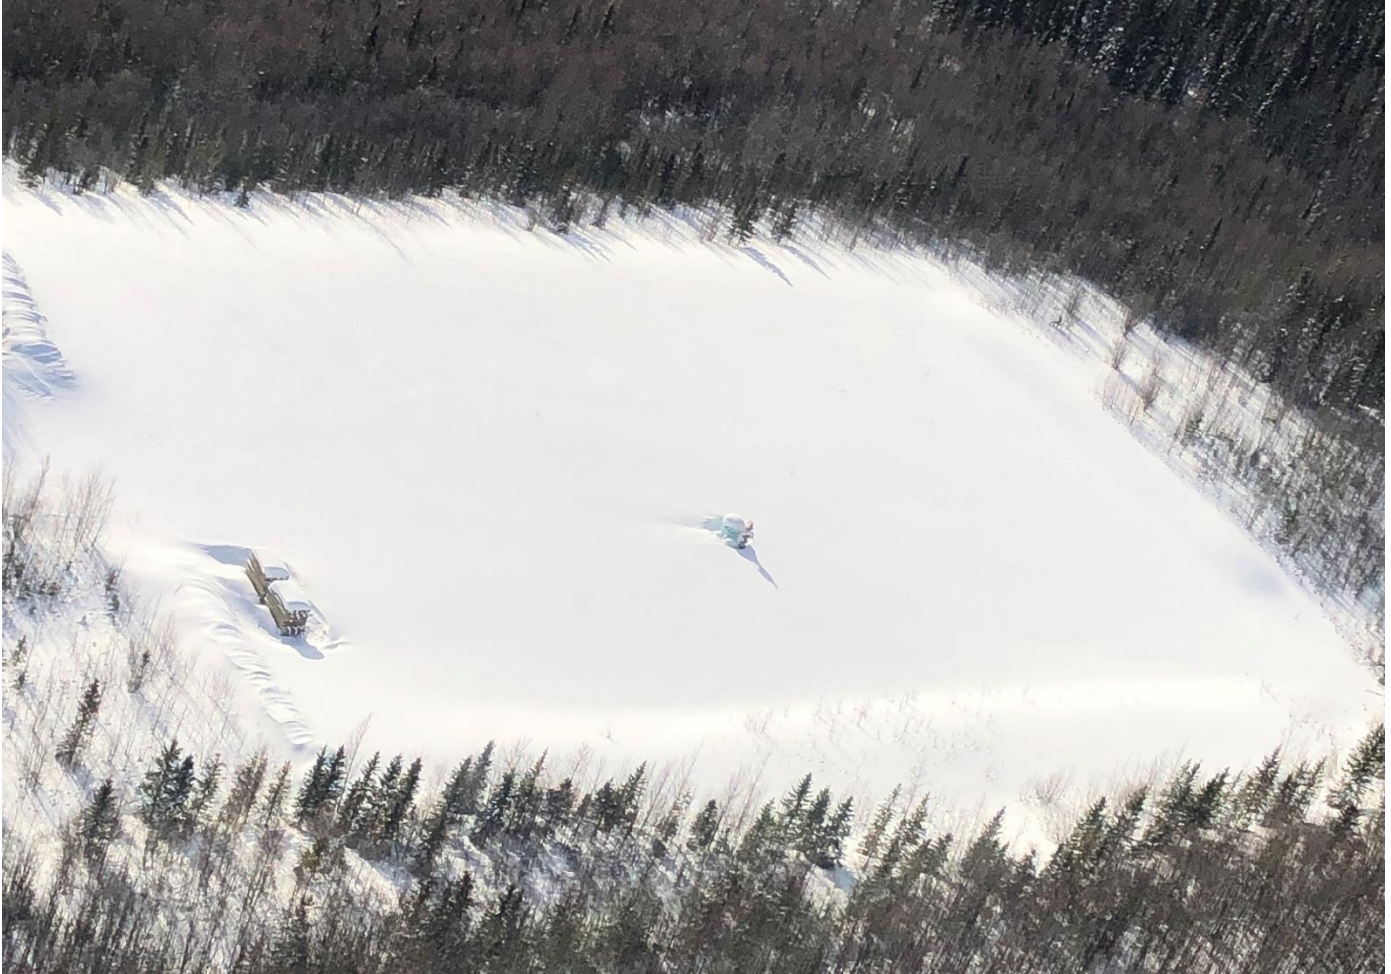
The well site appeared to be in good condition and free of vegetation (See Photo #1).

Photo #1: Aerial view of S. Pointed Mountain L-68.

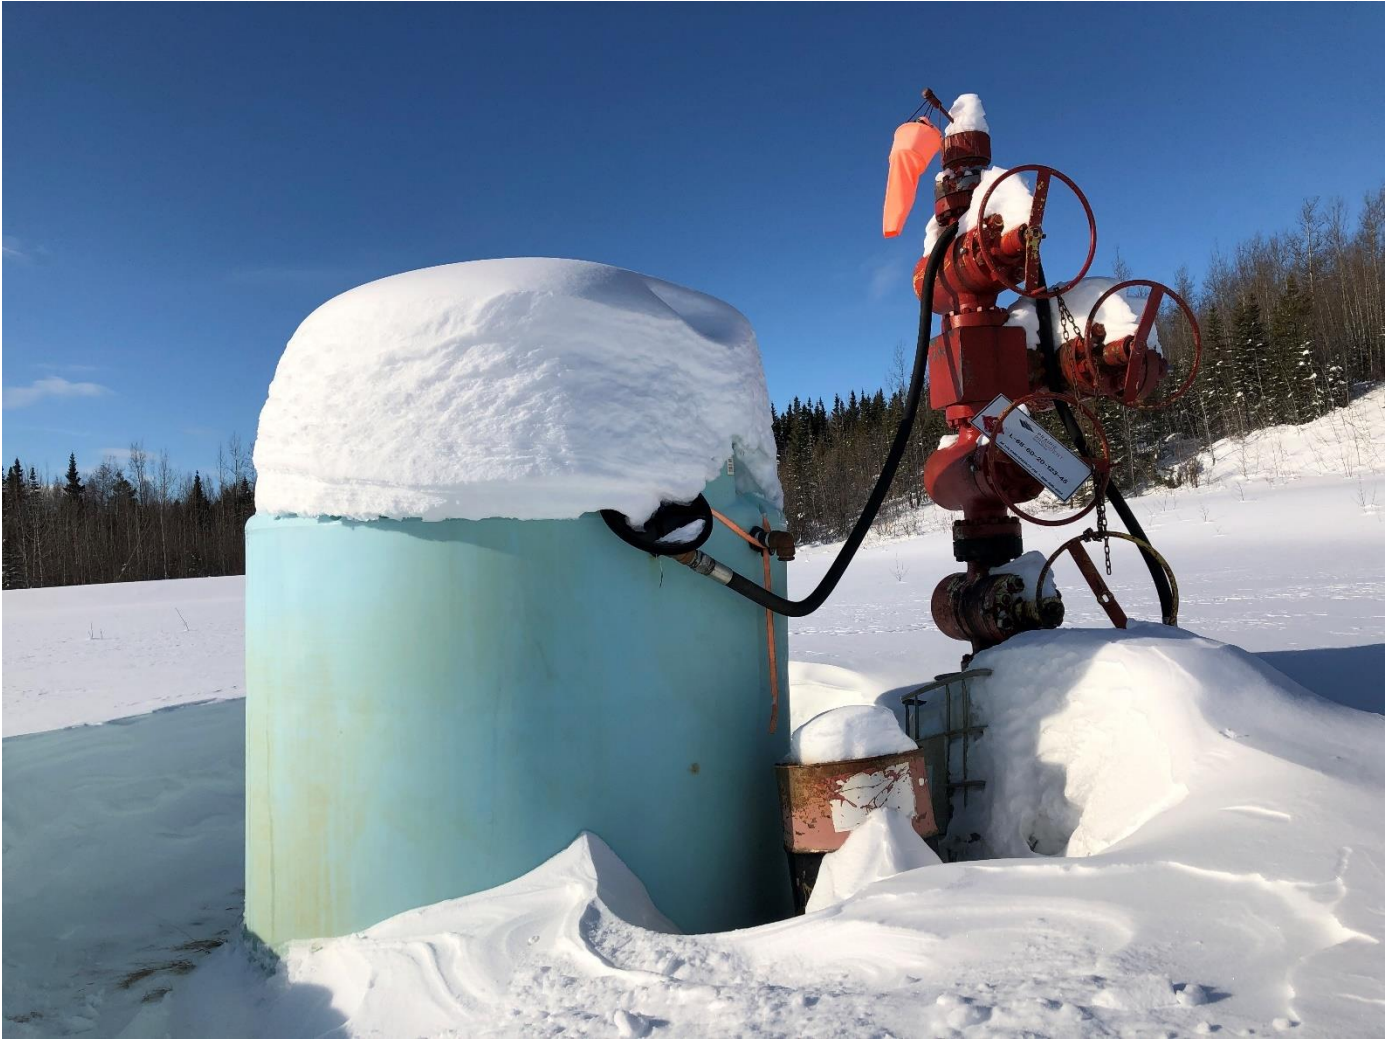
Prairie Provident Resources Ltd. reported non-serious surface casing vent flow.

8m³ tank tied into the surface casing vent to intercept any produced fluids from the SCV appears to have sufficient freeboard (See Photo #2).

A wind indicator was installed on the well head to ensure safe upwind approach (see Photo #2)

Photo #2: S. Pointed Mountain L-68 well head with SCV connected to tank to collect any liquids.

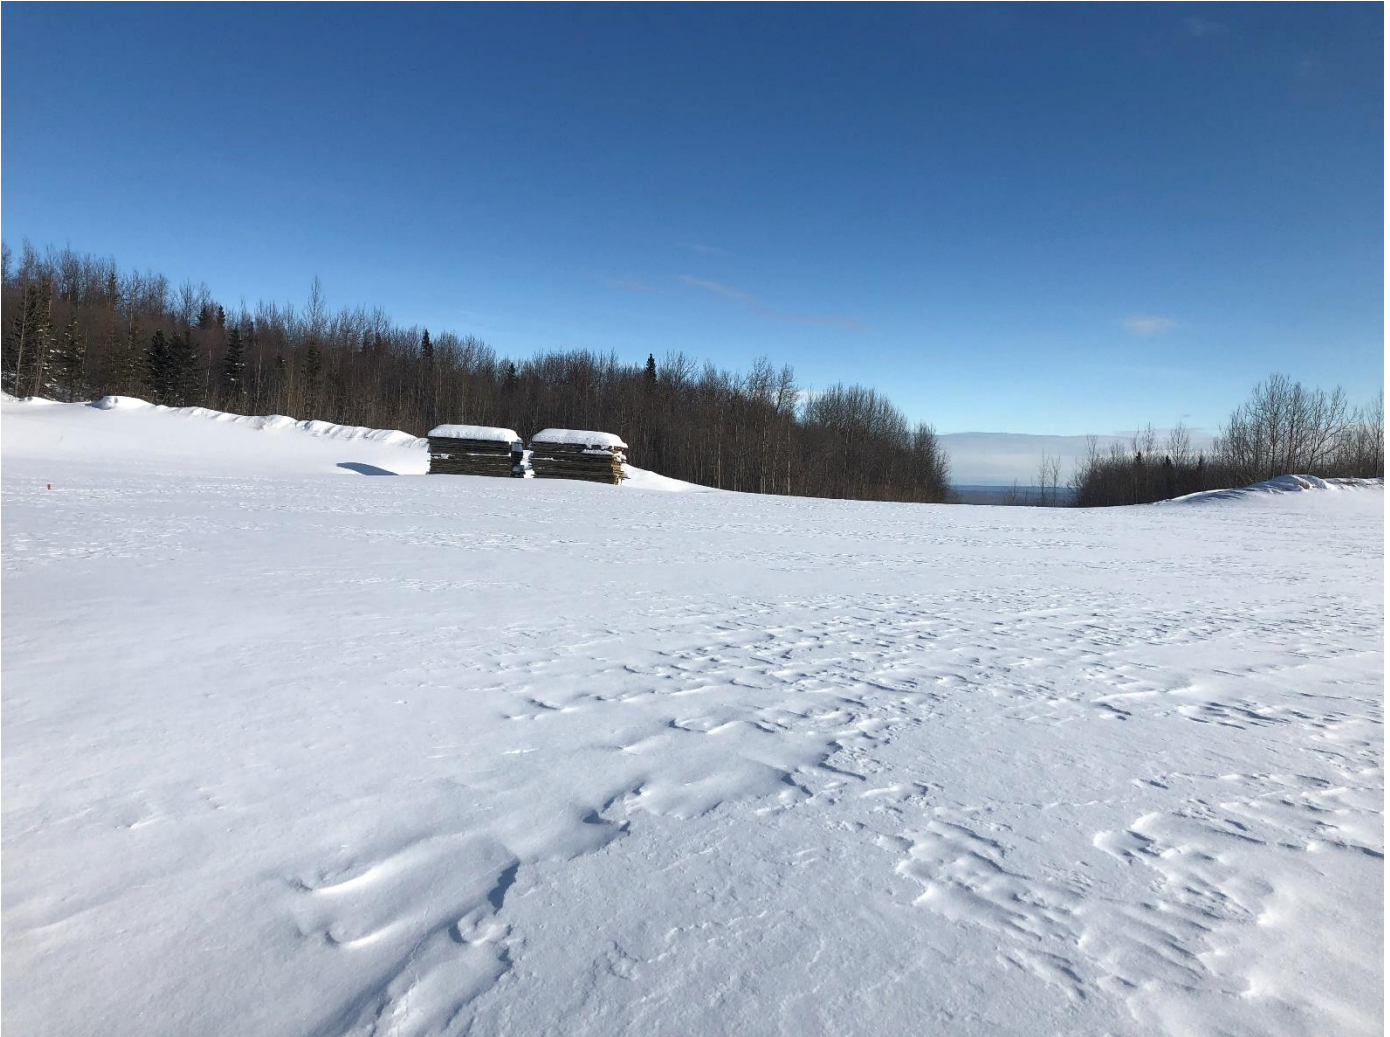
Rig matting was staged at the well site entrance for planned future abandonment operations.

Photo#3: S. Pointed Mountain L-68 rig matting staged at well site entrance.

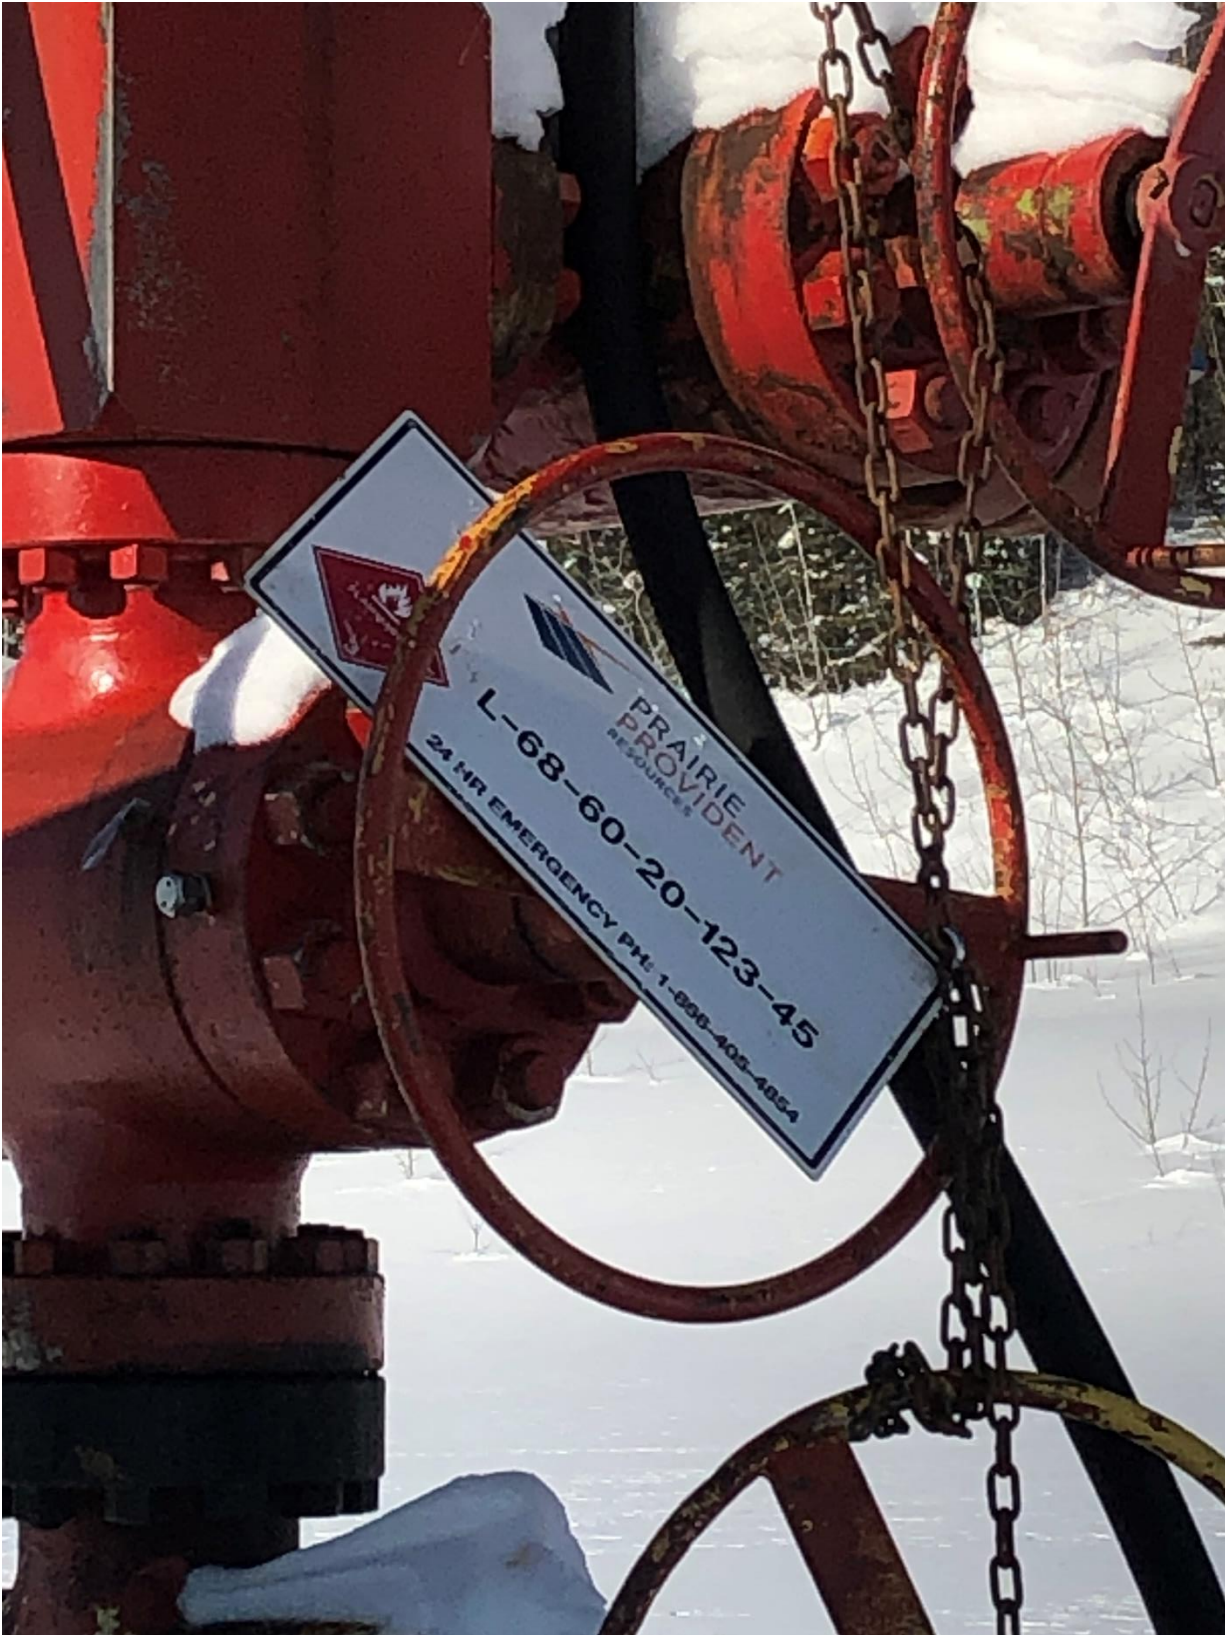
Activity on site	N/A		
Conditions	Satisfactory (Y/N)	Comments	
Site Access	Y		
Well Head Access	Y		
Signage	Y	(See Photo #4)	
General Housekeeping	Y	No debris noted on site above snow cover.	
SCV Open and dead	N	Reported SCV flow. Fluid containment, monitoring and flow measurements previously implemented as per OROGO requirements.

Photo#4: S. Pointed Mountain L-68 Signage.
