WELLSITE SUMMARY INSPECTION REPORT

Well/Facility Name:	S. Pointed Mountain L-68	Operator:	Prairie Provident Resources Canada Ltd.
Location of Inspection:	60° 11' 34" N 123° 31' 9" W	Access method:	Helicopter
Site Contractor:	N/A	Status:	Non-compliant suspended
Approval Info	ACW-2021-PPR-L-68-WID1207	WID:	1207
Date of Inspection	23-FEB-2022	H2S Site:	No

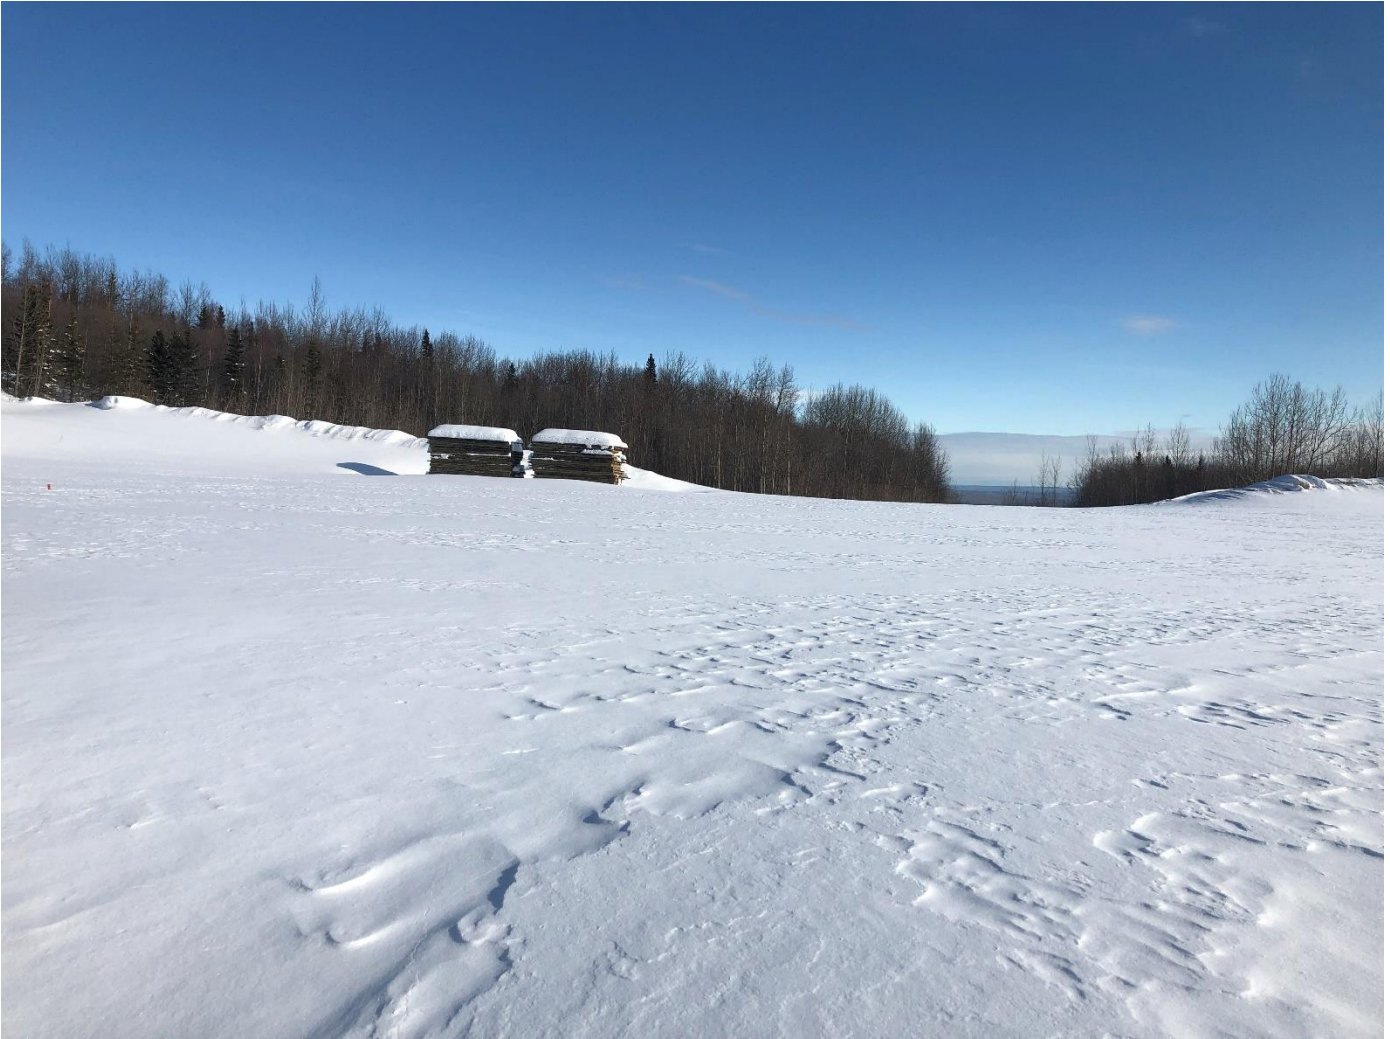
Rig matting was staged at the well site entrance for planned future abandonment operations.

Photo#3: S. Pointed Mountain L-68 rig matting staged at well site entrance.
