# OROGO Well Abandonment Verification Inspection Summary Report

Well name/ Facility: Cameron A-68

Operator: Strategic Oil Gas

Date of inspection: 2024-09-19

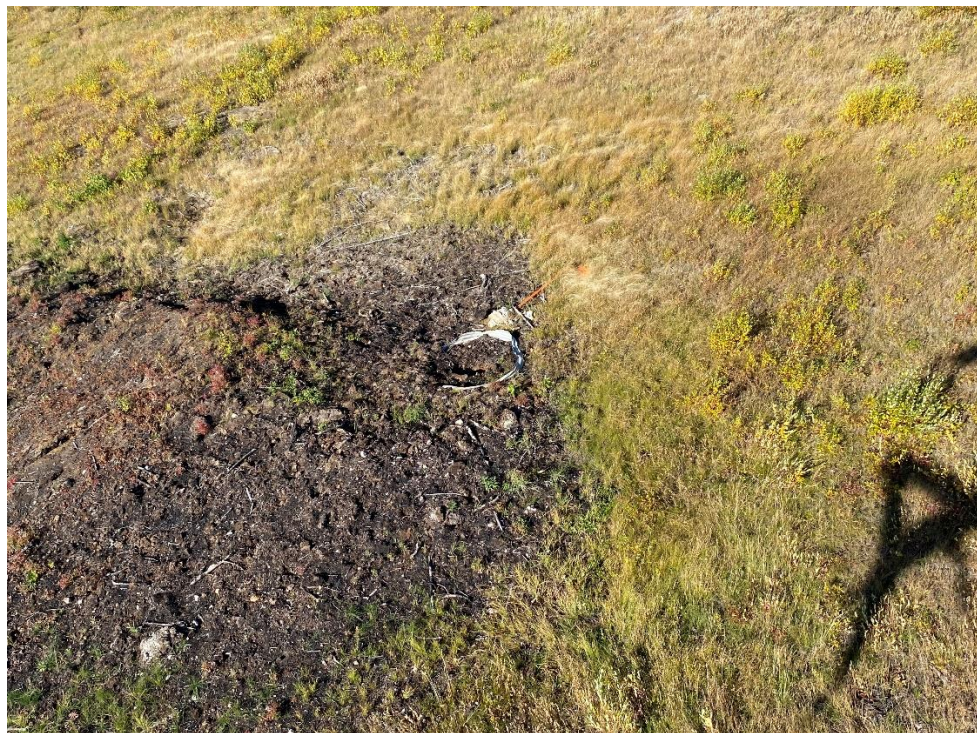
**If yes, provide details:** Cellar was not removed during abandonment operations (Photo #2). Well abandonment sign was not installed in accordance with section 6E of the *Well Suspension and Abandonment Guidelines and Interpretation Notes* (Photo #2).

Well center appears not to have been backfilled as part of the well abandonment operations (See Photo #2).

**Photo 2:** Cameron A-68 (WID1746) – Open excavation at well center, cellar still in place and improperly installed well abandonment sign.

The open excavation and cellar poses a risk to public safety and the environment as they are not readily seen or backfilled. As per OROGO's notice on September 25, 2024, temporary mitigation is required to be complete prior to October 31, 2024. Additionally, a plan to address the permanent mitigation of this excavation is required to be submitted to OROGO no later than December 15, 2024.

The well abandonment sig needs to be reinstalled in accordance with section 6E of the *Well*

*Suspension and Abandonment Guidelines and Interpretation Notes.*

As per OROGO's notice on September 25, 2024, temporary mitigation is required to be complete prior to October 31, 2024. Additionally, a plan to address the permanent mitigation of this excavation is required to be submitted to OROGO no later than December 15, 2024
