## Well Inspection Report

Well name: L-29-60-10-117-15

## Vapor Intrusion Assessment (VIA)

### Cameron Hills L-29

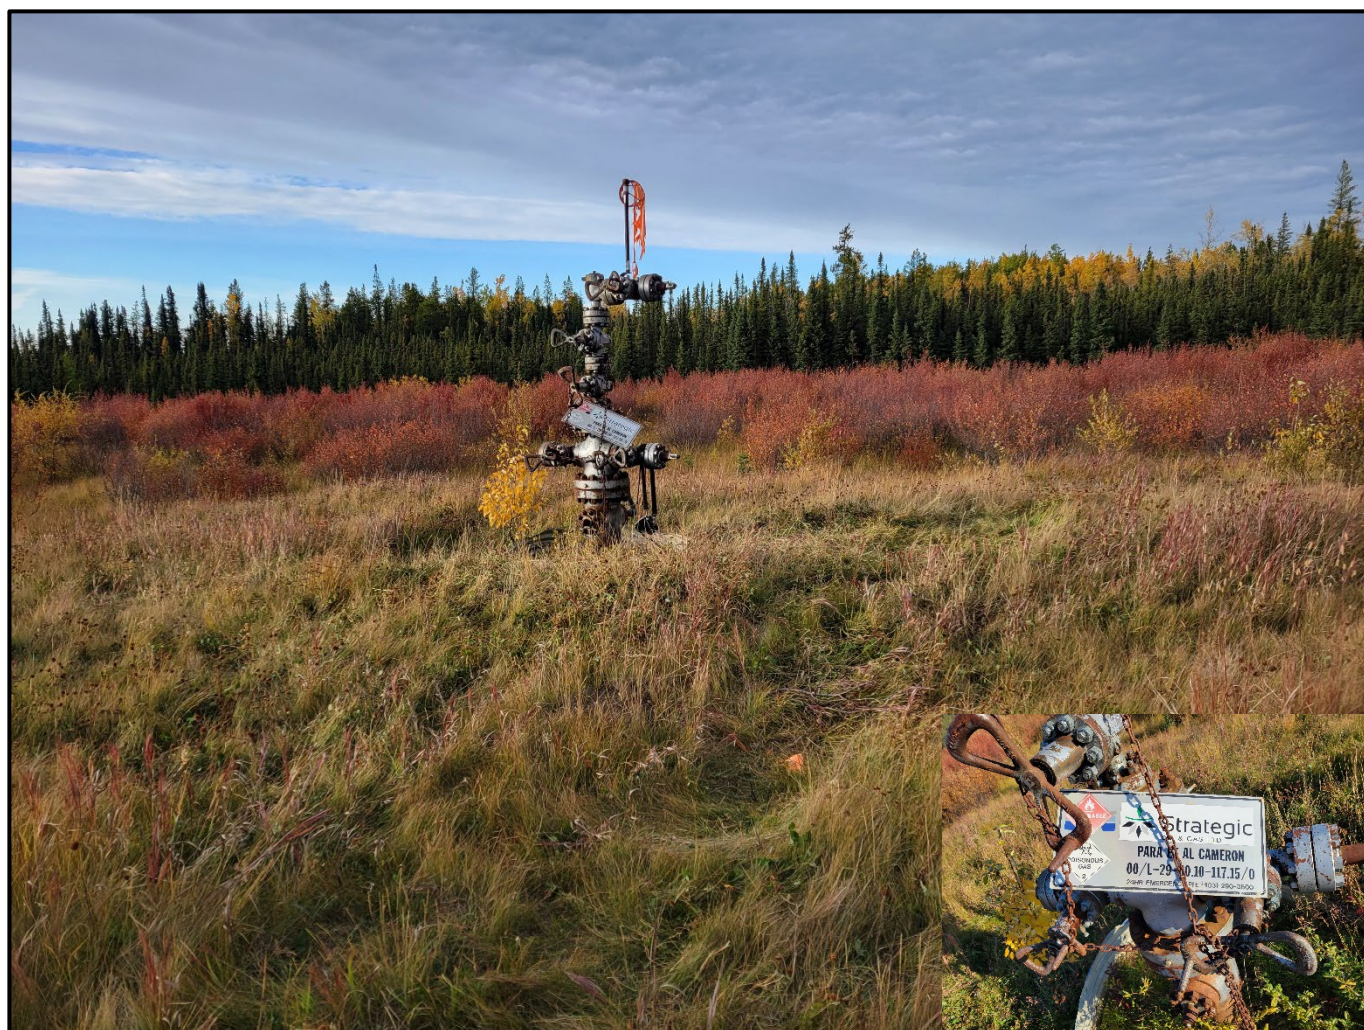
- 1) The Surface Casing Vent passed the ten-minute bubble test (1 ppm v/v methane) and no flow was observed.
- 2) A Ventbuster was installed on this well September 15, 2022 and the flow was monitored and data logged until September 18, 2022

- 4) The flow increases coincide with increased gas temperatures which occur when the ambient air temperatures also increased. This indicates that gas expansion due to temperature change is likely the cause of the low flow rates and not natural gas actively flowing in the surface casing.

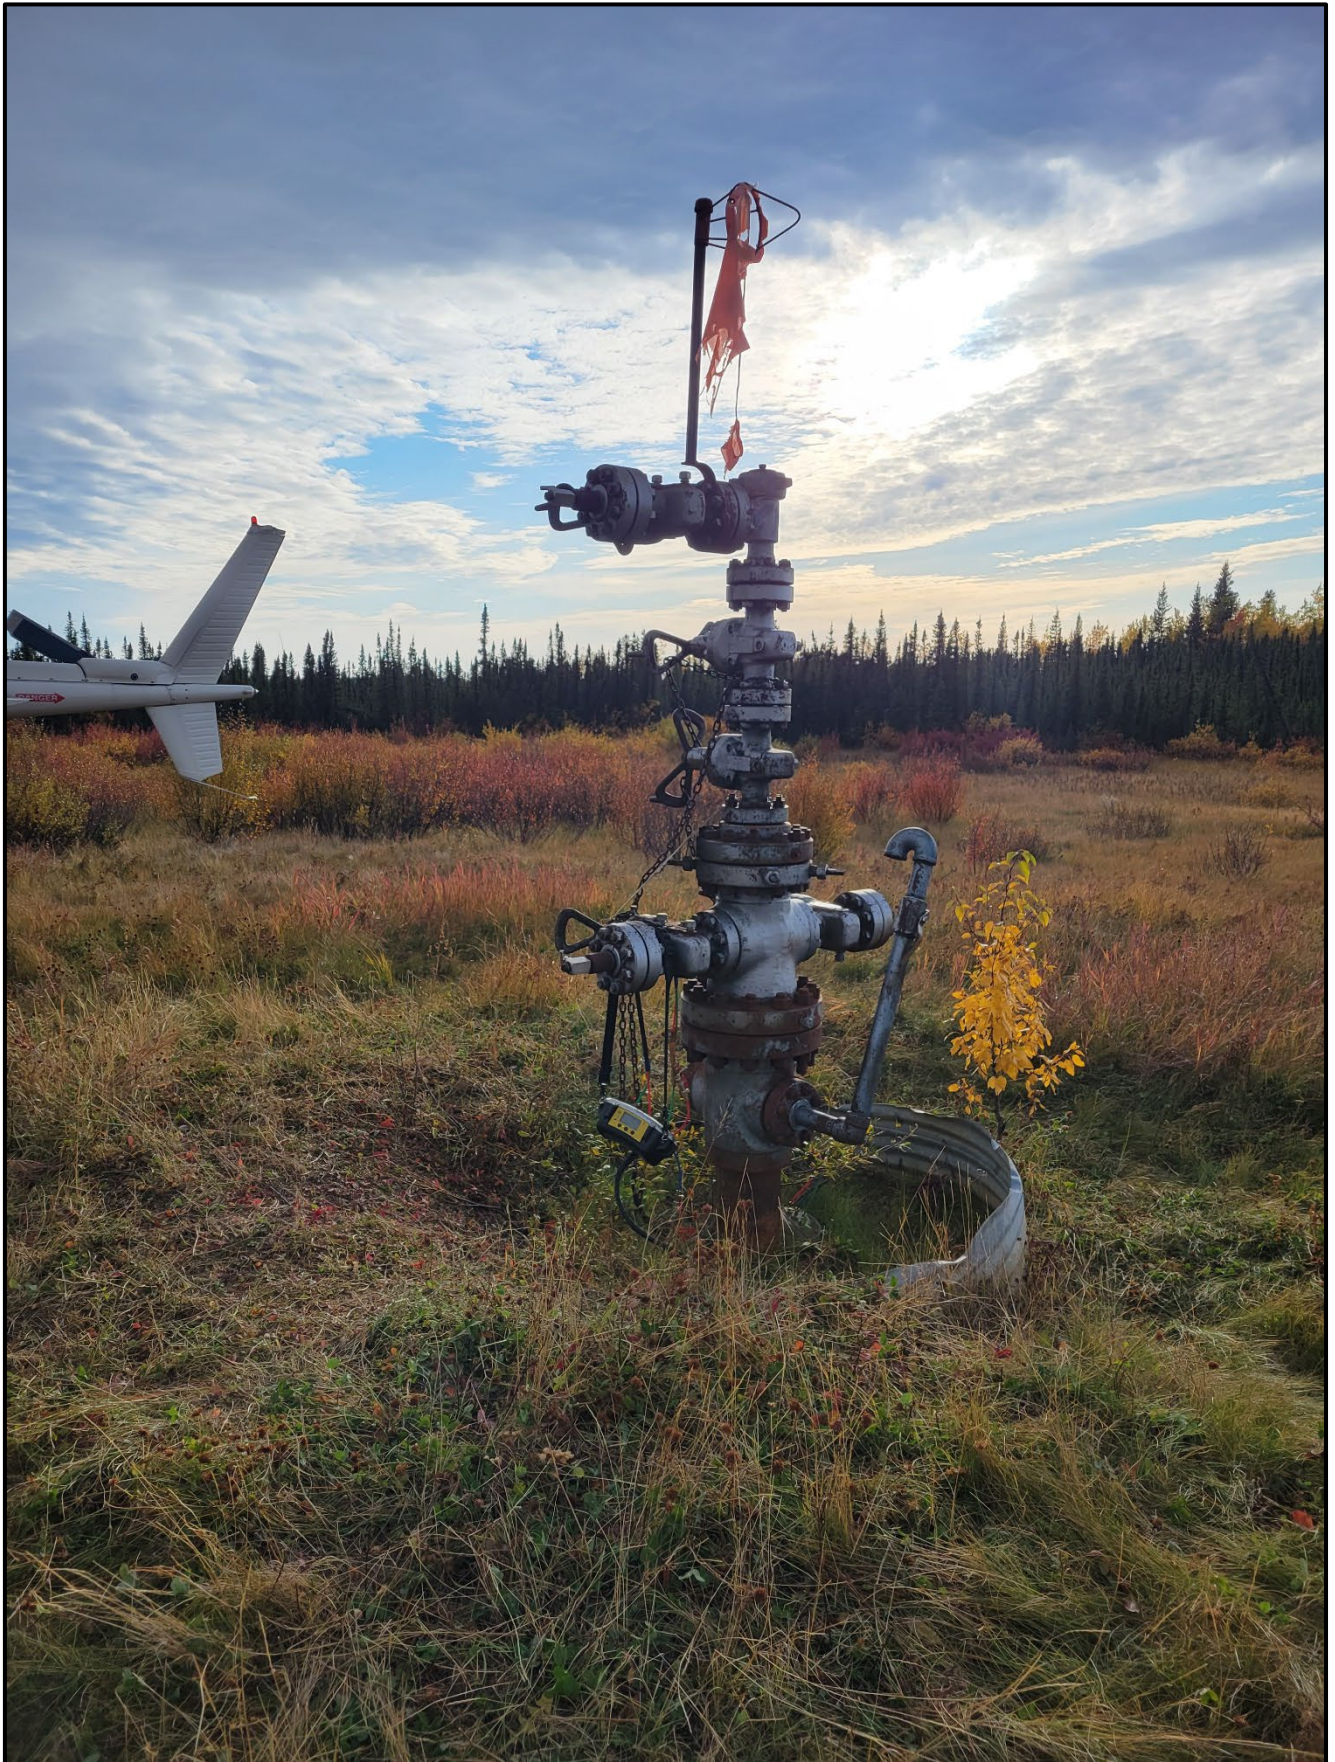
- 8) Light alkanes typically follow the concentration  $C1 \gg C2 > C3 > nC4 > nC5$ . The SCV and soil gases from this well are dominated by propane and heavier alkanes. This indicates that the gases originate from hydrocarbon or chemical contamination and/or the weathering and breakdown of hydrocarbon/chemical contamination and are not the result of leaking thermogenic natural gases from a geologic source at depth.

- 1) Natural gases in the SCV and soils near the wellbore contain low levels of  $C_2+$  gases indicating that this well is not impacted with leaking thermogenic natural gases.

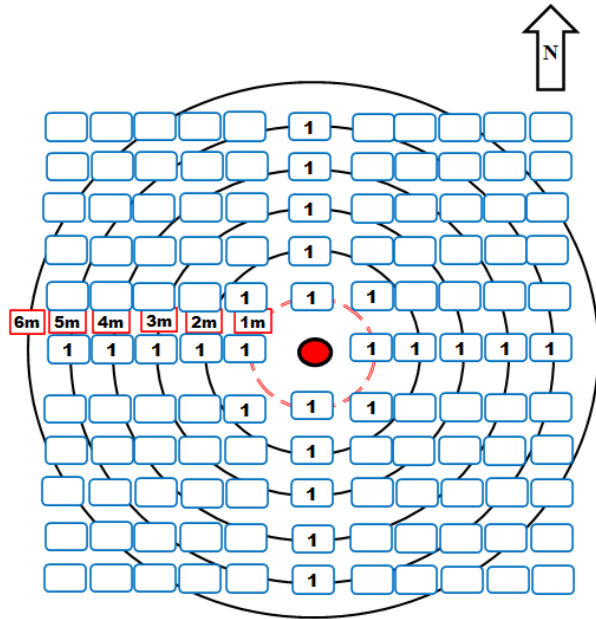
**Figure 1. AGM Non-Intrusive Surface PMD**

- 5) A surface combustible gas scan was performed near the wellbore using a Sensit Portable Methane Detector (PMD). All readings were low, (1 ppm v/v methane) compared to background (1 ppm v/v) established 20m southwest from the wellbore (Figure 1, Table 1).

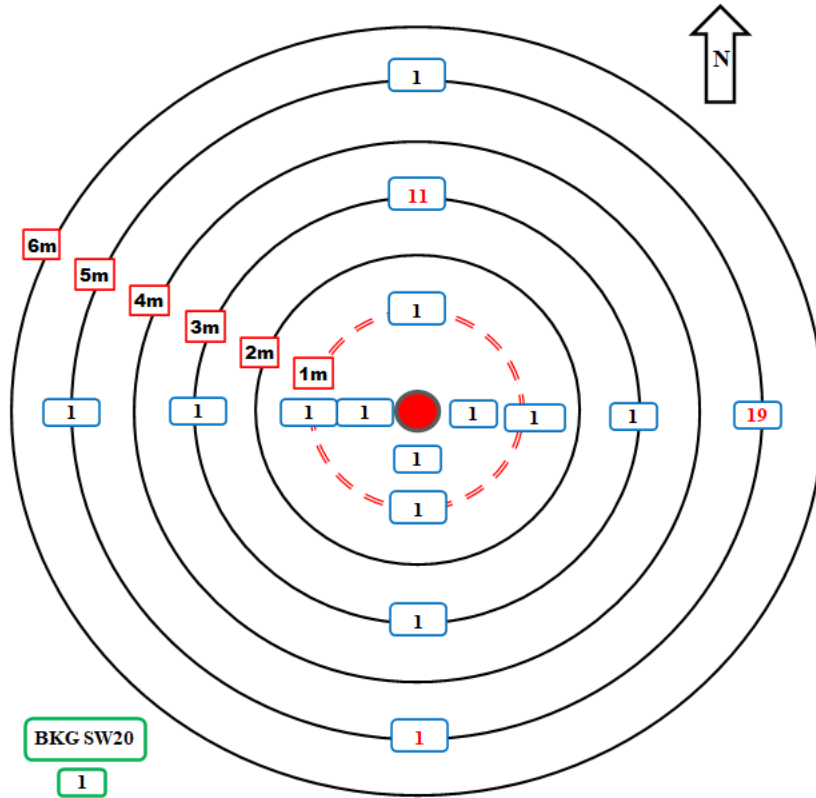
**Figure 2. AGM Intrusive SVPs-**

- 6) An intrusive soil gas migration test was then performed by drilling test holes and inserting Soil Vapor Probes (SVPs). Combustible gas readings in the SVPs were slightly elevated (up to 19 ppm v/v at E5), compared to the background probe (1 ppm v/v methane) installed approximately 20m southwest of the wellbore to establish background levels in the area and for comparison to other samples collected during this investigation (Figure 2, Table 2).

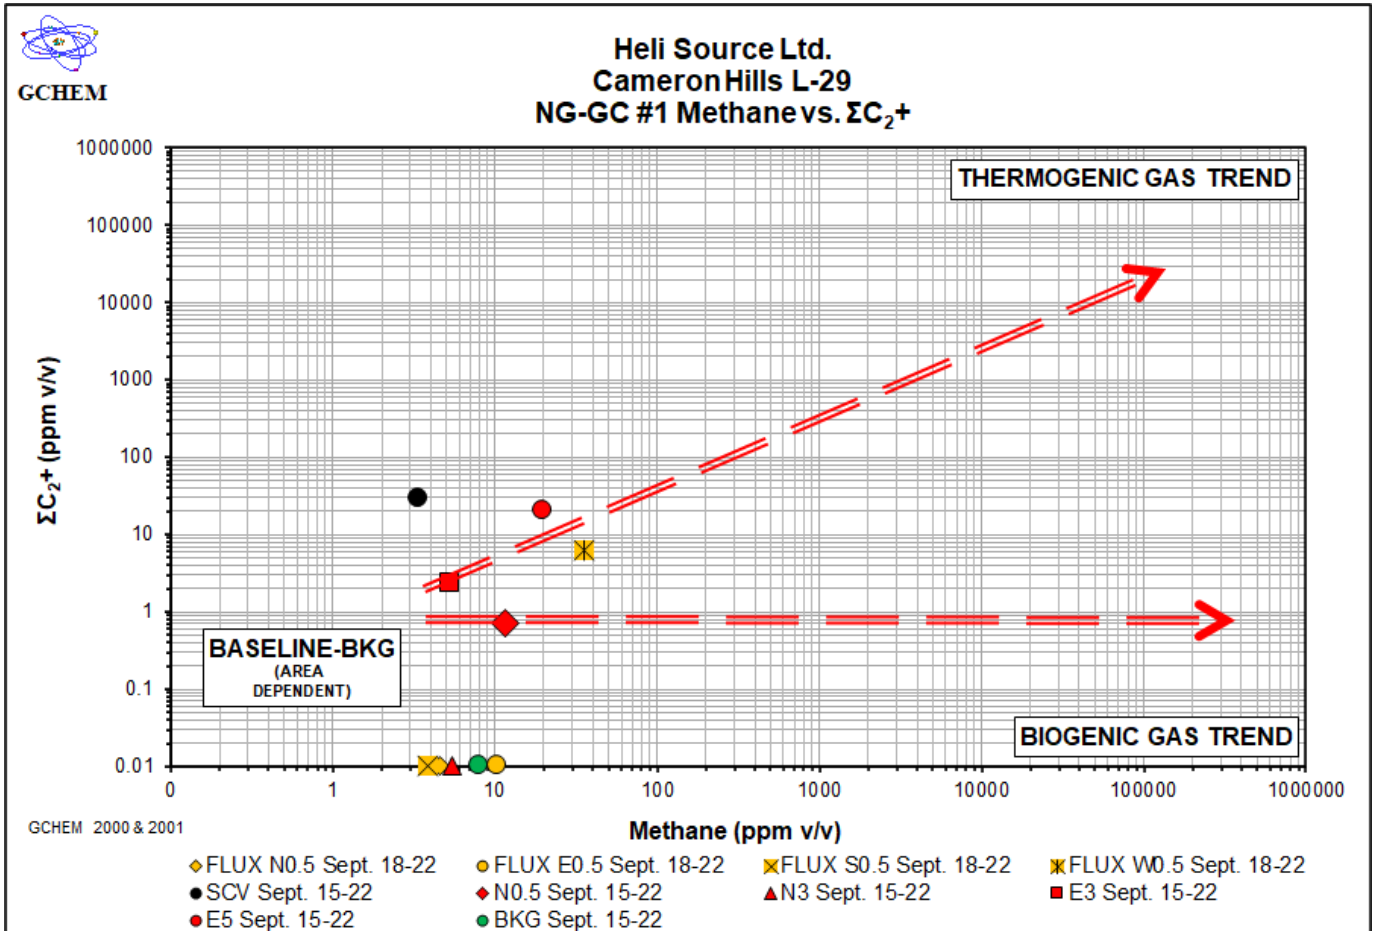
**Figure 3:  $\Sigma C_2+$  vs Methane.** Combustible gases detected in soils and SCVs at a wellhead may result from several origins. Natural gases indicative of SCVF or AGM are thermogenic in origin (natural gas in deep reservoirs), contain high methane and  $C_2+$  contents and plot in the Upper RH Quadrant. Low natural gas levels in background, off lease areas are naturally present in soils, vary from region to region and plot in the Lower LH Quadrant. Biogenic gases (swamp-gas) are produced by bacteria, are comprised of predominantly methane and plot in Lower RH Quadrant. Samples plotting in the Lower LH and RH do not contain SCVF or AGM and would not require down-hole remediation

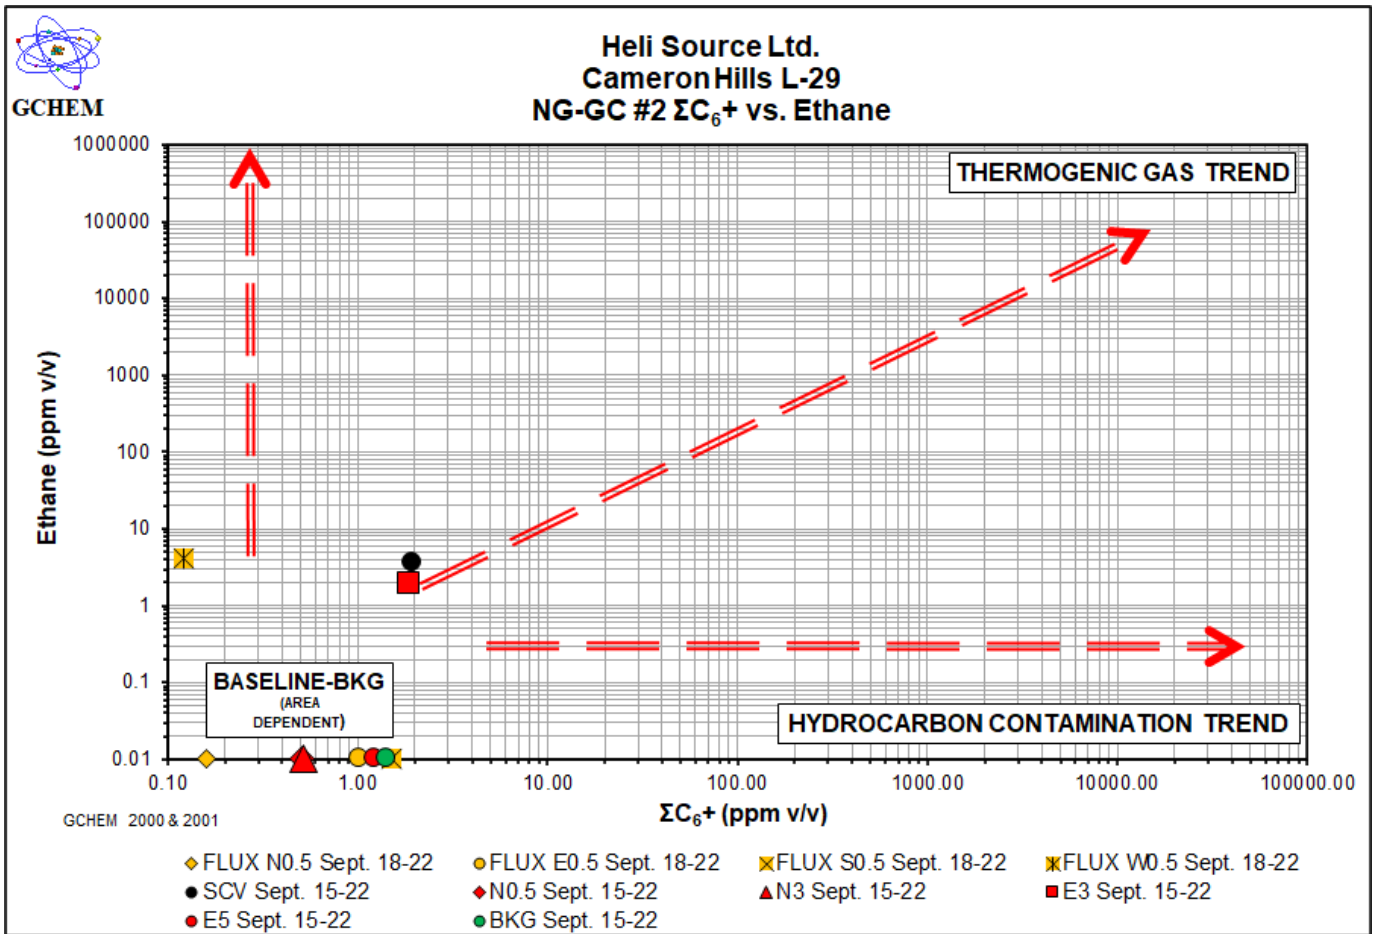
**Figure 4: ΣC<sub>6</sub>+ vs Ethane.** C<sub>6</sub>+ gases are relatively large molecules that do not readily or easily migrate in large quantities from depth upwards through subsurface fractures or micro-fractures to surface. Contamination by oil spills, fuels, and solvents is indicated by soil vapor samples that have high contents of C<sub>6</sub>+ compounds and plot in the Lower RH Quadrant. Samples plotting in the Lower LH and RH Quadrants do not contain evidence of either SCVF or AGM and would not require downhole repair operations.

- 1) C<sub>6</sub>+ contents of the SCV and soil gas samples are low and are similar to expected baseline readings. Measured combustible gas levels are not the result of near surface hydrocarbon or chemical contamination.

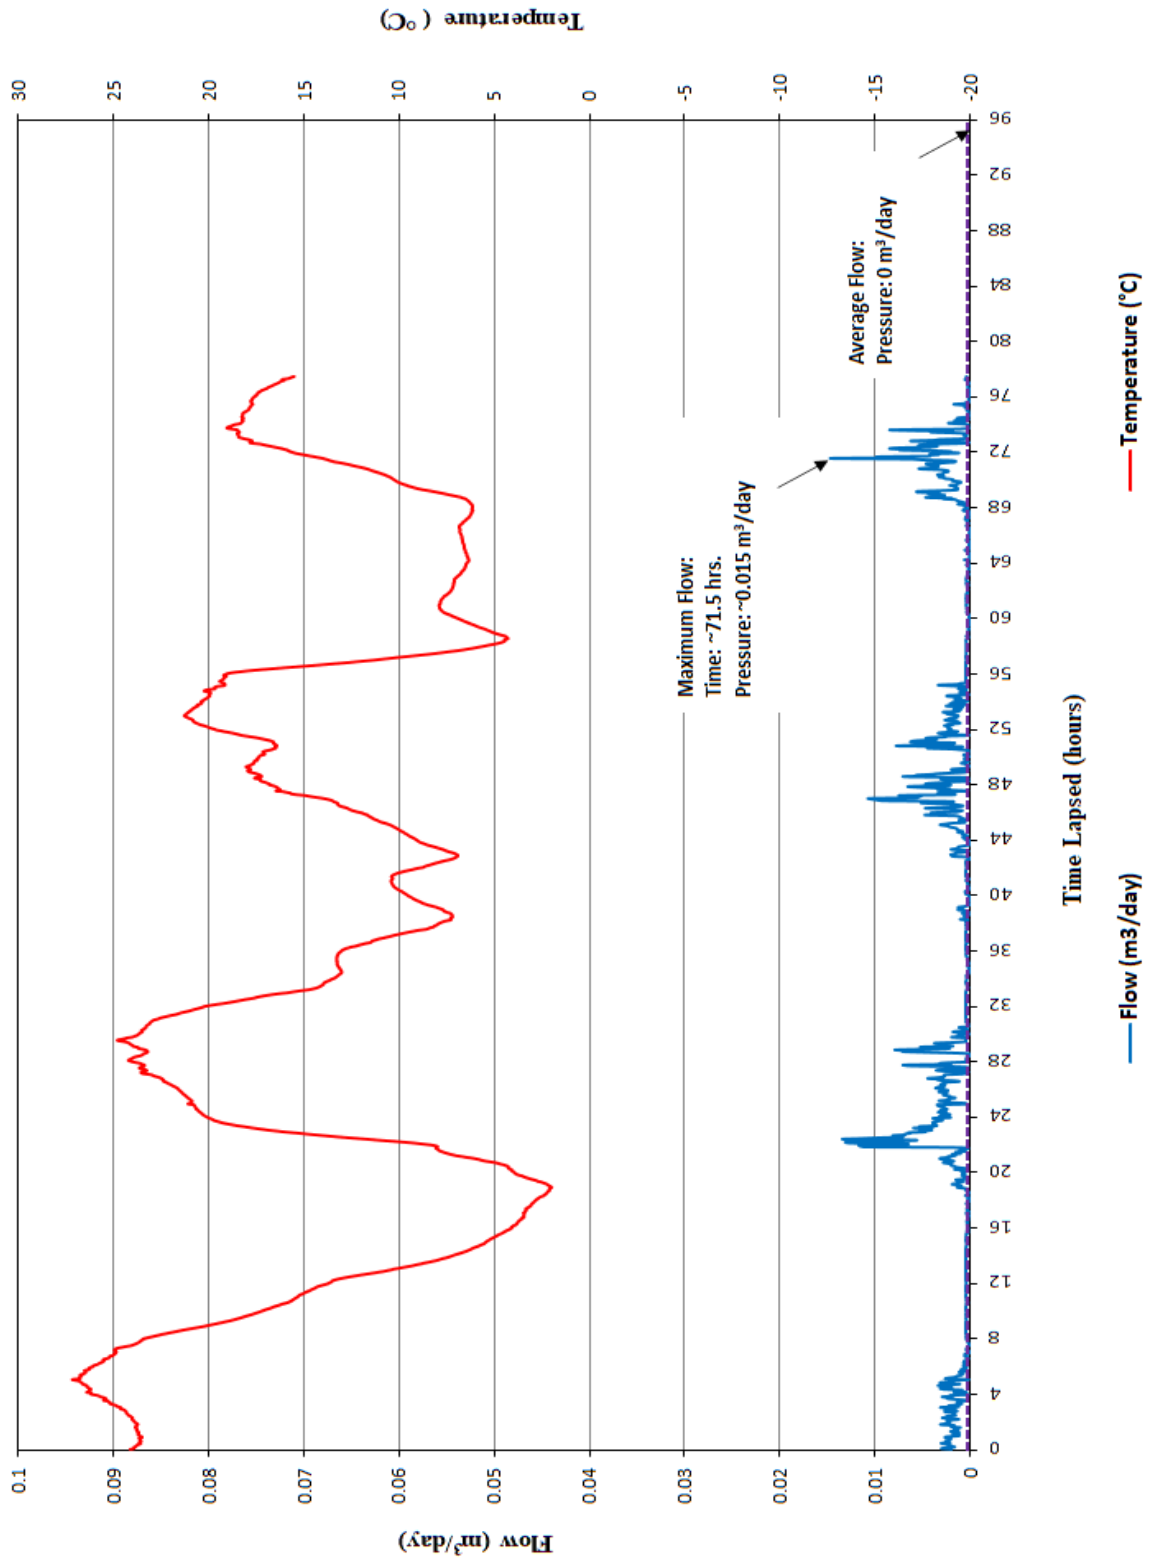
Heli Source Cameron Hills L-29  
SCV Flow Rate Monitoring  
September 15 to September 18, 2022

- 3) Small flows (<math><0.01\text{ m}^3/\text{day}</math>) were measured when the gas temperature increased. The average flow rate was near  $0\text{ m}^3/\text{day}$  over the three-day test.

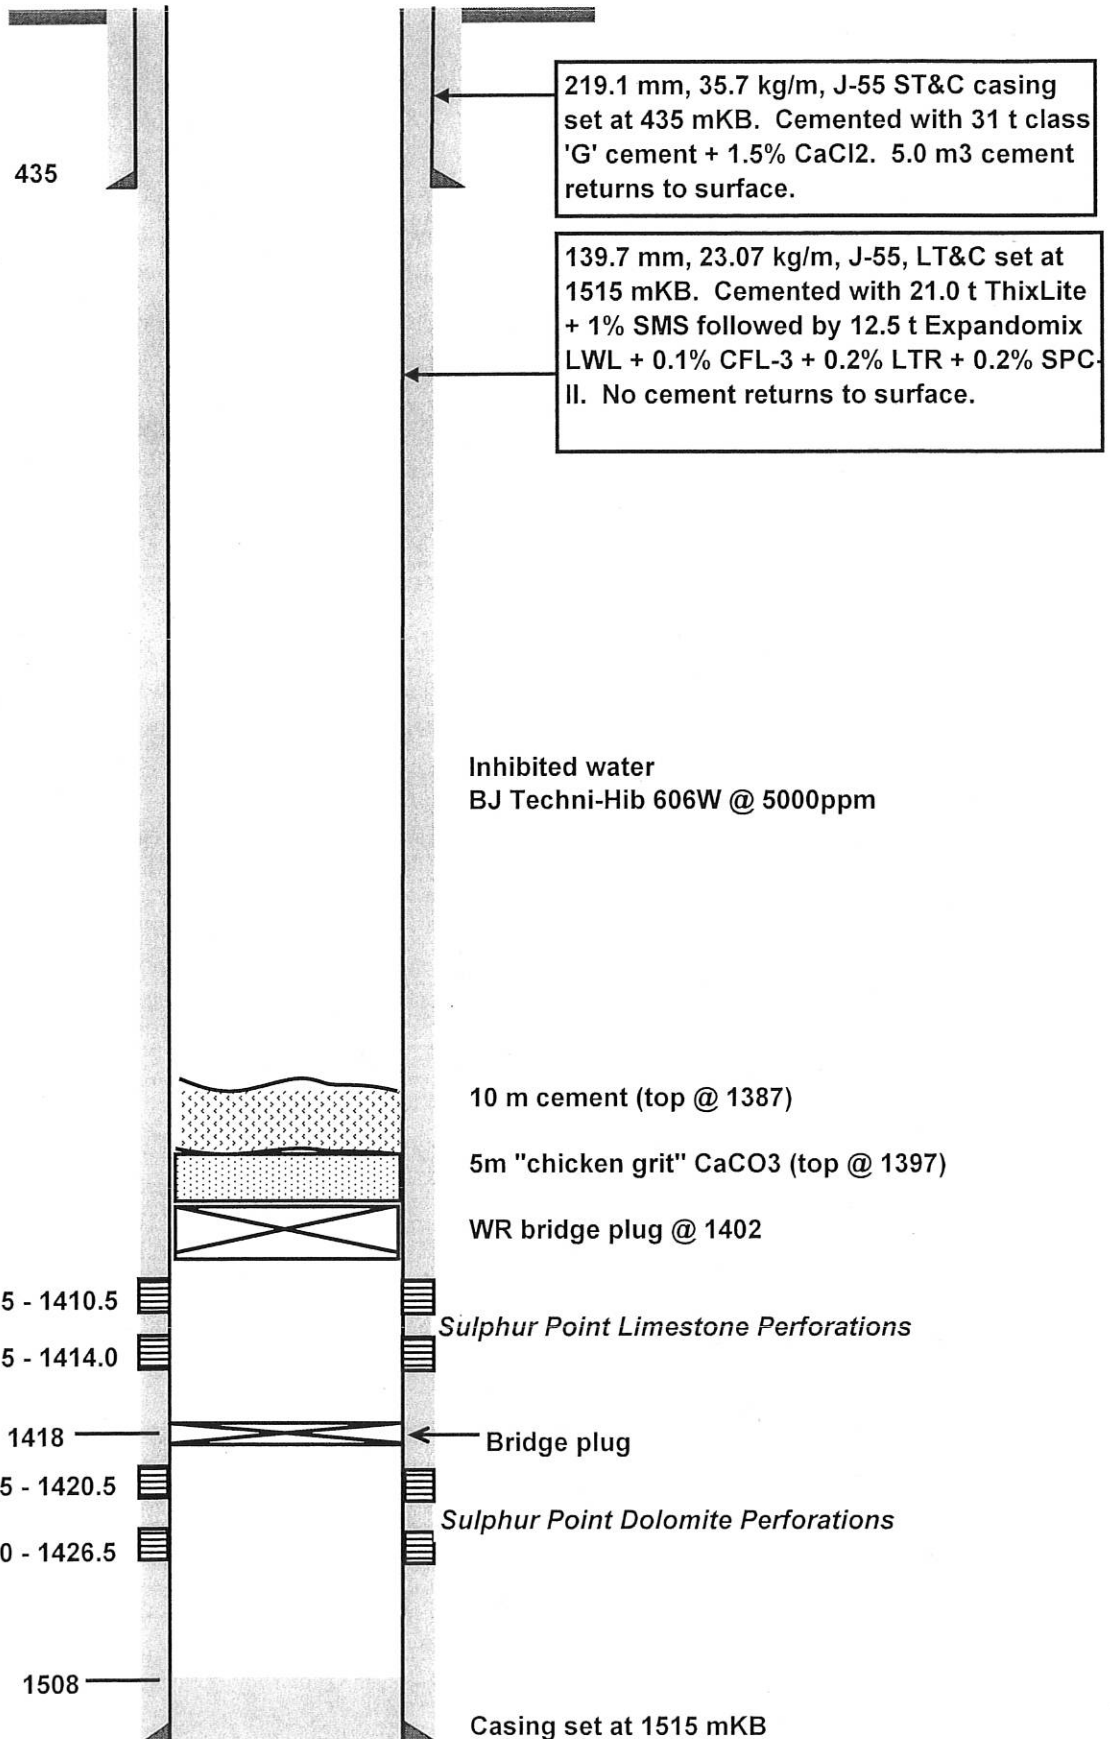
# PARA ET AL CAMERON L-29

As suspended 20100305

KB: 759.51 m  
GL: 754.11 m
