Well Inspection Report

Well name: 300 / O-15 / 6030-12300/00

Well Schematic

Paramount Berkley Arrowhead O15

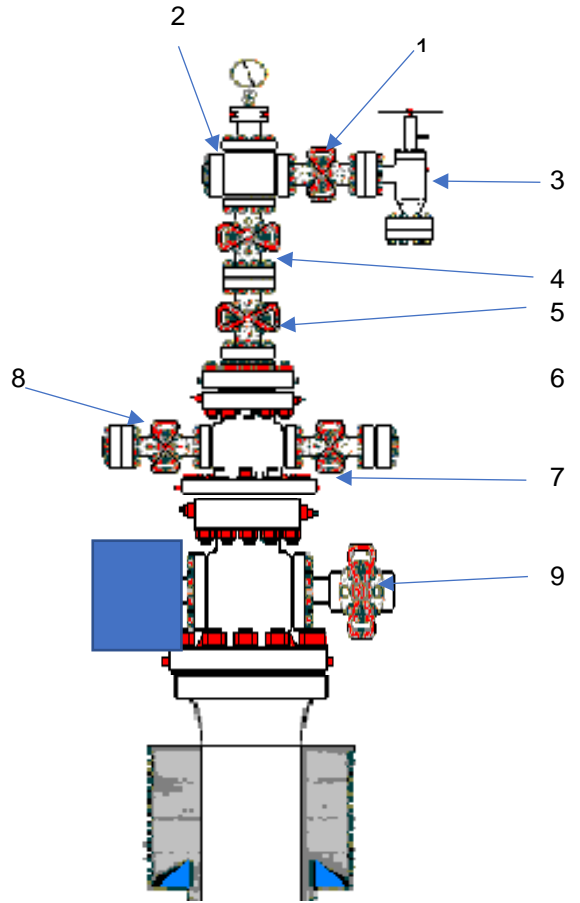
WELLHEAD DESCRIPTION

- 1) Walker, Tubing Valve, 3 1/8" x 34.5 MPa, S/N : 23430-1
- 2) Flange Flow Tee Block, Walker, 3 1/8" , R-35, 34.5 MPa
- 3) Master Flo, 90 Degree Choke, 3 1/8", 34.5 MPa
- 4) Upper Master Valve: Walker 3 1/8", 34.5 MPa, S/N: 23429-1
- 5) Lower Master Valve: Walker 3 1/8", 34.5 MPa, S/N: 23428-1
- 6) Flange Connection: Walker, 11", 34.5 Mpa, R-54, S/N 6A0103
- 7) Prod Casing Valve, Walker, 34.5 MPa, 2 1/16", S/N: 2249188
- 8) Prod Casing Valve, Walker, 34.5 MPa, 2 1/16", S/N: 6A0103T3C
- 9) Inter Casing Valve, Walker, 34.5 Mpa, 2 1/16", S/N: 9412129-1H

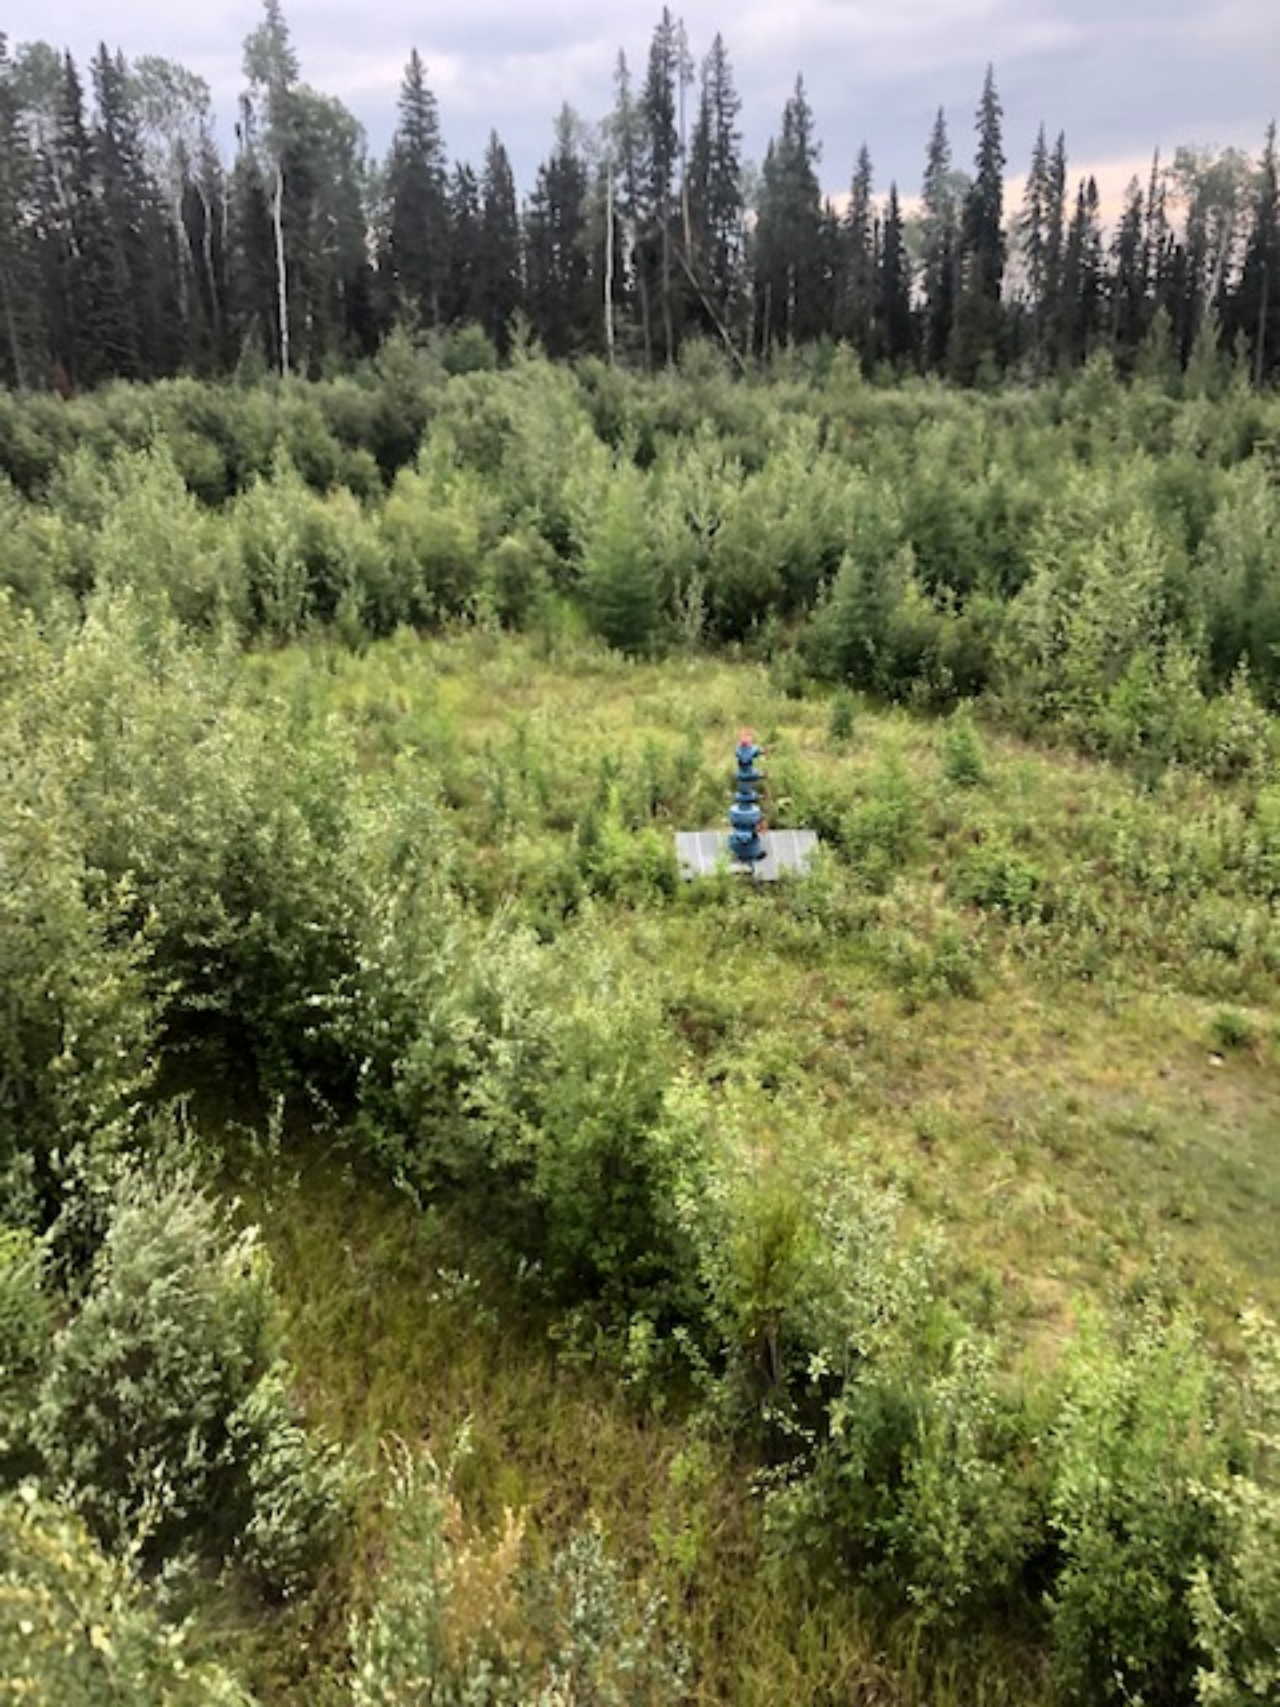
Surface Solutions
Oil and Gas Optimization
IF FOUND PLEASE CALL
(781) 538-1874 / (781) 831-1710
OR VISIT OUR WEBSITE
WWW.FUTUREENERGY.COM

S/N

Install Surface Solutions Electronic Continuous Pressure Recorder on Surface Casing Vent. Surface Solutions - Hawk 9000/9500c with 6000 kPa PSV, Serial Number 61394. Install 11:00 hrs x 22-Jul-22

Remove Surface Solutions Hawk 9000C/9500c continuous electronic monitor gauge. No pressure on surface casing. Re-install Surface Solutions Hawk 9000C/9500c continuous electronic monitor gauge with 6000 KPa PSV at 11:00 hrs.

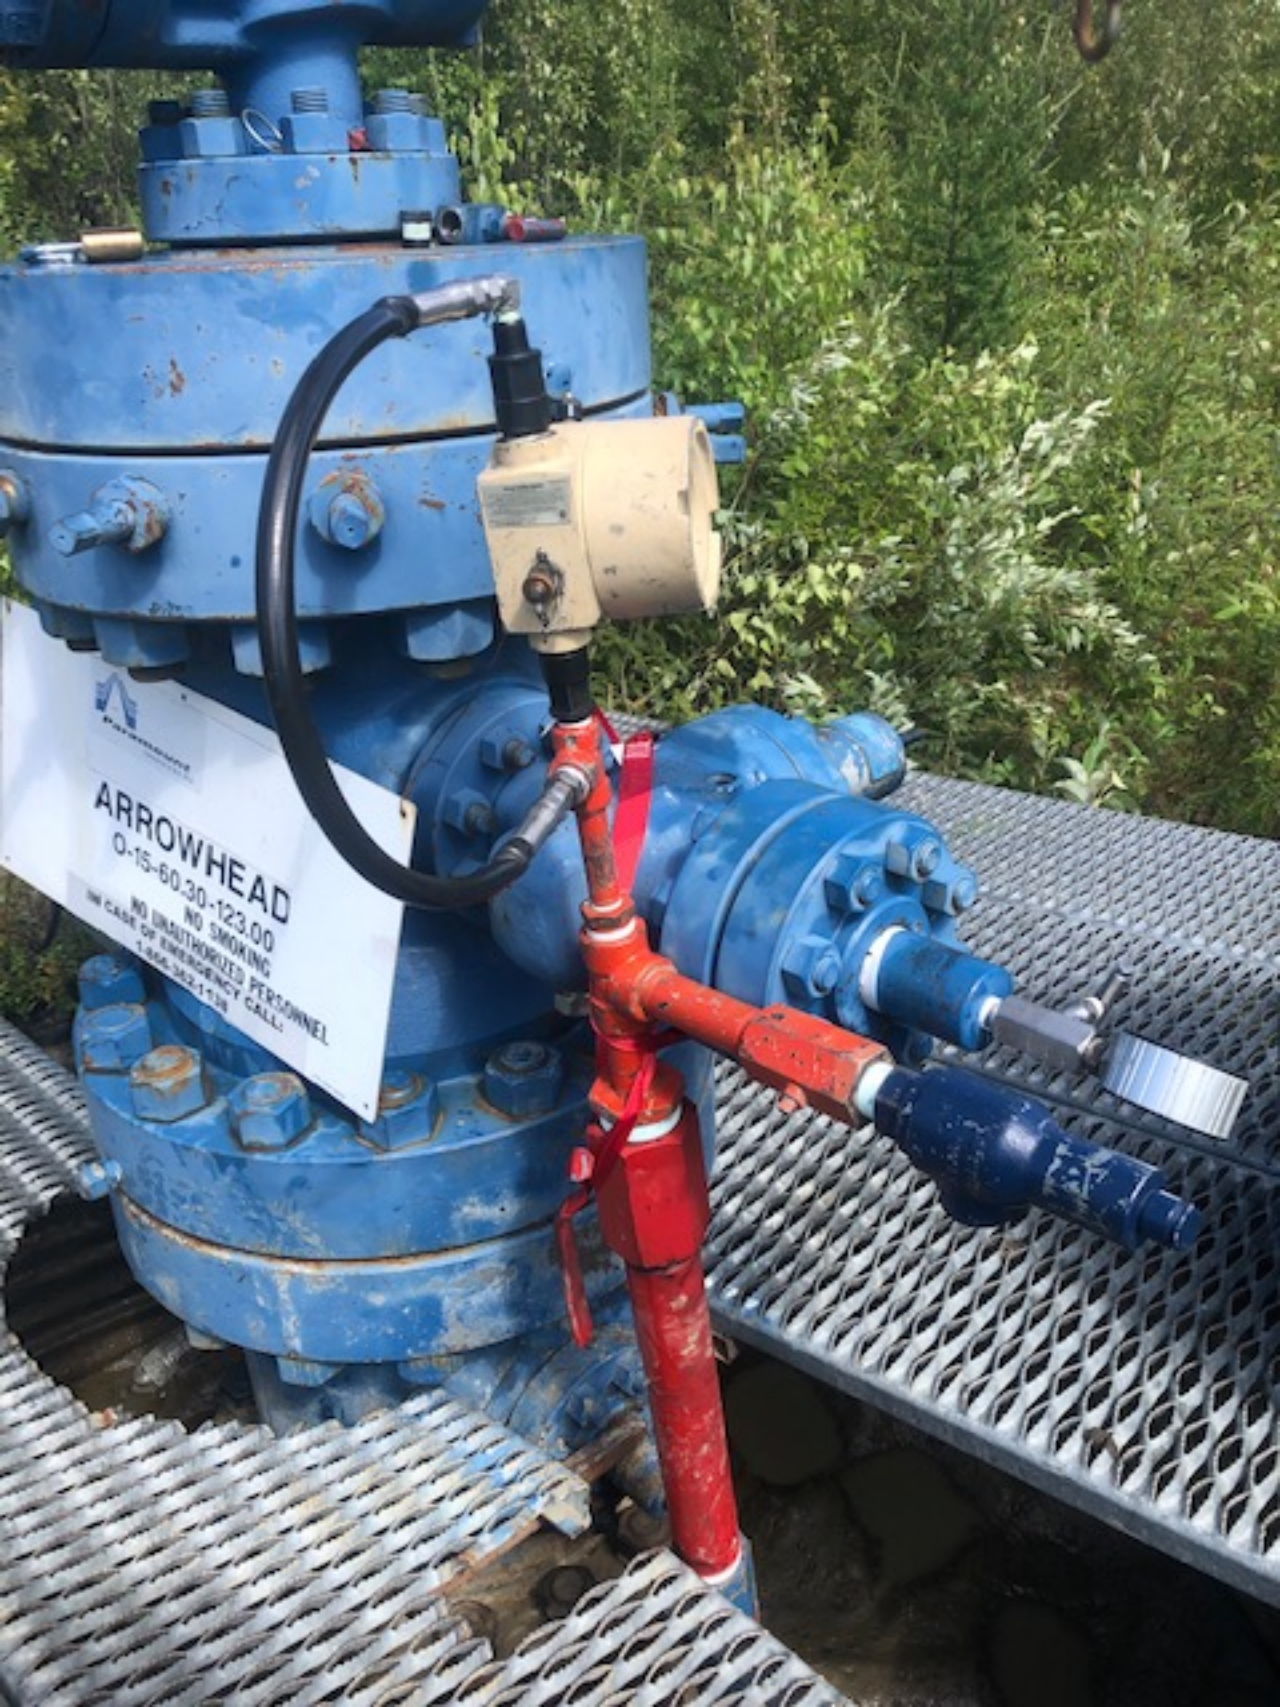
ARROWHEAD
0-15-60.30-123.00

NO SMOKING
NO UNAUTHORIZED PERSONNEL
IN CASE OF EMERGENCY CALL:
1-800-363-1318

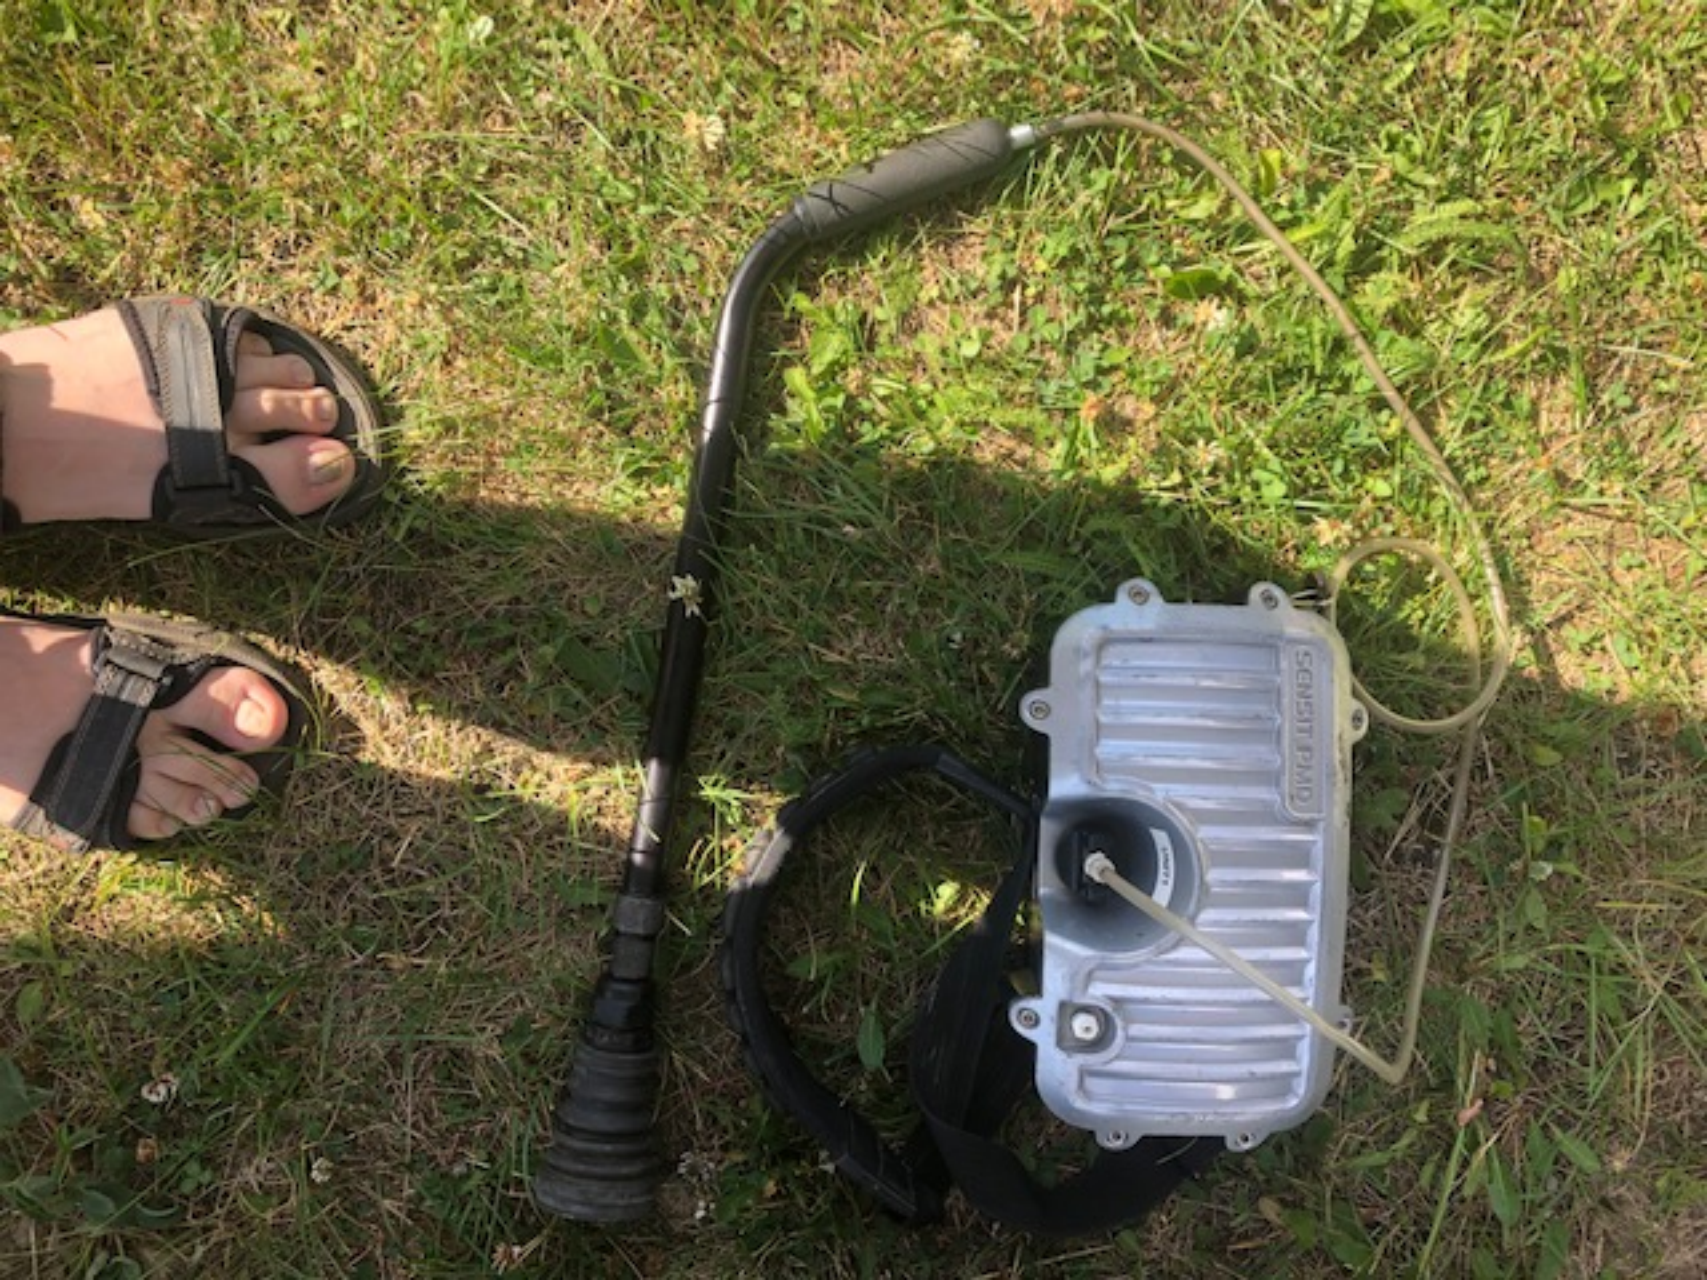
SENSIT[®]
SENSIT Technologies
S/N 1573
www.aastlebleksensors.com

Perform Gas Migration testing at 1-2-3 distances from wellhead on North / South / East / West grids with Sensit (s/n : 1922) Portable Methane Detector that measures methane gas in ppm.

1.0 meters: East = 1.0 ppm. North = 0.0 ppm. West = 3.0 ppm. South = 1.0 ppm
2.0 meters: East = 1.0 ppm. North = 1.0 ppm. West = 2.0 ppm. South = 1.0 ppm
3.0 meters: East = 2.0 ppm. North = 1.0 ppm. West = 1.0 ppm. South = 2.0 ppm
