OROGO Well Abandonment Verification Inspection Summary Report

Well name/ Facility: Cameron B-25

Operator: Strategic Oil and Gas Ltd.

Date of inspection: 2024-09-18

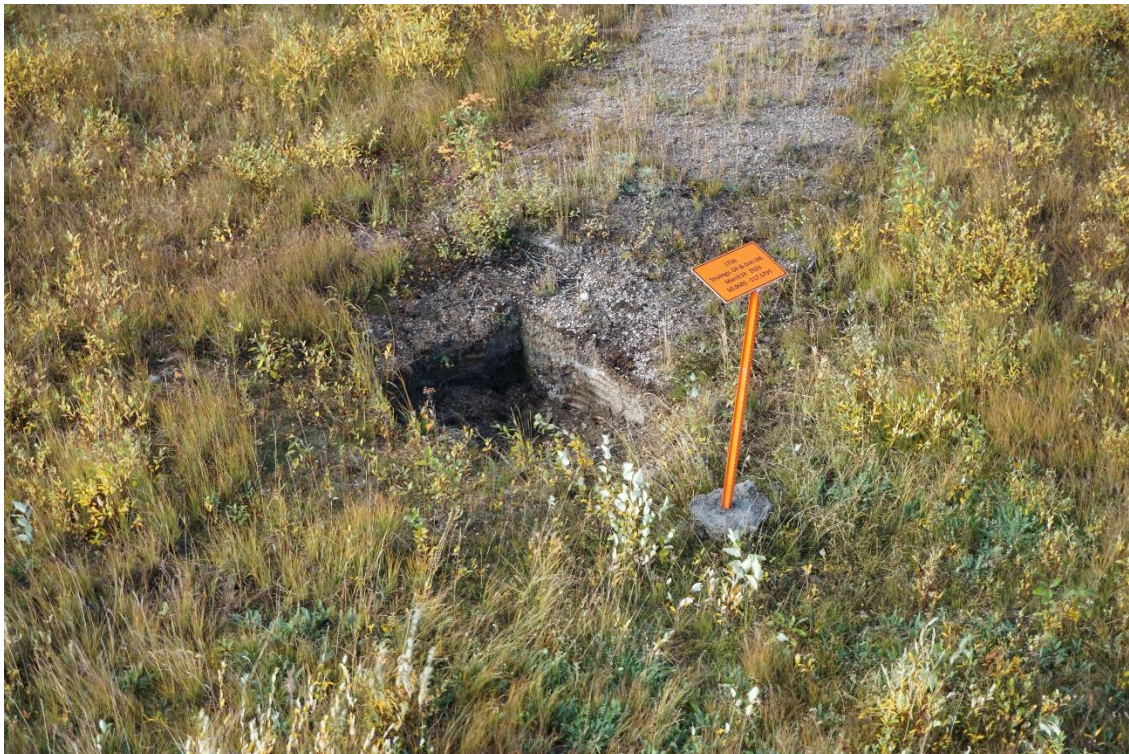
If yes, provide details: Well center must be properly backfilled and mounded to prevent the ponding of water (Photo #2) **as noted in the September 25, 2024 notice by OROGO**

As seen in Photo #2, the well sign has been bent over and may be on its way to falling off. This well sign is not satisfactorily installed and must be installed in a permanent manner as per section 6E of the *Well Suspension and Abandonment Guidelines and Interpretation Notes*

Photo #2 Close up view of the well center which has not been backfilled and mounded to prevent the ponding of water. The well sign is also bent over and may fall off in the near future.

If yes, provide details: The open excavation poses a risk to public safety and the environment as they are not readily seen or backfilled. As per OROGO's notice on September 25, 2024, temporary mitigation is required to be complete prior to October 31, 2024. Additionally, a plan to address the permanent mitigation of this excavation is required to be submitted to OROGO no later than December 15, 2024

As per OROGO's notice on September 25, 2024, temporary mitigation is required to be complete prior to October 31, 2024. Additionally, a plan to address the permanent mitigation of these pilings is required to be submitted to OROGO no later than December 15, 2024.
