Well Inspection Report

Well name: L-44-60-10-117-15

Vapor Intrusion Assessment (VIA)

Cameron Hills L-44

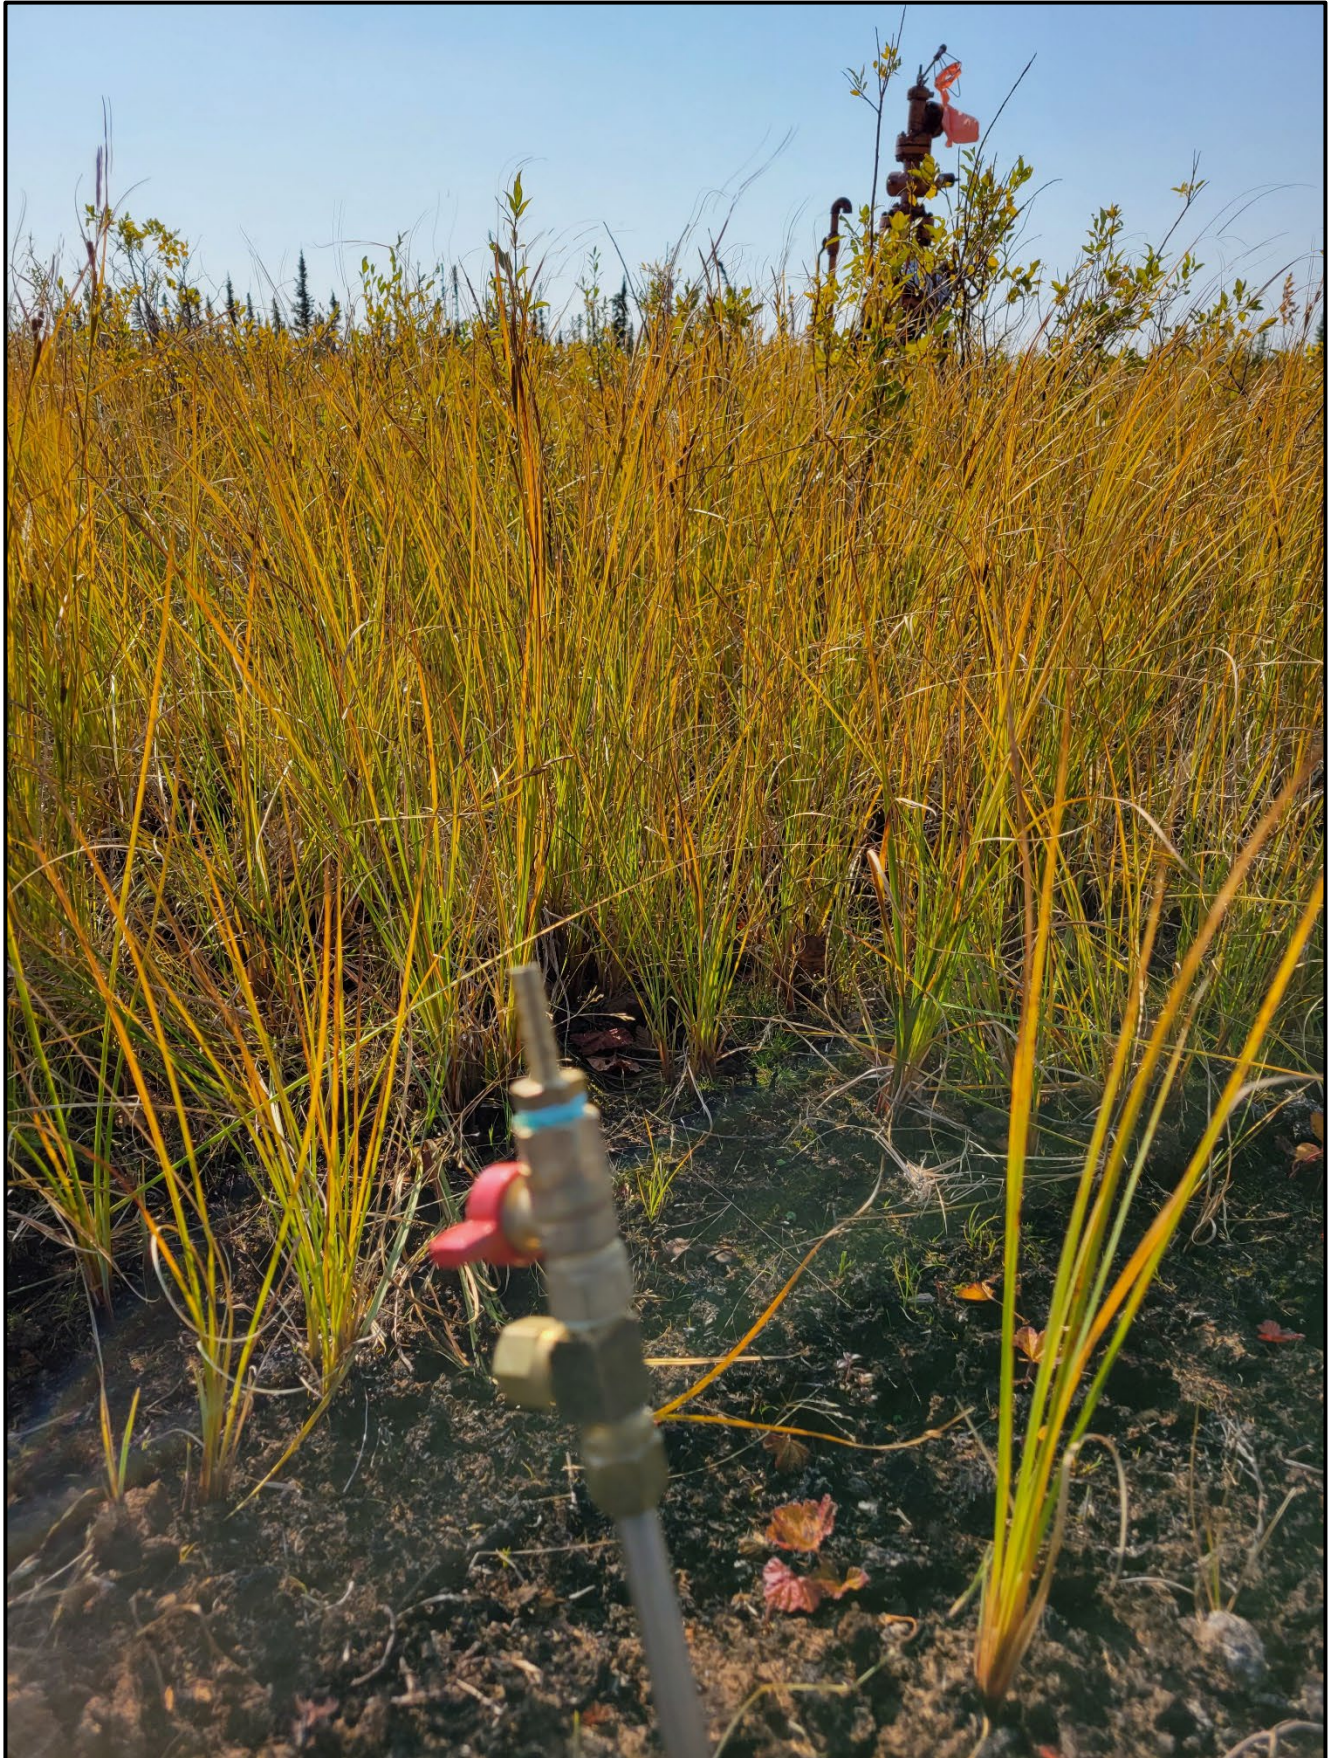
Figure 4: ΣC_6+ vs Ethane. C_6+ gases are relatively large molecules that do not readily or easily migrate in large quantities from depth upwards through subsurface fractures or micro-fractures to surface. Contamination by oil spills, fuels, and solvents is indicated by soil vapor samples that have high contents of C_6+ compounds and plot in the Lower RH Quadrant. Samples plotting in the Lower LH and RH Quadrants do not contain evidence of either SCVF or AGM and would not require downhole repair operations.

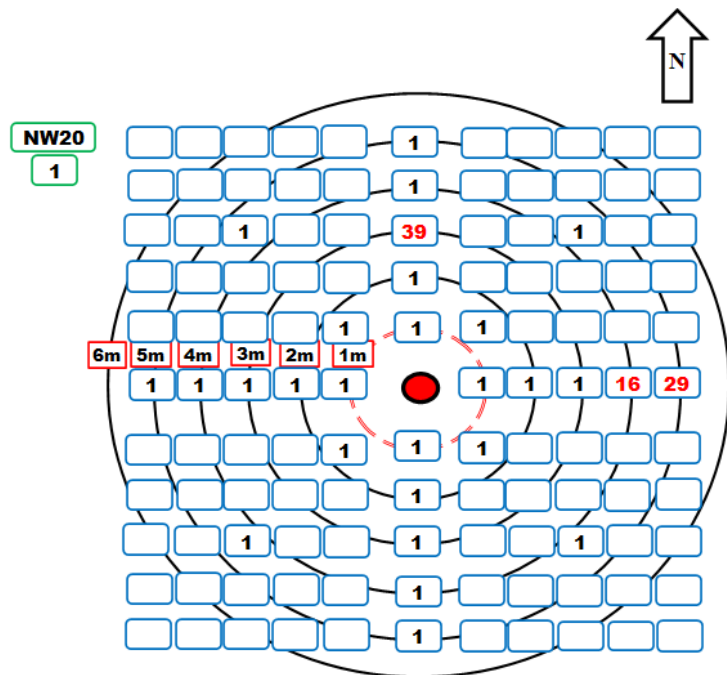
Figure 1. AGM Non-Intrusive Surface PMD

- 1) The Surface Casing Vent passed the ten-minute bubble test (1 ppm v/v methane).
- 2) A surface combustible gas scan was performed near the wellbore using a Sensit Portable Methane Detector (PMD). Most readings were low, but some were elevated (i.e. up to 39 ppm v/v methane at N3) compared to background (1 ppm v/v) established 20m northwest from the wellbore (Figure 1, Table 1).

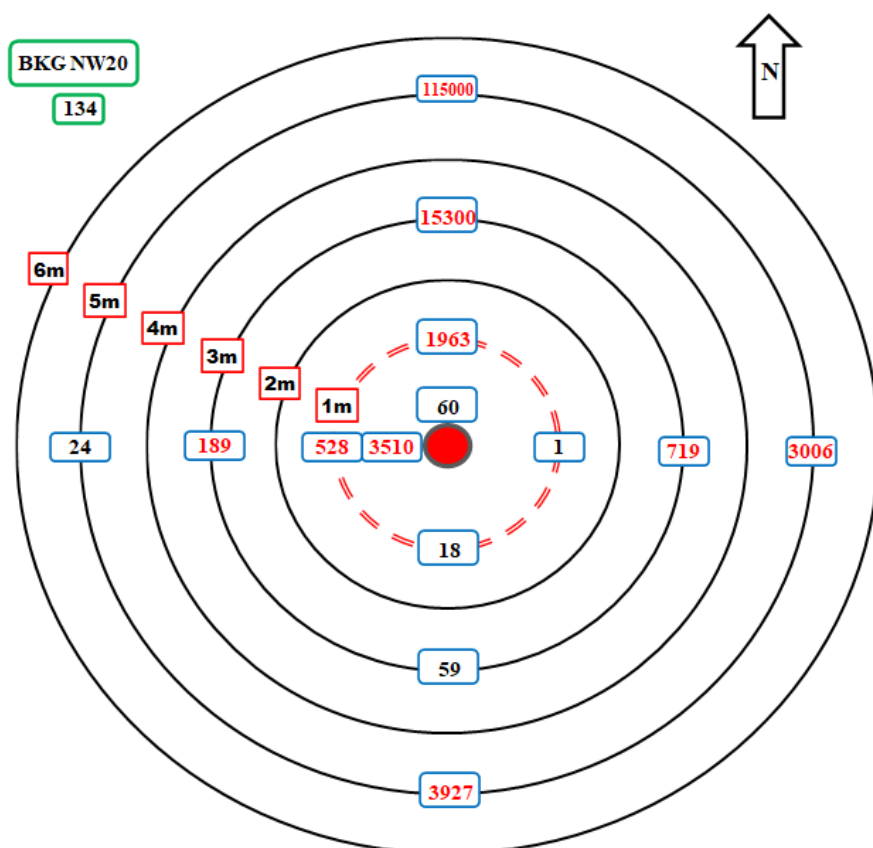
Figure 2. AGM Intrusive SVPs-

- 3) An intrusive soil gas migration test was then performed by drilling test holes and inserting Soil Vapor Probes (SVPs). Combustible gas readings in the SVPs were elevated (up to 11500 ppm v/v at N5), compared to the background probe (1 ppm v/v methane) installed approximately 20m northwest of the wellbore to establish background levels in the area and for comparison to other samples collected during this investigation (Figure 2, Table 2).

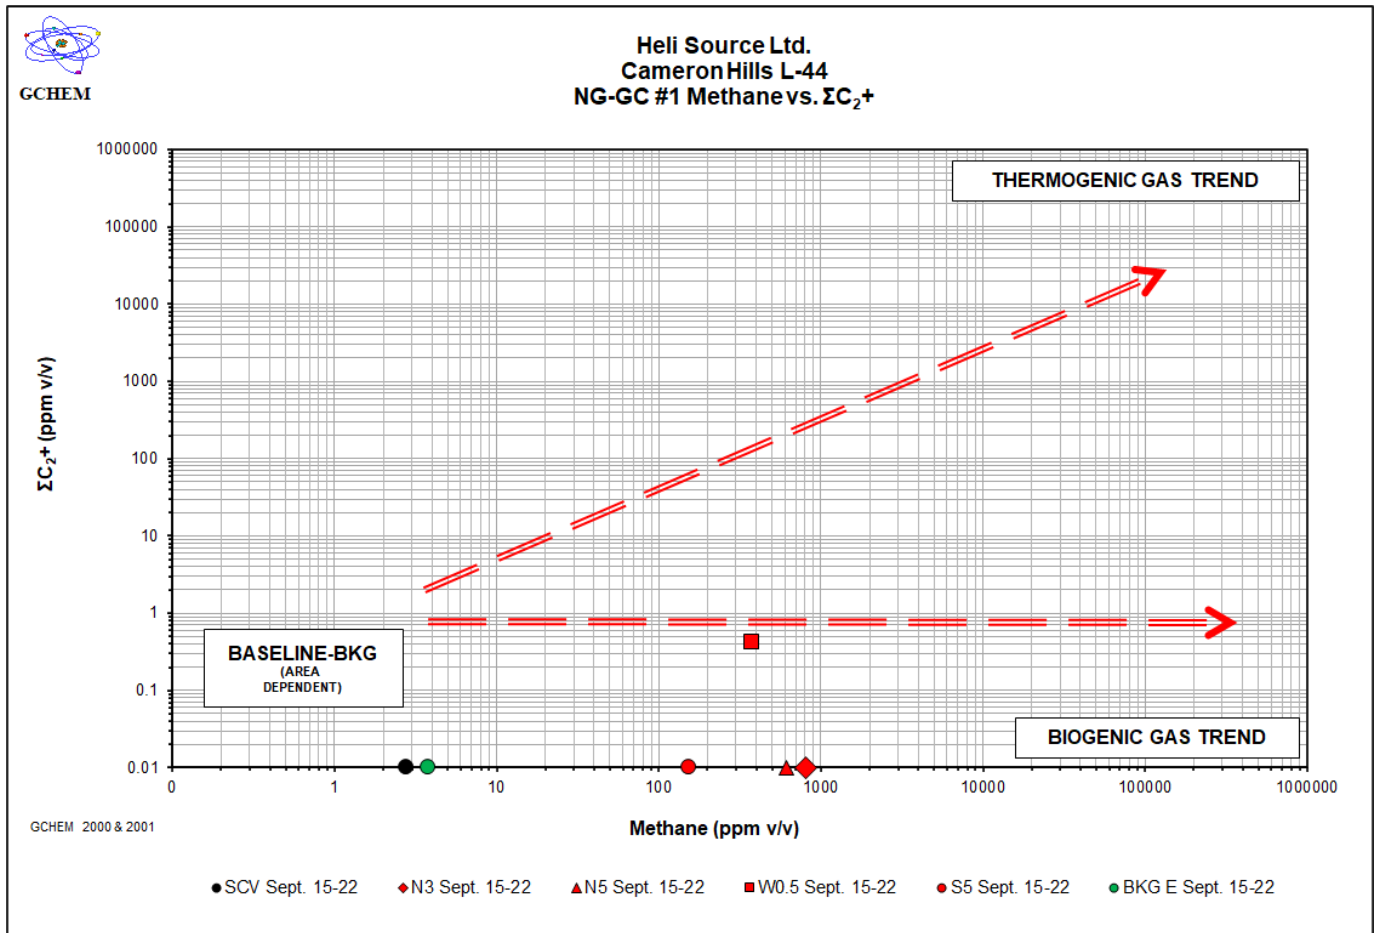
Figure 3: ΣC_2+ vs Methane. Combustible gases detected in soils and SCVs at a wellhead may result from several origins. Natural gases indicative of SCVF or AGM are thermogenic in origin (natural gas in deep reservoirs), contain high methane and C_2+ contents and plot in the Upper RH Quadrant. Low natural gas levels in background, off lease areas are naturally present in soils, vary from region to region and plot in the Lower LH Quadrant. Biogenic gases (swamp-gas) are produced by bacteria, are comprised of predominantly methane and plot in Lower RH Quadrant. Samples plotting in the Lower LH and RH do not contain SCVF or AGM and would not require down-hole remediation

- 1) Natural gases in the SCV and soils near the wellbore contain low levels of C_2+ gases indicating that this well is not impacted with leaking thermogenic natural gases.

- 5) C₂ + light alkane gas levels in soil gases collected near the wellbore are low, comparable to background established 20m east of the wellbore (Figure 3). Elevated combustible gas readings in the soils are the result of the presence of biogenic methane (swamp gas).

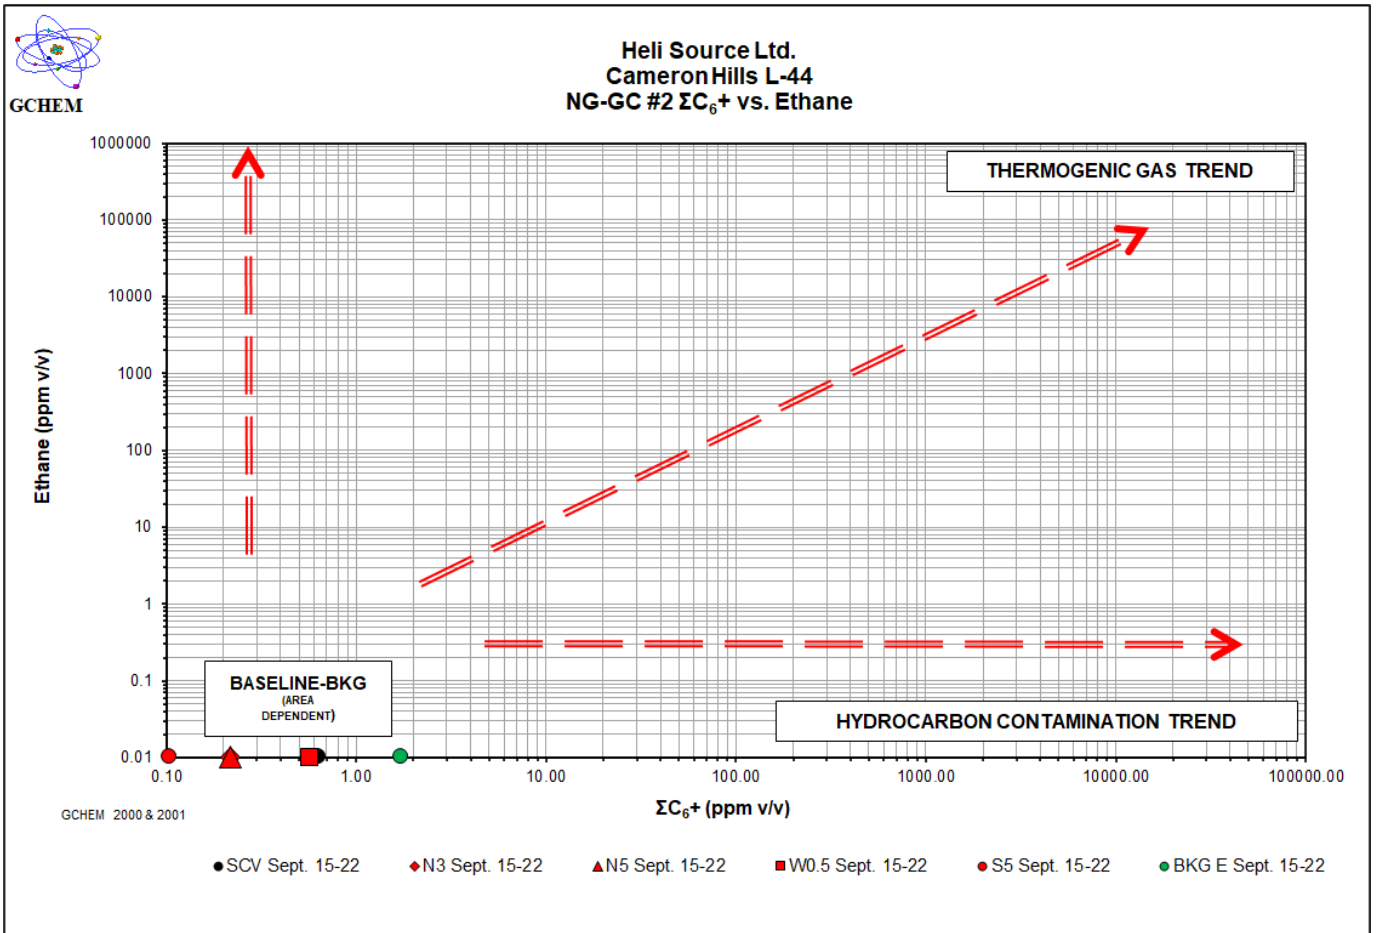
- 1) C_6+ contents of the SCV and soil gas samples are low and are similar to expected baseline readings. Measured combustible gas levels are not the result of near surface hydrocarbon or chemical contamination.

- 6) C₆₊ contents in the soil samples are low and comparable to background levels (Figure 4).
- 7) This well does not contain evidence of SCVF or gas migration at the time of this investigation.

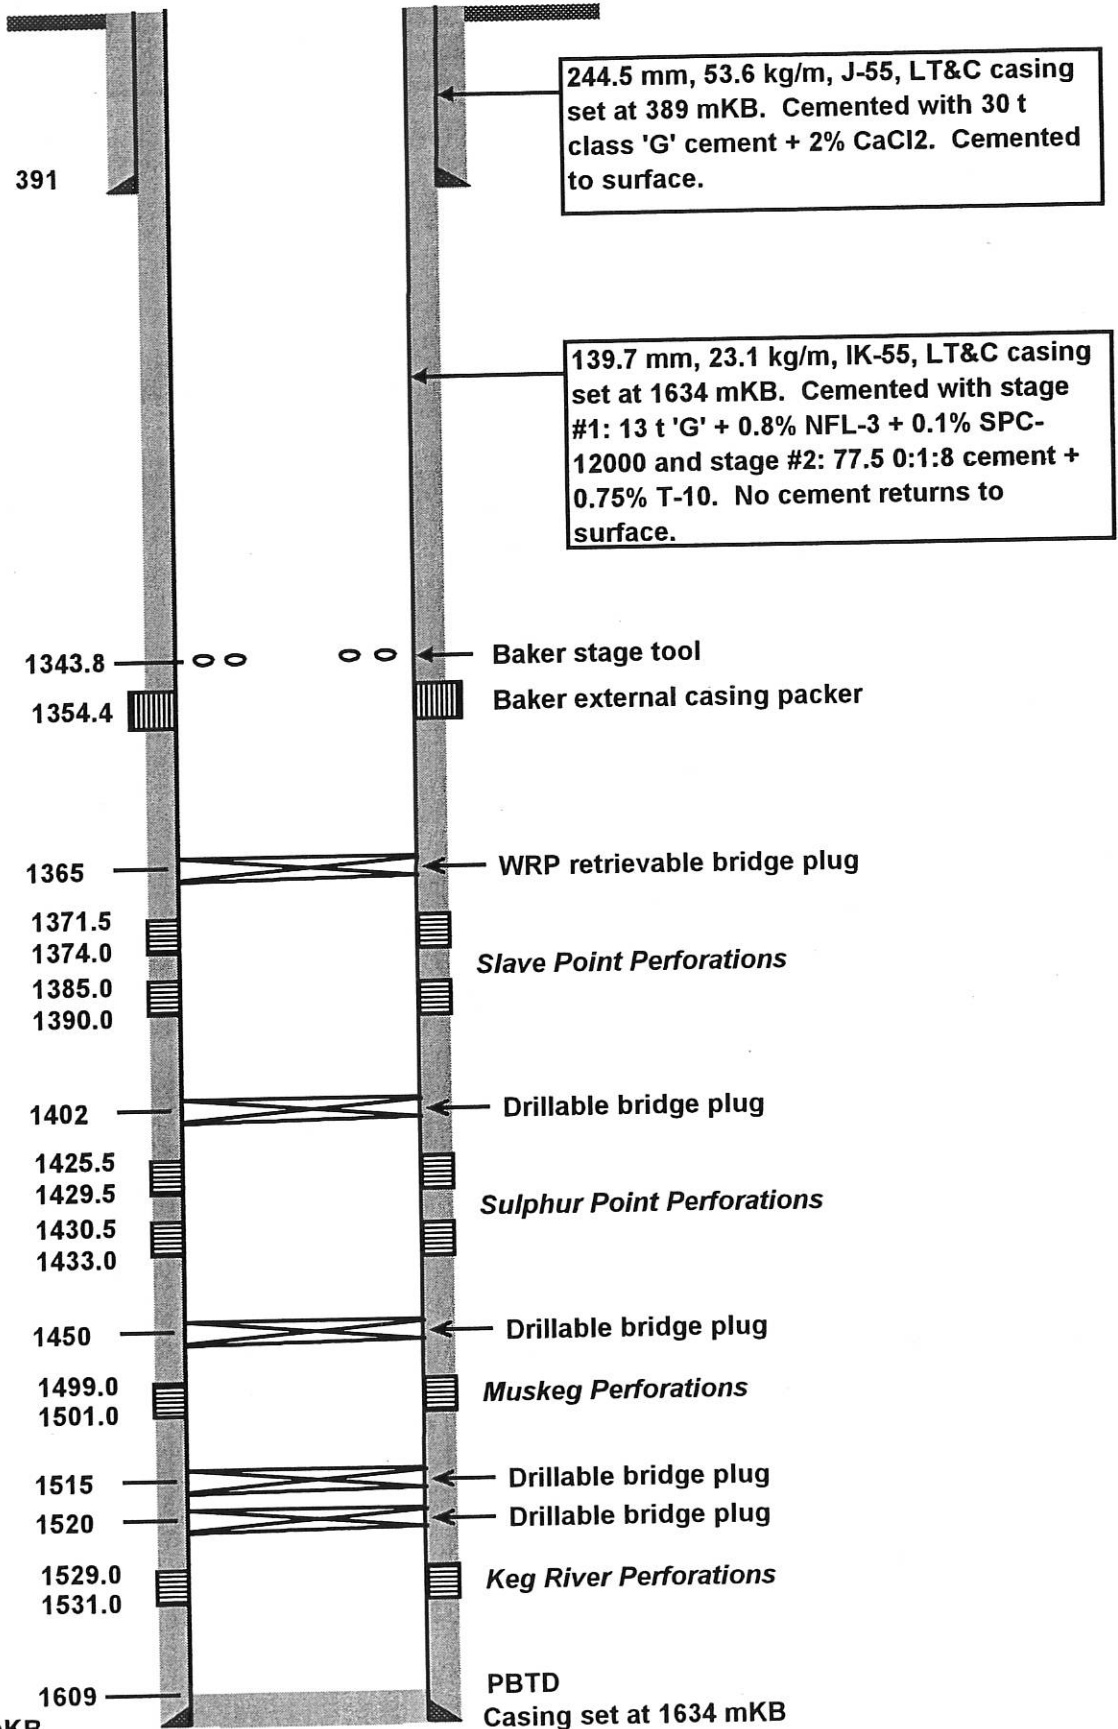
PARAMOUNT ET AL CAMERON L-44
 60° 10' N, 117° 30' W
 Bottom Hole Diagram (as of March 16, 1990)

244.5 mm, 53.6 kg/m, J-55, LT&C casing set at 389 mKB. Cemented with 30 t class 'G' cement + 2% CaCl₂. Cemented to surface.

139.7 mm, 23.1 kg/m, IK-55, LT&C casing set at 1634 mKB. Cemented with stage #1: 13 t 'G' + 0.8% NFL-3 + 0.1% SPC-12000 and stage #2: 77.5 0:1:8 cement + 0.75% T-10. No cement returns to surface.

Baker stage tool
 Baker external casing packer

WRP retrievable bridge plug

Slave Point Perforations

Drillable bridge plug

Sulphur Point Perforations

Keg River Perforations

Total depth = 1634 mKB
