OROGO Well Inspection Summary Report

Well name: Cameron L-44

Operator: Strategic Oil and Gas

Date of inspection: 2022-09-23

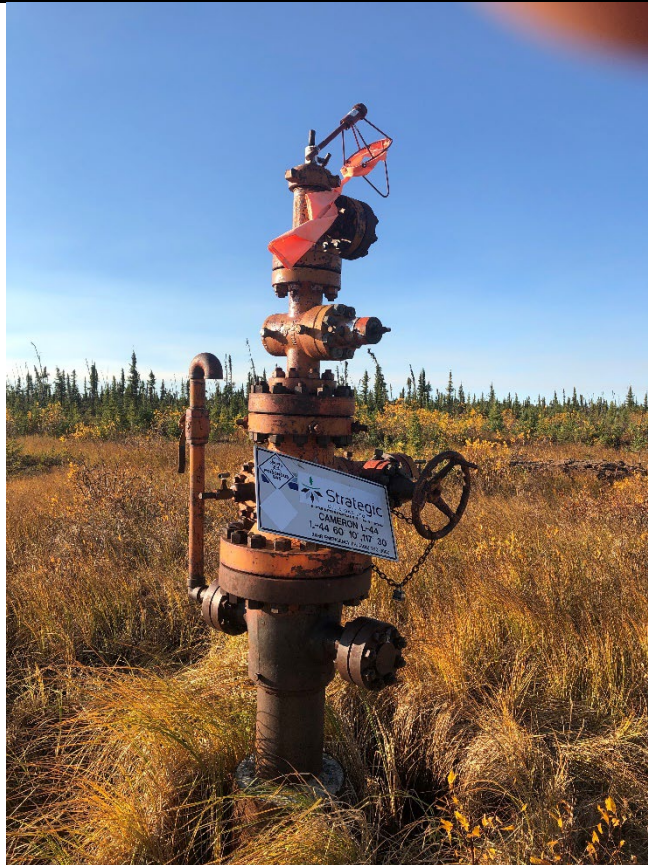
Photo #2: Cameron L-44 wellhead

1) WIND INDICATOR: The current wind indicator on site is not functional and requires replacement (See photo #2). During the next planned visit of Strategic Oil and Gas Ltd. (Strategic) to this well, the wind indicator will have to be replaced to reflect the requirements of Section 5A of the Well Suspension and Abandonment Guidelines and Interpretation Notes (Guidelines).

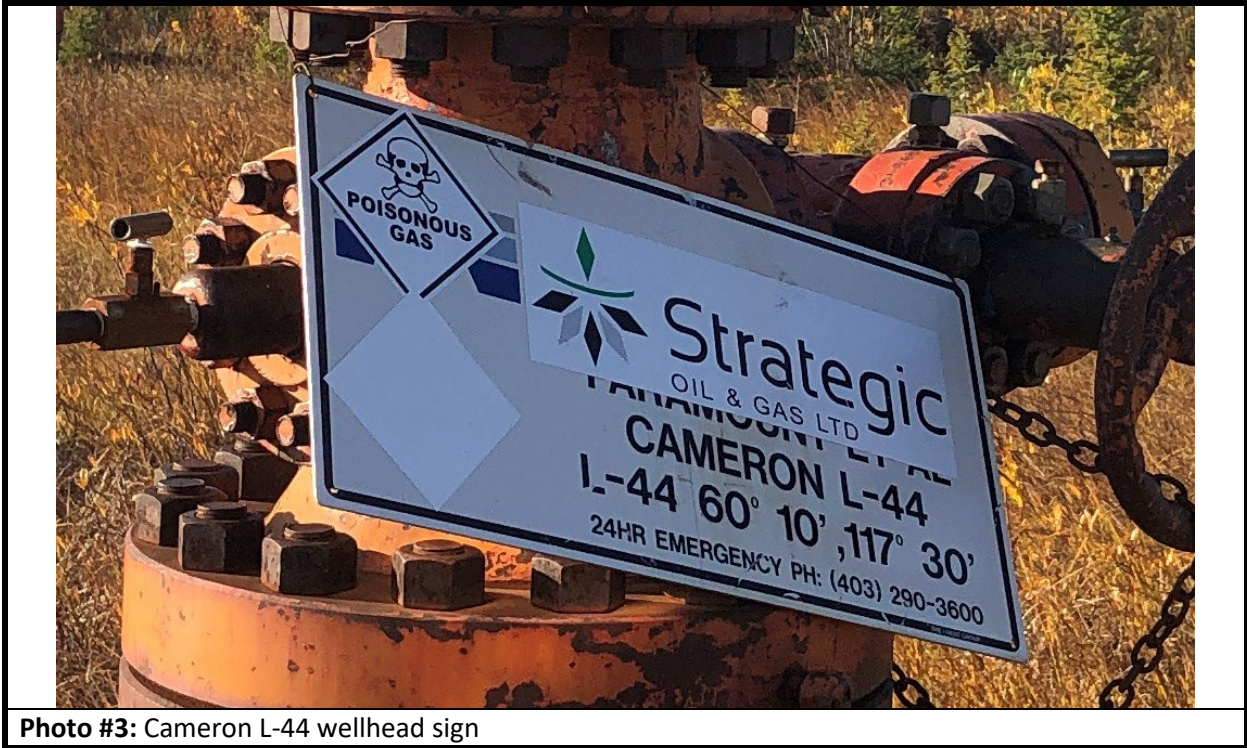
Photo #3: Cameron L-44 wellhead sign

2) WELLHEAD SIGN: The current wellhead sign indicating the well name and ID does not meet the requirements of Section 5A of the Guidelines. In addition the current sign does not provide the correct emergency contact information for Strategic (See photo #3). During the next planned visit of Strategic to this well, the sign will have to be updated to reflect the requirements of Section 5A of the Guidelines revised in 2022.
