## Well Inspection Report

Well name: M-31-60-10-117-00

M-31 – September 2022

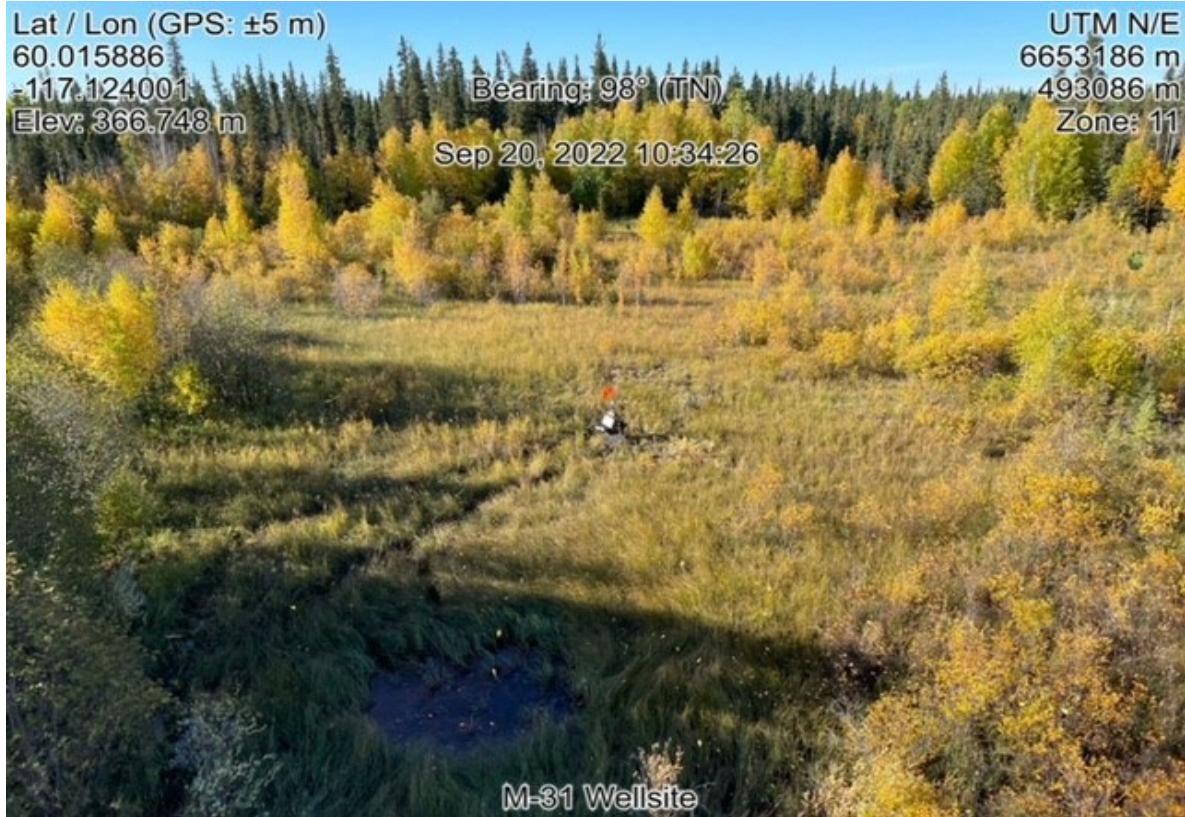
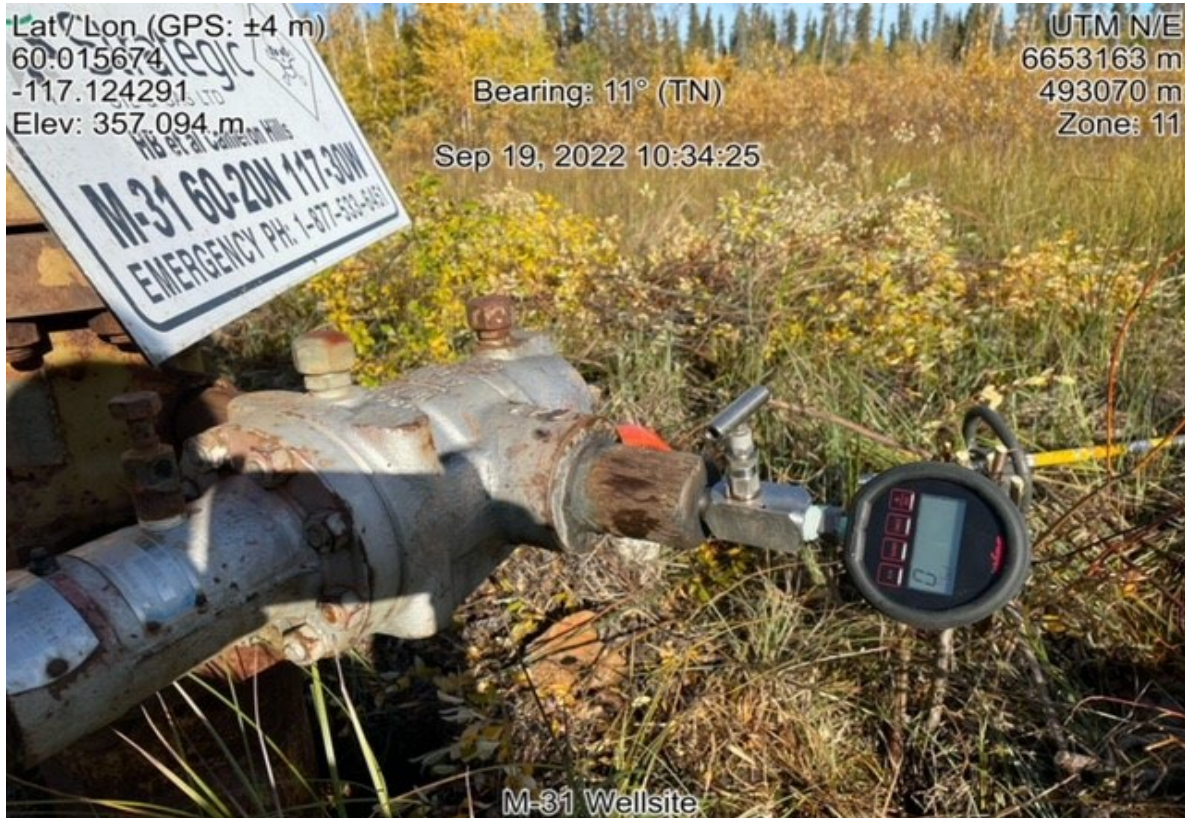
10 minute Bubble test completed on SCV, no visible bubbles indicated. See attached pictures for shut in pressures taken on Tubing and Casing. No H2S or LEL's detected while inspection was conducted.

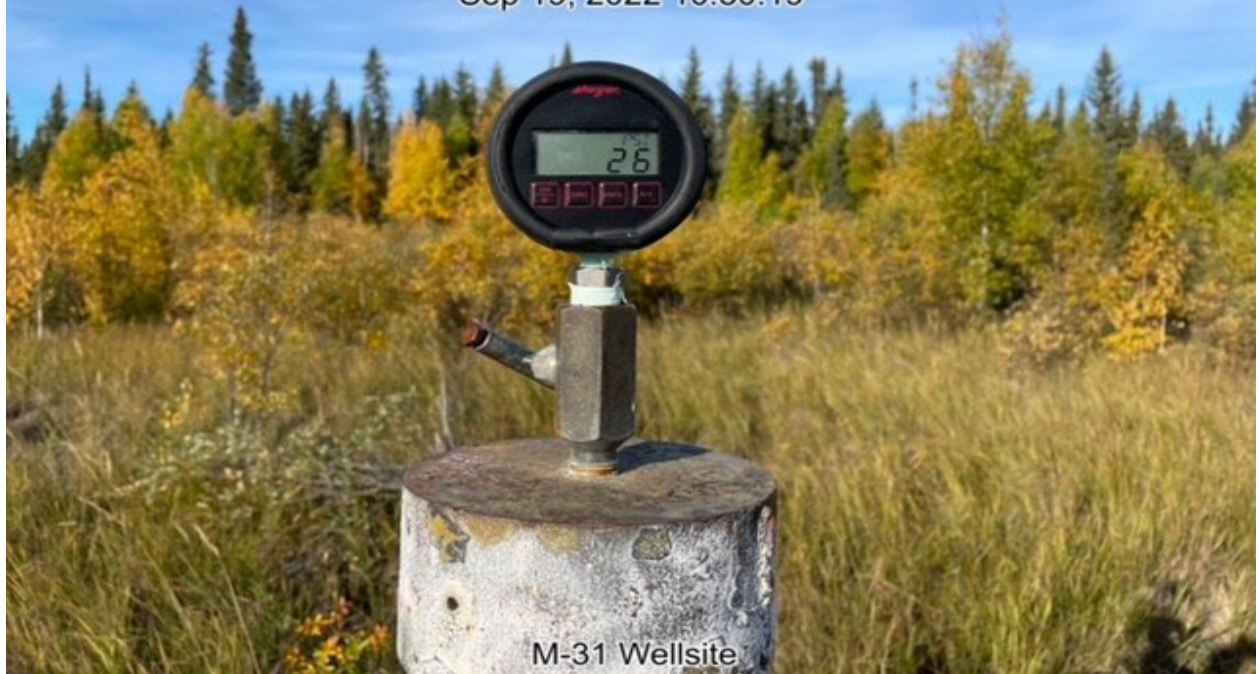
M-31 Wellsite

If yes, provide details: Bubbles noted around wellhead, water and wet conditions on wellsite in muskeg area creating air pockets when walking thru area. Gas Migration testing completed independently by G-Chem at this site in September 2022, GMT testing results will be provided separately.

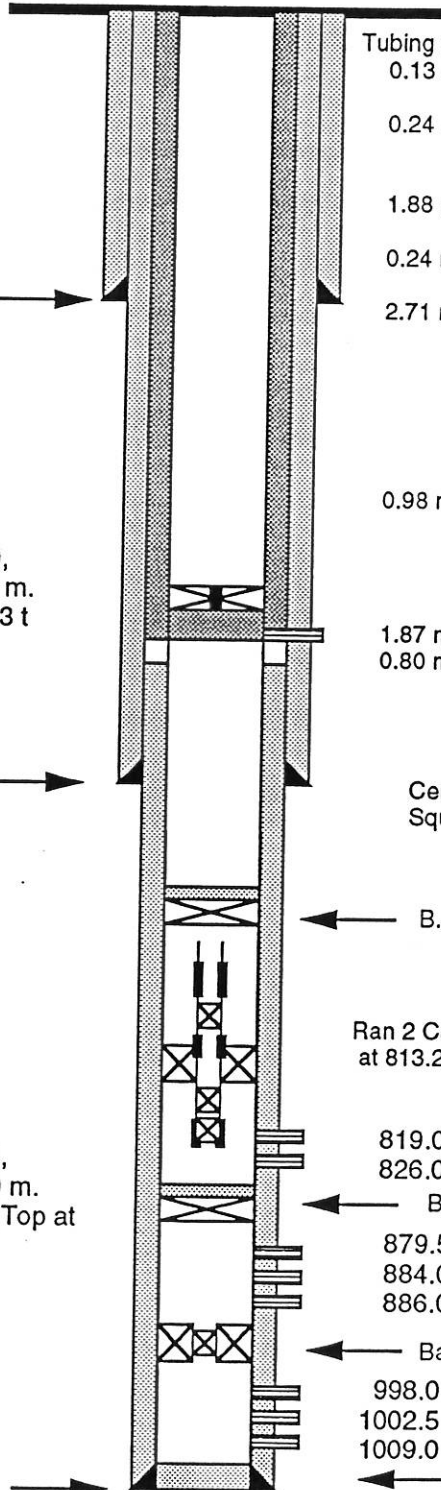
## PARAMOUNT et al CAMERON M - 31 60° 10' 117° 0' WELL COMPLETION SCHEMATIC

KBE : 358.3 m  
GLE : 354.7 m

Cement retainer @ ~~797 m~~ 745 m  
Squeeze perforations @ 756 - 757 mKB

B. P. @ 797 m      PBD 787 mKB mKB

Ran 2 Cardium 60.3 mm RNT tubing bridge plugs at 813.25 mKB and 808.4 mKB. inside tubing.

819.0 -822.5 mKB  
826.0 -828.5 mKB      Slave Point perforations  
B. P. @ 870 m      PBD 861.0 mKB  
879.5 -881.5 mKB      Sulphur Point perforations  
884.0 -885.0 mKB  
886.0 -887.5 mKB

Baker LOK-SET @ 990 mKB with blanking plug  
998.0 -1001.0 mKB  
1002.5 -1005.0 mKB      Keg River perforations  
1009.0 -1013.0 mKB  
PBD ? mKB

Set 244.5 mm, 48.1 kg/m, H-40, ST&C ERW casing @ 200 mKB.

Set 177.8 mm, 25.3 kg/m, H-40, ST&C, ERW casing @ 796 m.  
Cemented to surface? with 20.3 t 0:1:0 'G'

Set 114.3 mm, 14.14 kg/m, J-55, ST&C, ERW casing @ 1060 m.  
Cemented with 6.6 t 0:1:0 'G'. (Top at 621 m calculated.)
