Well Inspection Report

Well name: M-74-60-10-117-15

M-74 Wellsite Inspection September 2022

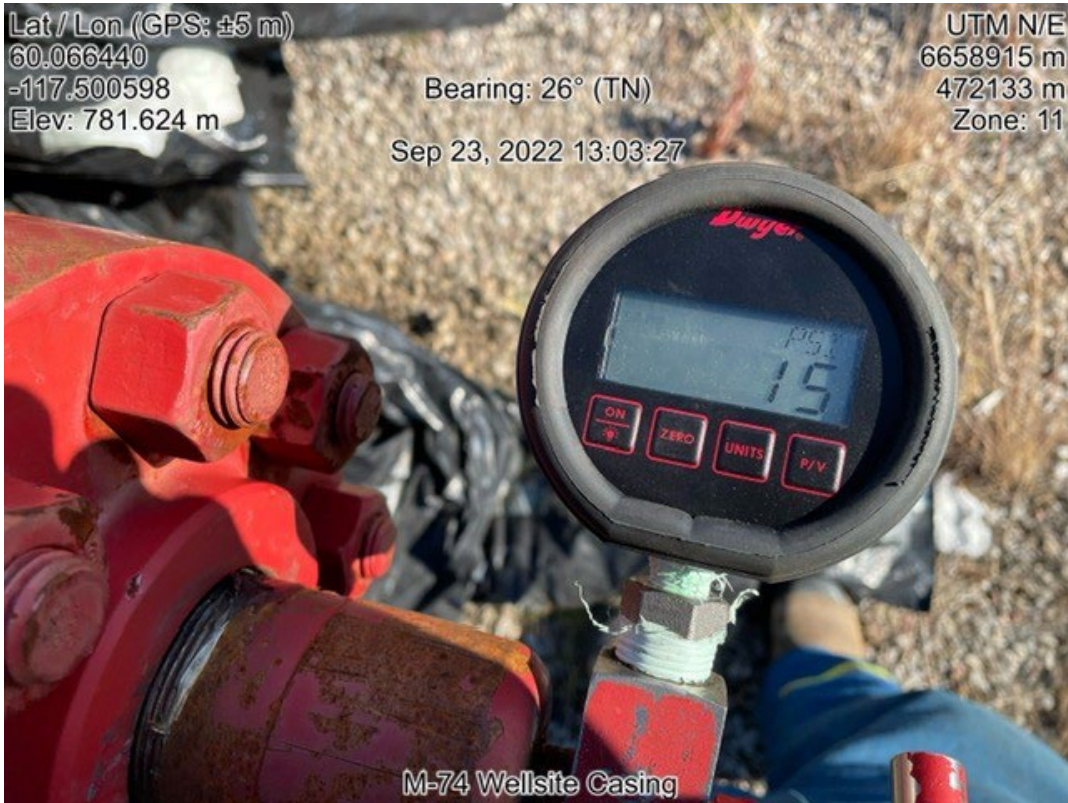
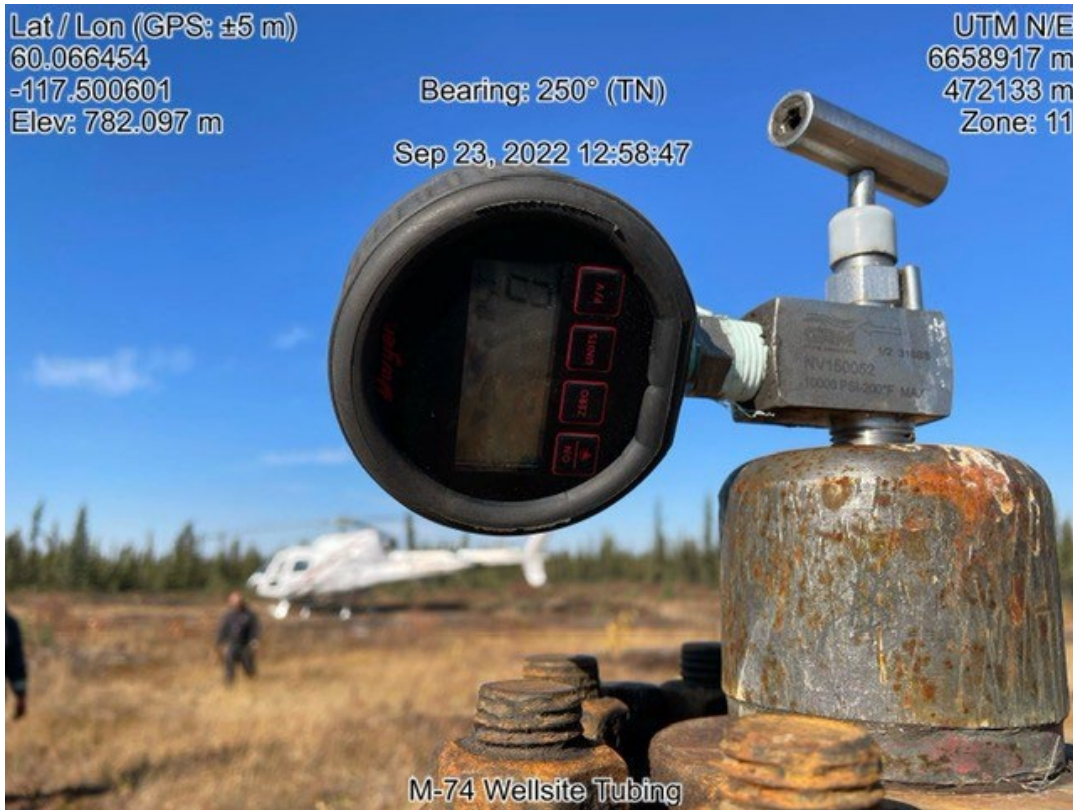
10 minute Bubble test completed on SCV, no visible bubbles indicated. See attached pictures for shut in pressures taken on Tubing and Casing. No H₂S or LEL's detected while inspection was conducted. Gas Migration testing completed independantly by G-Chem at this site in September 2022. No H₂S or LEL's detected during this inspection.

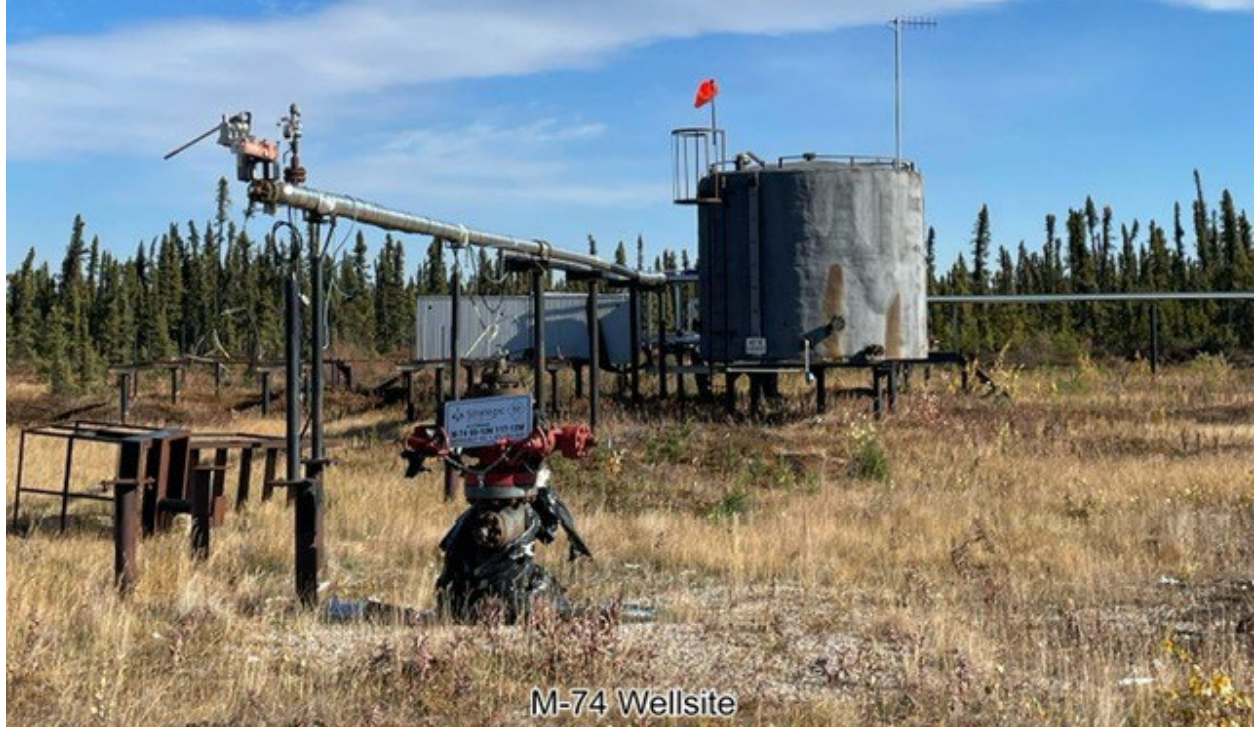
M-74 Wellsite

Tubing
