OROGO Well Abandonment Verification Inspection Summary Report

Well name/ Facility: Cameron 2H-03
4 digit WID/ Facility Name: 2073

Operator: Strategic Oil Gas
Well status: Abandoned

Date of inspection: 2024-09-17
Access method: Helicopter

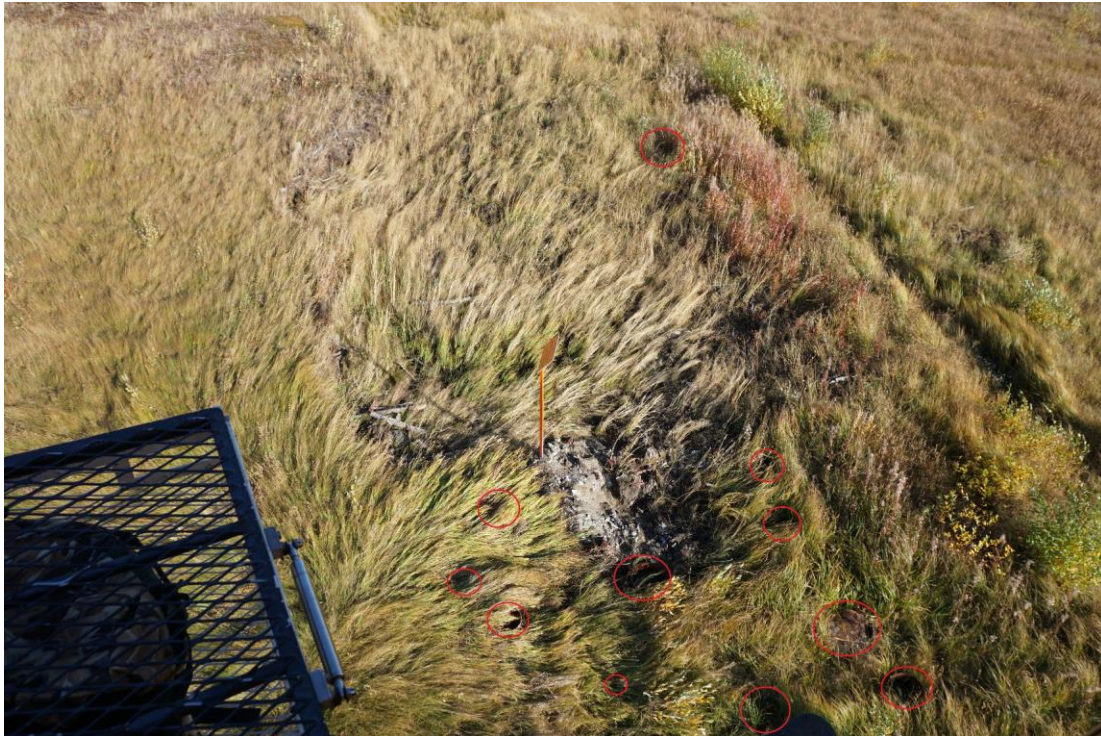
If yes, provide details: 11 hollow pilings were identified on site. These pilings were cut just above ground level and visually obscured by vegetation (See Photo #1 and #2).

- 2 Pilings – 20" diameter
- 8 Pilings – 18" diameter
- 1 piling – 6" diameter

Photo #1: Cameron 2H-03 (WID2073) – 11 identified unsecured pilings circled in red

If yes, provide details: Remaining pilings pose a risk to public safety and the environment as they are hollow and not readily seen. As per OROGO's notice on September 25, 2024, temporary mitigation is required to be complete prior to October 31, 2024. Additionally, a plan to address the permanent mitigation of these pilings is required to be submitted to OROGO no later than December 15, 2024.

As per OROGO's notice on September 25, 2024, temporary mitigation is required to be complete prior to October 31, 2024. Additionally, a plan to address the permanent mitigation of these pilings is required to be submitted to OROGO no later than December 15, 2024.

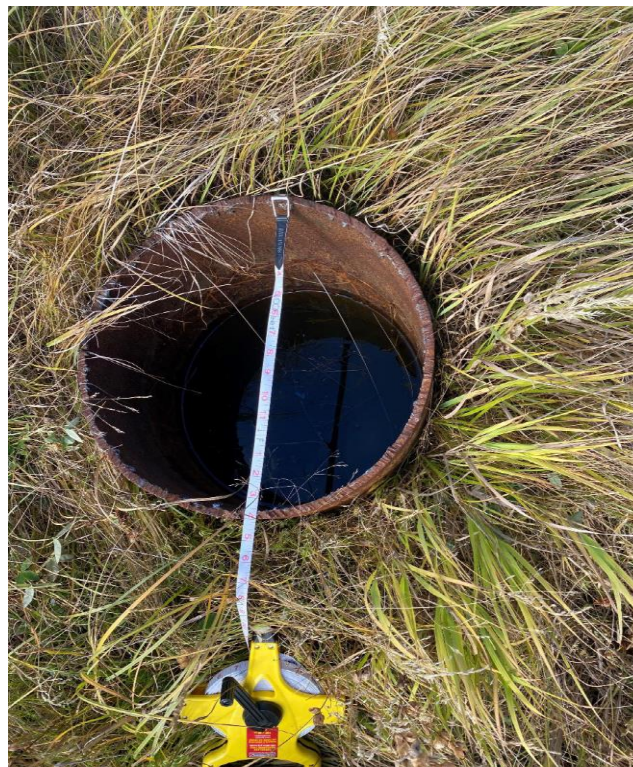
Photo 2: Cameron 2H-03 (WID2073) – 18" Unsecured piling

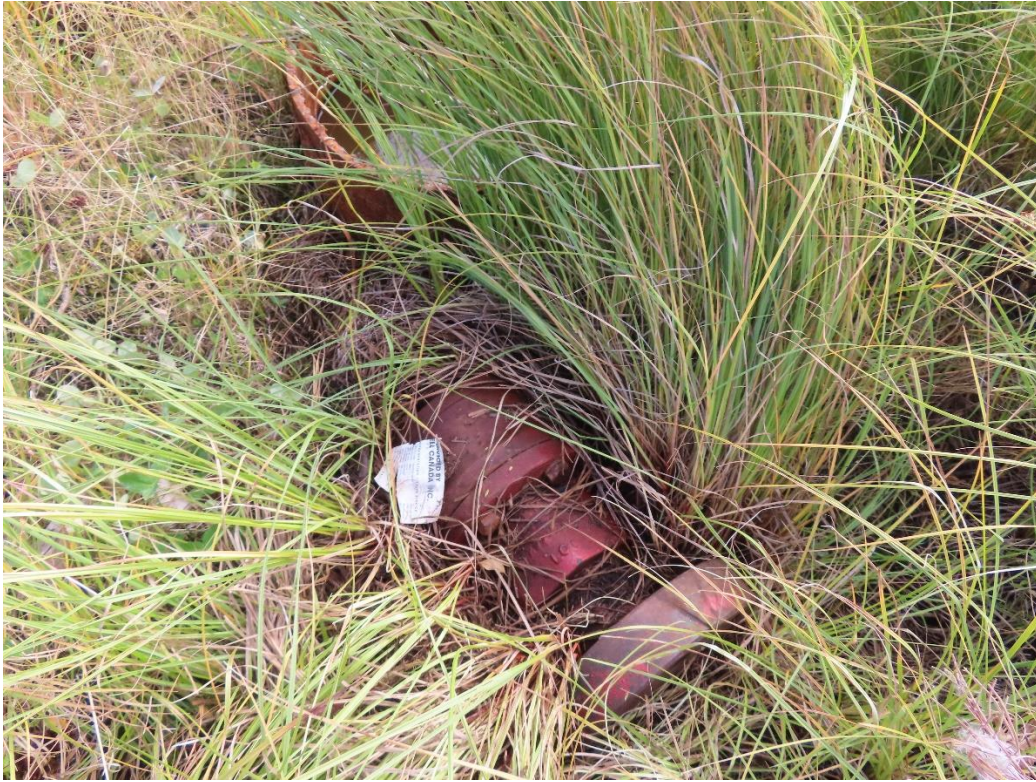
Some debris was also located on site that requires removal (See Photo #3).

Photo #3: Cameron 2H-03 (WID2073) – Debris (Wellhead Valve) on site requiring removal.

Site debris should be collected and removed from site upon the next visit to site by SOG.
