## WELLSITE SUMMARY INSPECTION REPORT

Well/Facility Name:	H-58/Cameron Hills	Operator:	Strategic Oil and Gas Ltd.
Location of Inspection:	Cameron Hills Production Field	Access method:	Helicopter – Great Slave Helicopters
Site Contractor:	None	Status:	Compliant Suspended – Production Well
Approval Info	OA-2018-003	WID:	1975
Date of Inspection	12/SEP/2019	H2S Site:	Yes

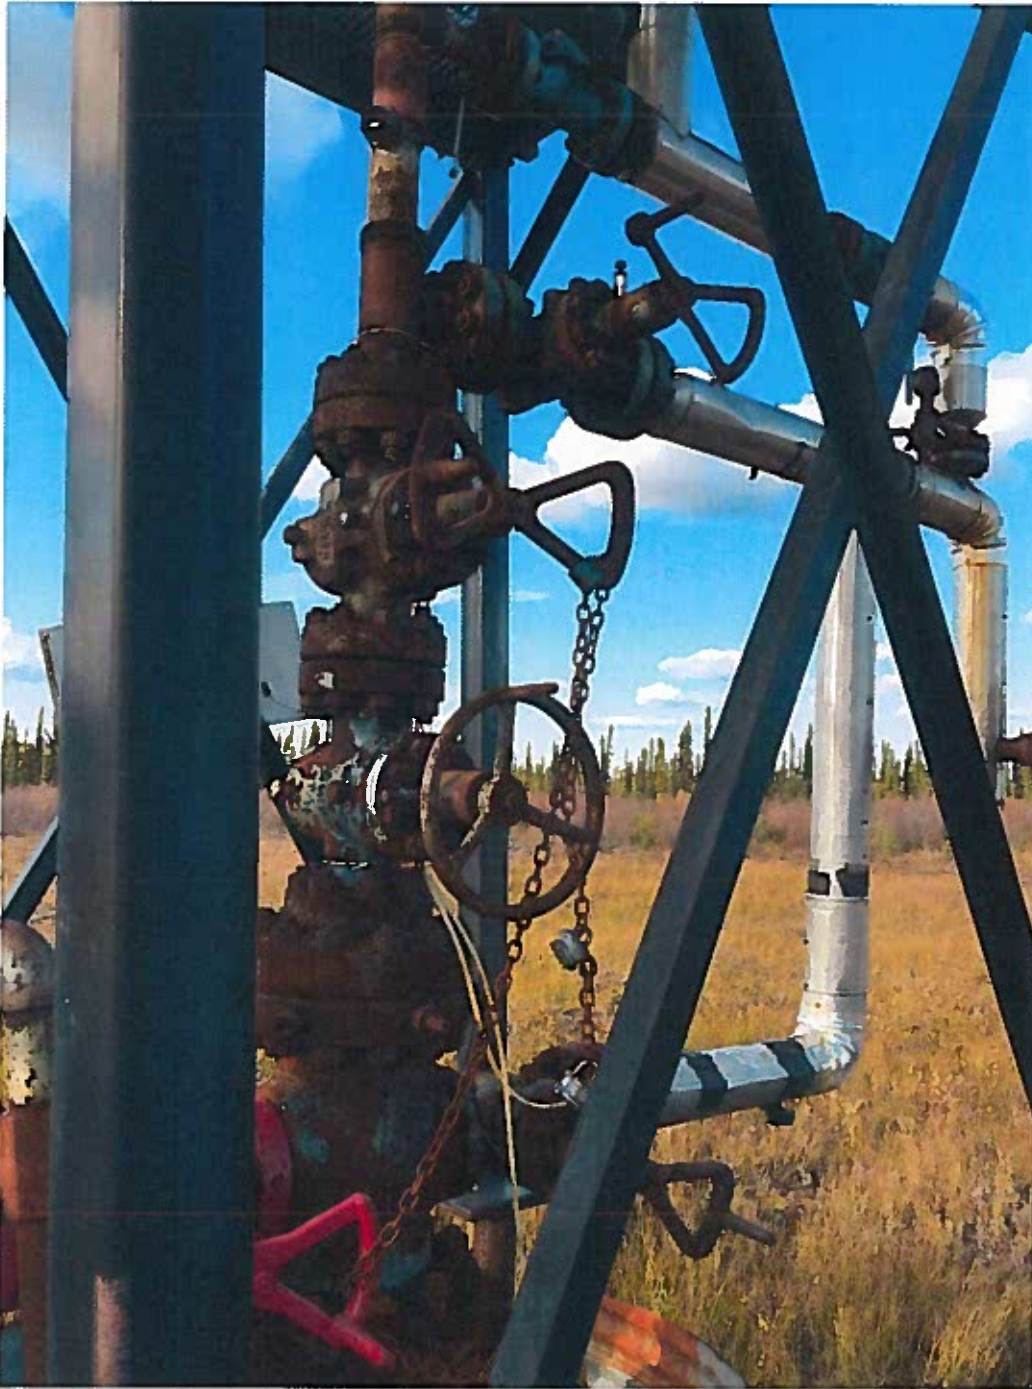
<b>Activity on site</b>	Gas migration testing and annual well inspections conducted by GChem (Contractor)		
<b>Conditions</b>	<b>Satisfactory (Y/N)</b>	<b>Comments</b>	
Site Access	Y		
Well Head Access	N	One well head valve not secured. (Photo #2) All well head valves must be secured to prevent unauthorized operation.	
Signage	Y		
General Housekeeping	Y		
SCV Open and dead	Y	0 Bubbles in 10 min at SCV.

Photo #2: One well head valve not secured. All well head valves must be secured to prevent unauthorized operation
