WELLSITE SUMMARY INSPECTION REPORT

Well/Facility Name:	L-40/Cameron Hills	Operator:	Strategic Oil and Gas Ltd.
Location of Inspection:	Cameron Hills Production Field	Access method:	Helicopter – Great Slave Helicopters
Site Contractor:	None	Status:	Compliant Suspended – Production Well
Approval Info	OA-2018-003	WID:	2045
Date of Inspection	12/SEP/2019	H2S Site:	Yes

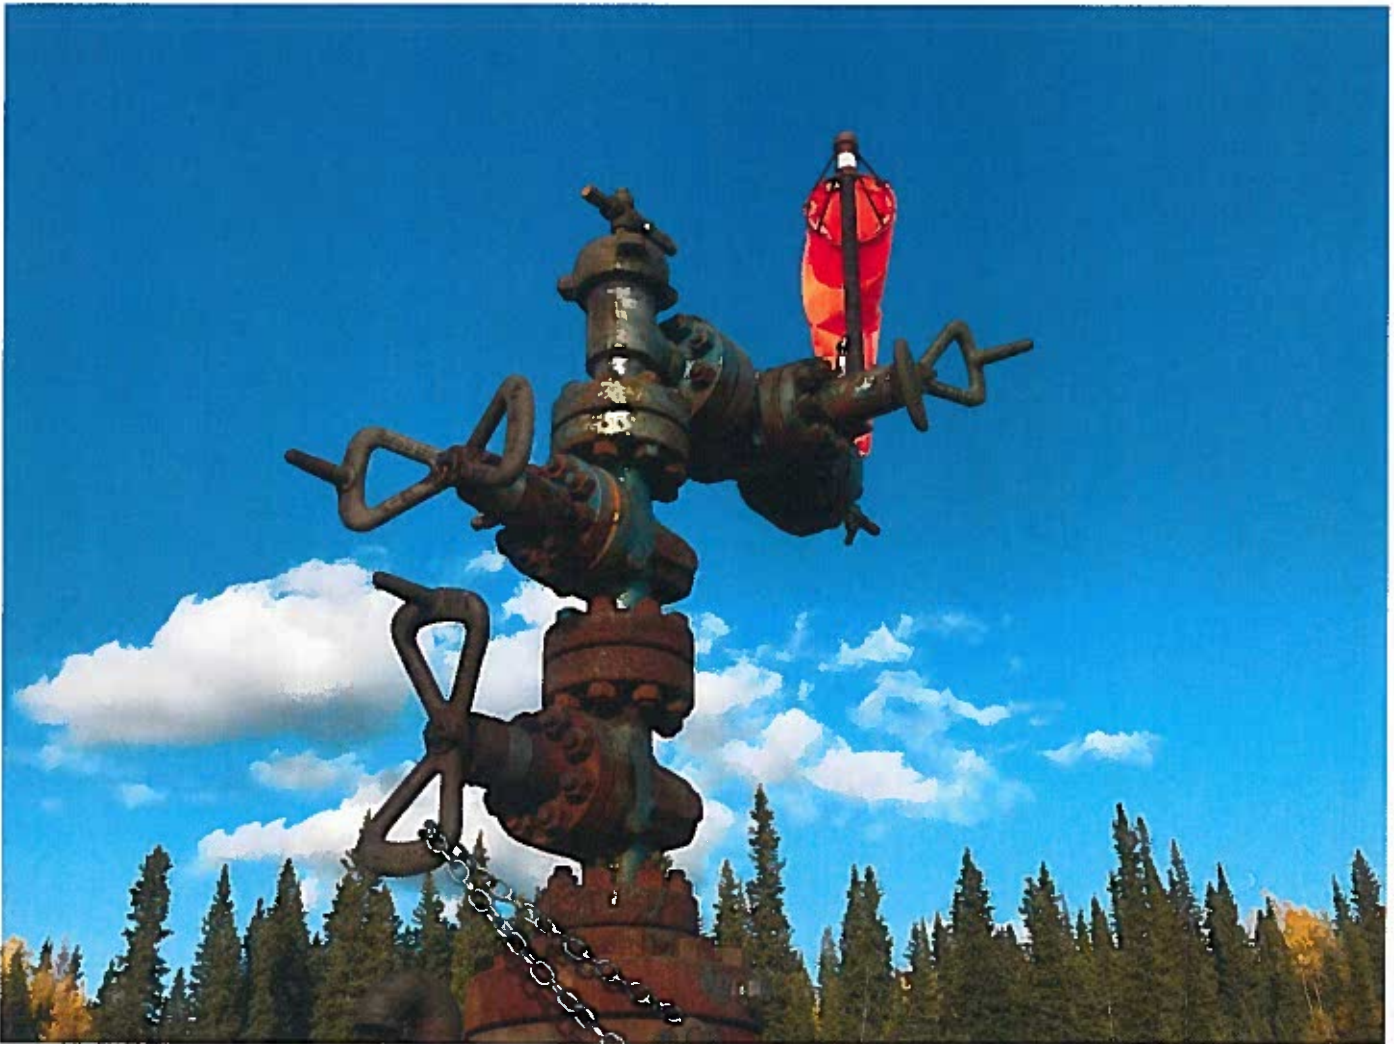
Photo # 1: Well head - Well head valves not secured. Chain too short. All well head valves must be secured to prevent unauthorized access.

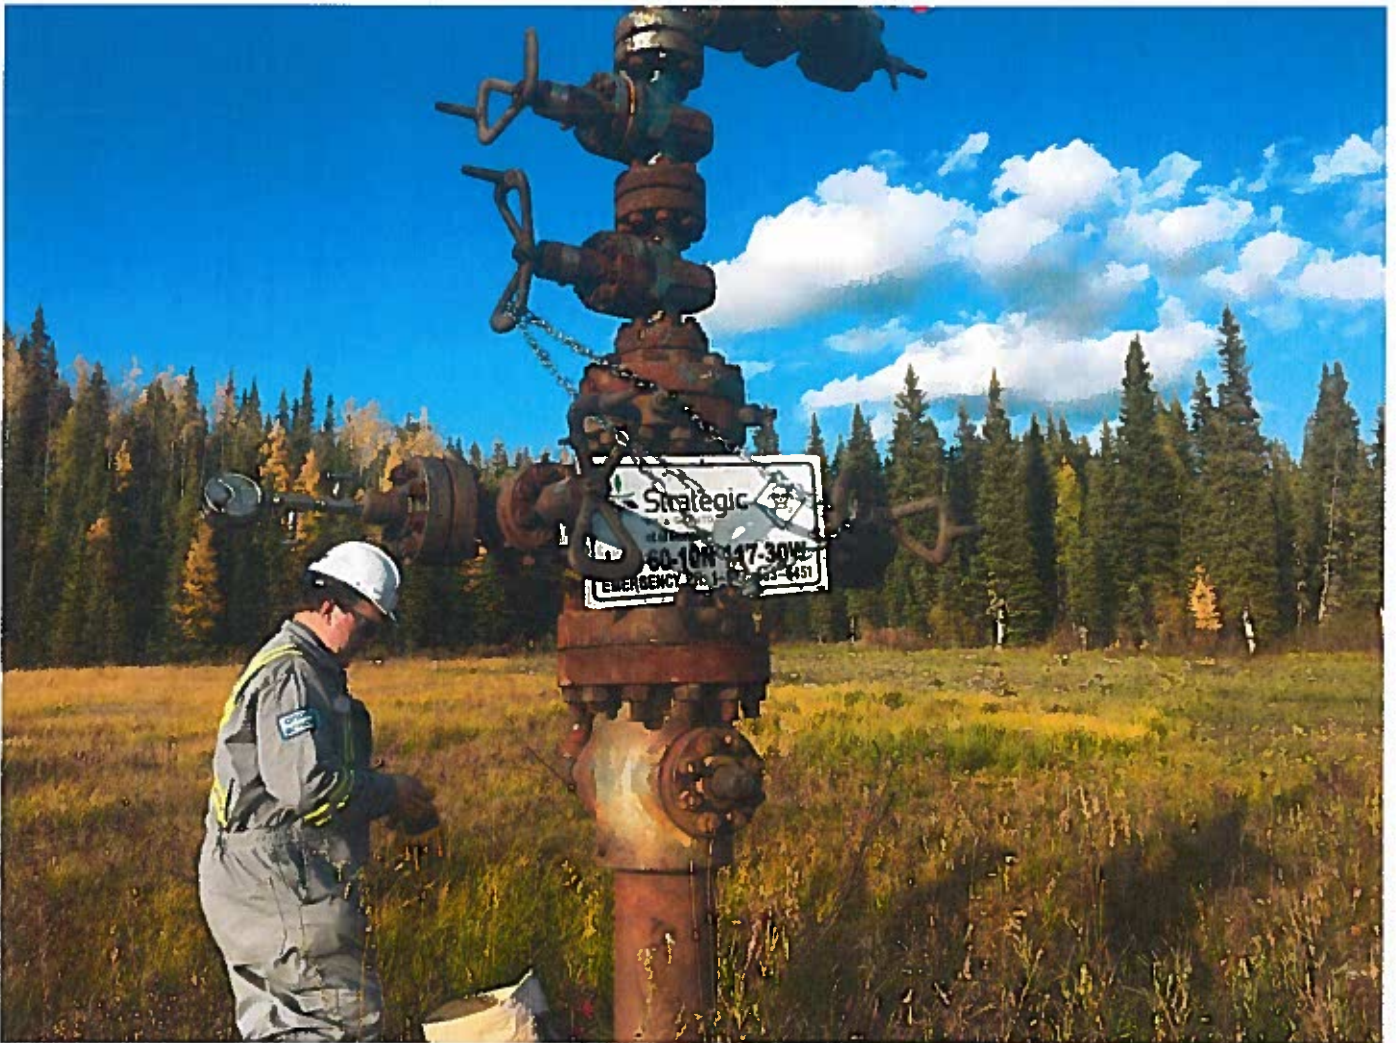
Photo # 2: Well site - Well head valves not secured. Key left in padlock. All well head valves must be secured to prevent unauthorized access.
