## WELLSITE SUMMARY INSPECTION REPORT

Well/Facility Name:	Cameron N-06	Operator:	Strategic Oil and Gas Ltd. (SOG)
Location of Inspection:	Cameron Hills	Access method:	Helicopter
Site Contractor:	None	Status:	Compliant Suspended – Production Well
Approval Info	OA-2018-003	WID:	2067
Date of Inspection	10/SEP/2020	H2S Site:	Yes

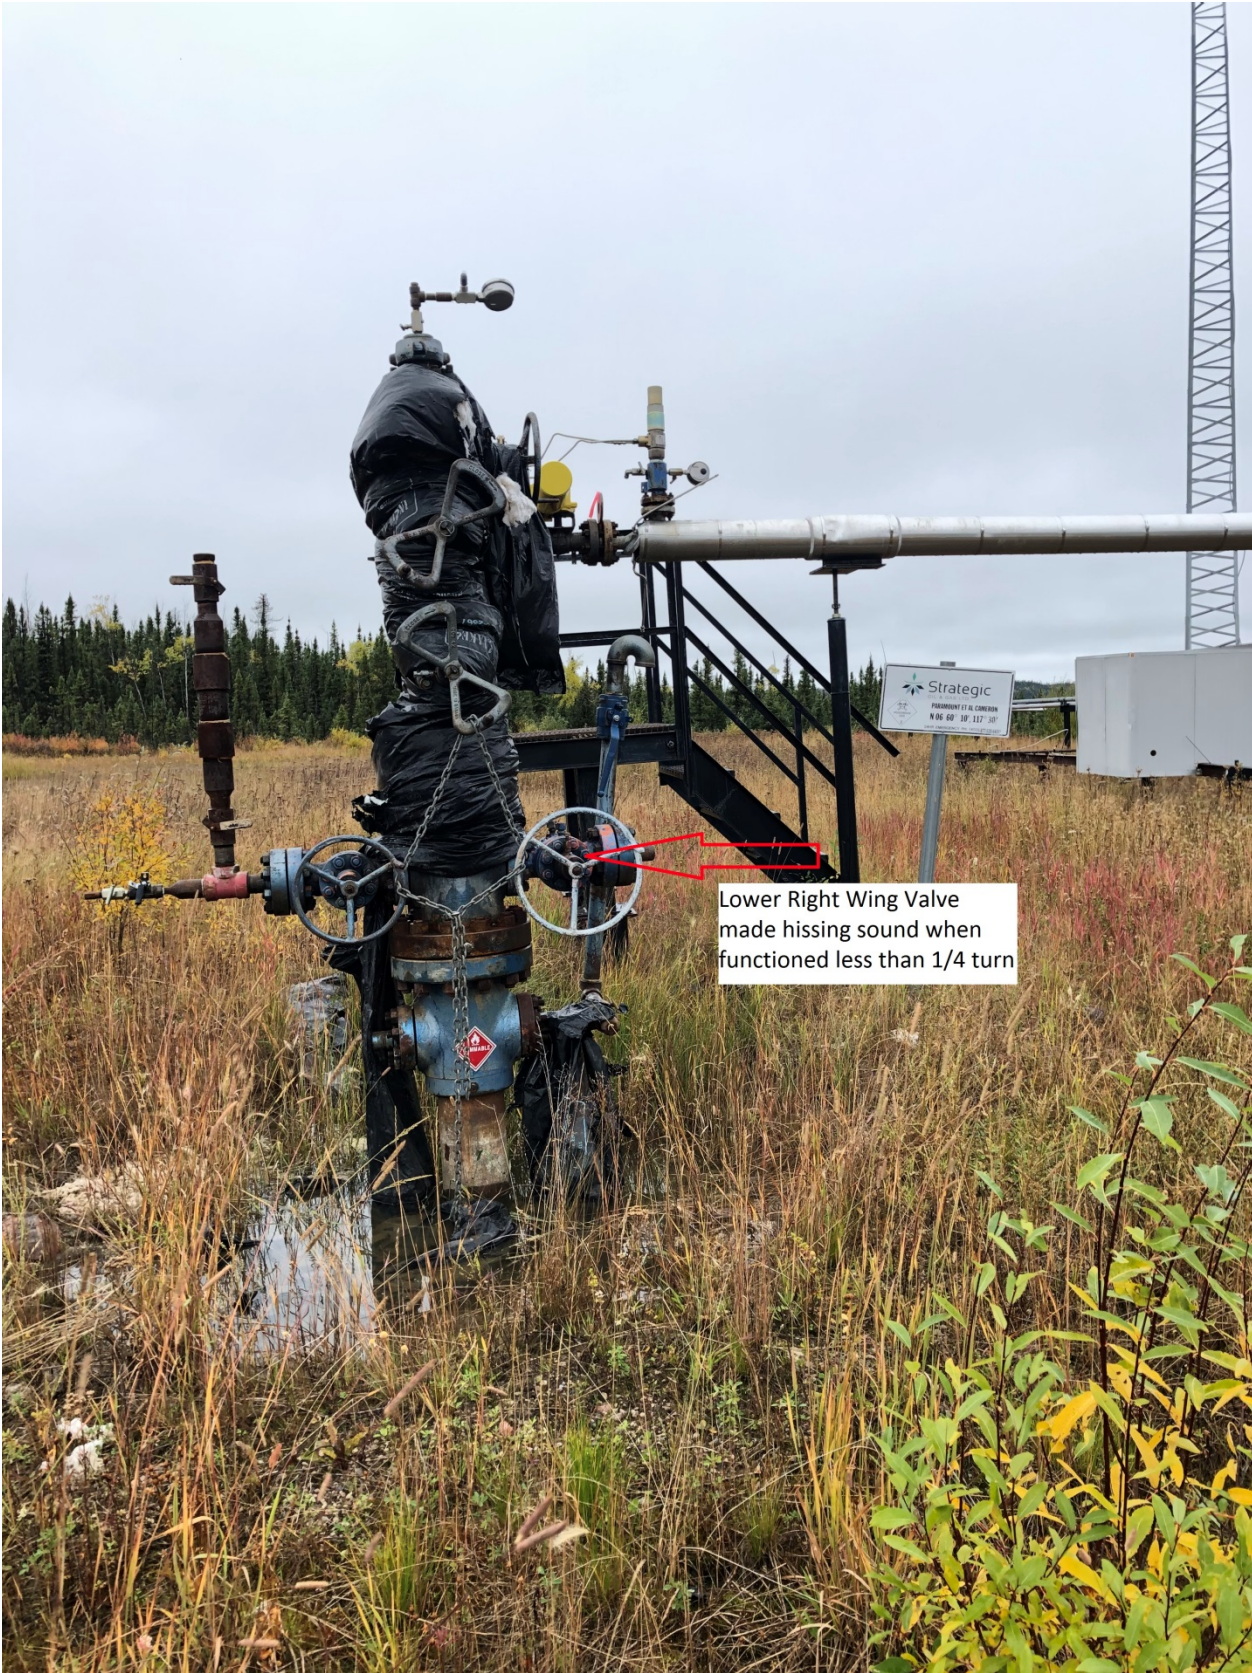
Activity on site	Satisfactory (Y/N)	Comments
Site Access	Y	
Wellhead Access	Y <sup>1</sup>	<p>Although well head valves were secured and locked, the lower right valve made hissing sound when actuated less than ¼ turn. (See Photo #1)</p> <p>1. Operator notified of well head valve issue on September 11, 2020. Well Inspection was conducted on September 16, 2020, operator reported all well head valves functioned with no visible or audible leaks. Valves were greased and cycled with no issues reported. Shut in casing pressure at 6kPa and shut in tubing pressure at 5kPa.</p>
Signage	Y	
General Housekeeping	Y	
SCV Open and dead	Y	0 bubbles observed in 10 min.

Photo #1: N-06 wellhead - lower right valve.

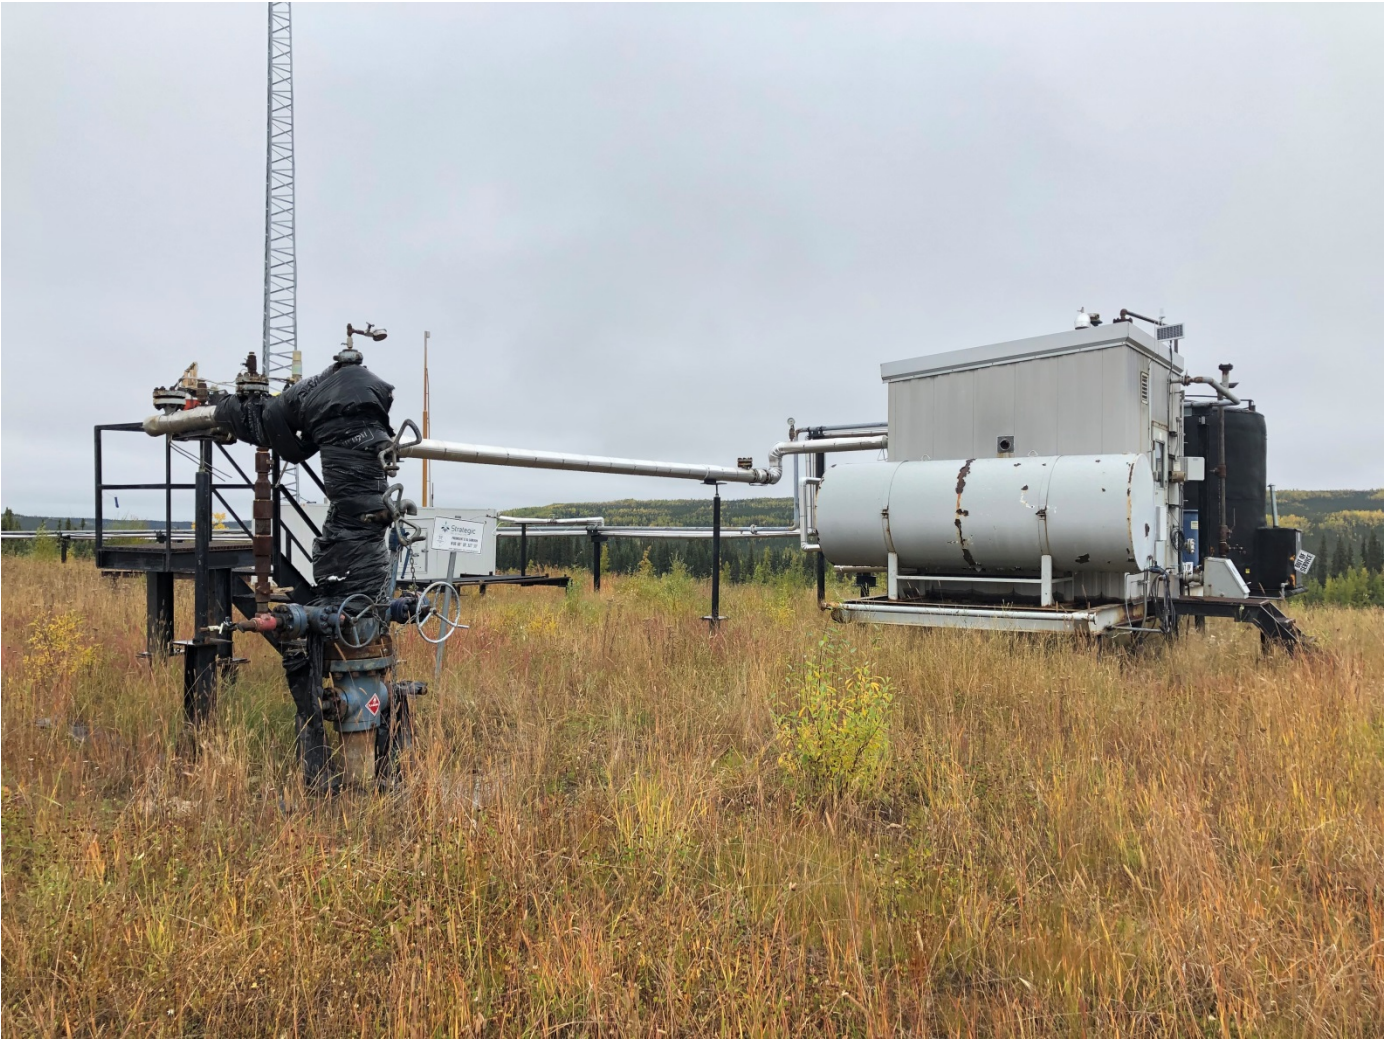
Photo #2: Wellhead and production facilities.
