WELL INSPECTION REPORT

Well Name: A-73 60-21, 117-30

Current Inspection Date: November 1, 2020 WID:

A-73 Wellsite Inspection Corrections October 26, 2020

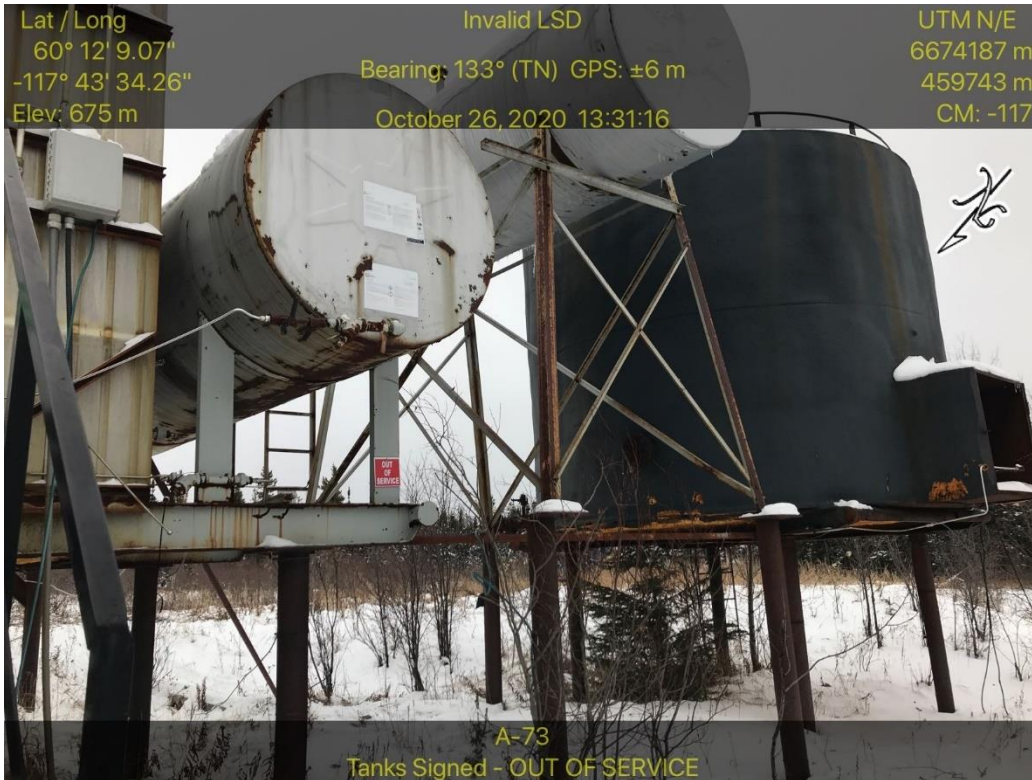
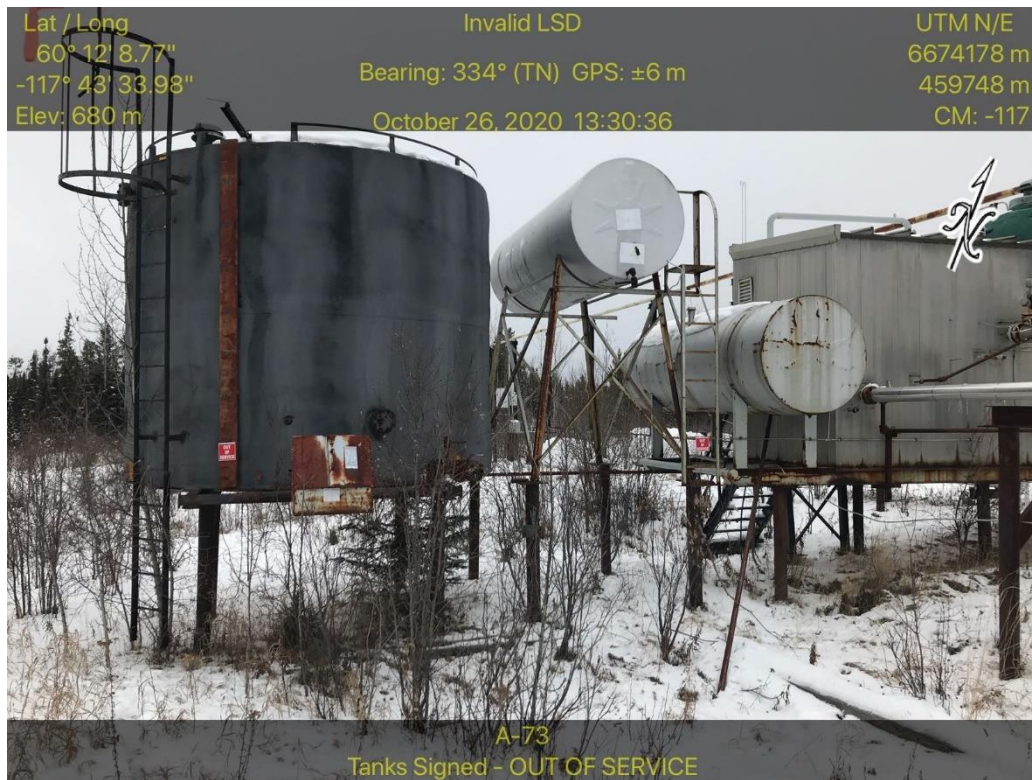
This was work performed to correct deficiencies identified by OROGO during their September inspections.

1. Cleared brush for additional helicopter landing
2. Prepared propane tanks for moving with Helicopter, then lifted tanks from A-73 to Steen River for return to Bluewave
3. Checked all production tanks on site and verified that they are all empty and only has residue last contained.
4. As a result of deteriorating weather, only three of the four propane vessels were removed. All vessels are empty and the Receiver plans to remove the fourth and final vessel at the next inspection cycle anticipated in February 2021.
