Well Inspection Report

Well name: C-75-60-10-117-15

C-75 Wellsite Inspection Pictures

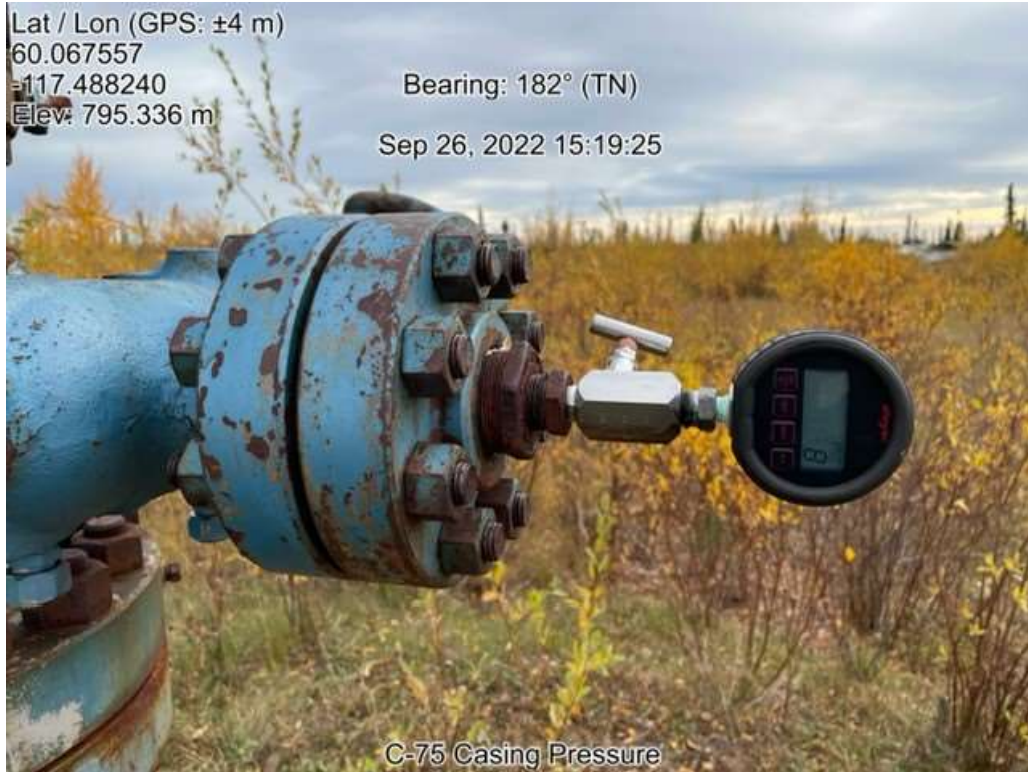
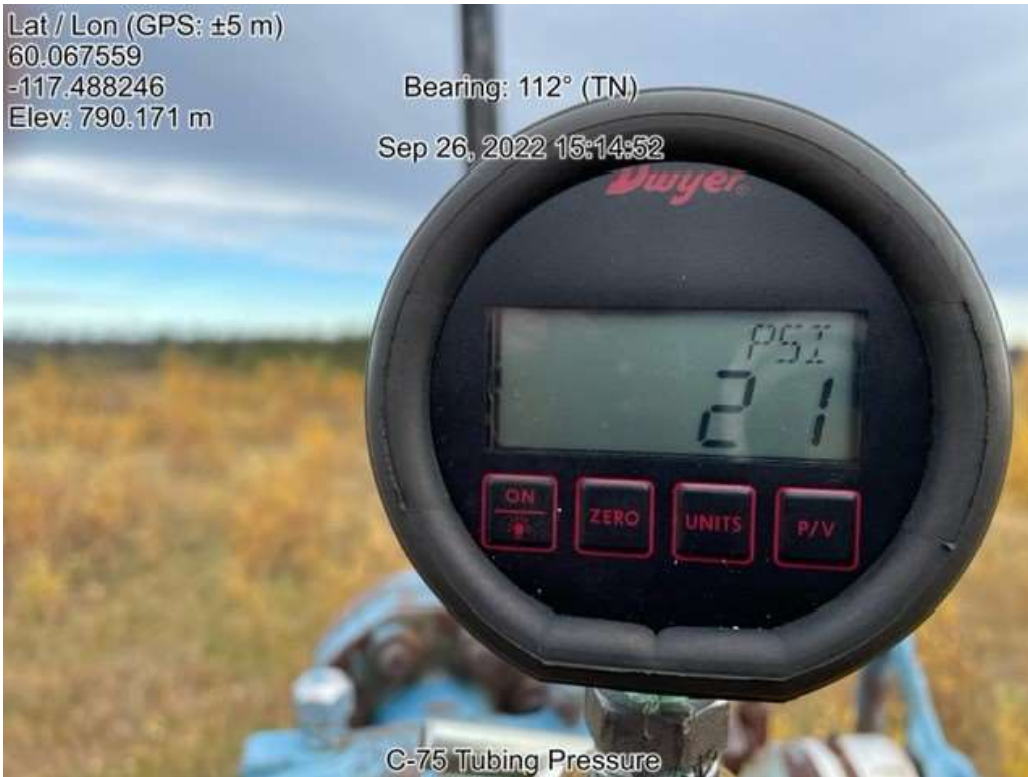
10 minute Bubble test completed on SCV, no visible bubbles indicated. See attached pictures for shut in pressures taken on Tubing and Casing. No H2S or LEL detected while on site.
