OROGO Well Inspection Summary Report

Well name: Cameron L-47

Operator: Strategic Oil and Gas

Date of inspection: 2022-09-23

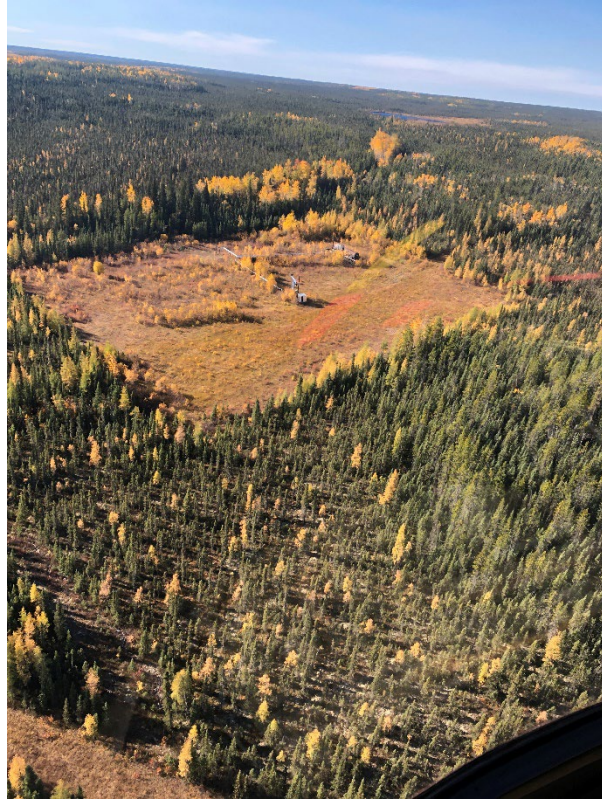
Photo #1: Aerial view of the Cameron L-47 well site.

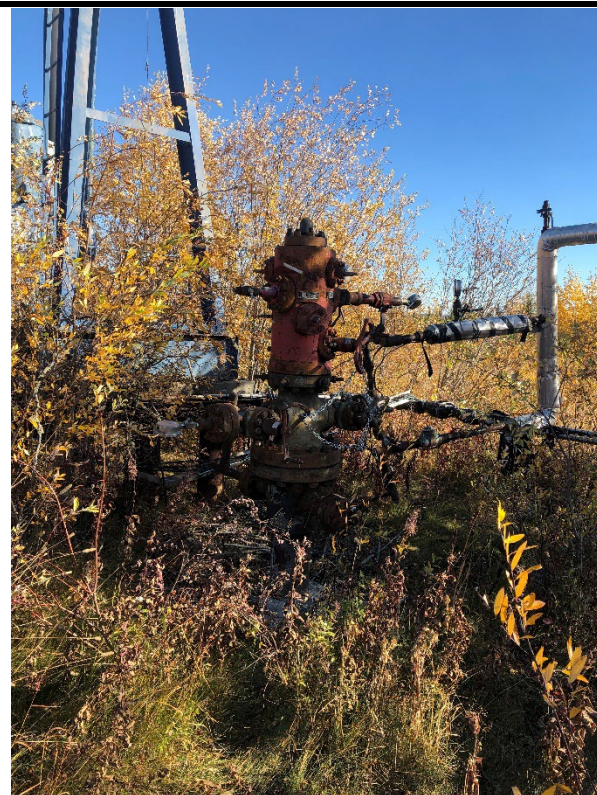
1) BRUSHING AROUND WELLHEAD: During the inspection, vegetation had encroached the area directly adjacent the wellhead (See Photo #2). Section 5A of the Well Suspension and Abandonment Guidelines and Interpretation Notes (Guidelines) requires clearing of all brush and debris within 25m of the wellhead. During the next planned visit of Strategic Oil and Gas Ltd. (SOG) to this well, brushing will need to meet the requirements of Section 5A of the Guidelines.

Photo # 2: Cameron L-47 Wellhead.

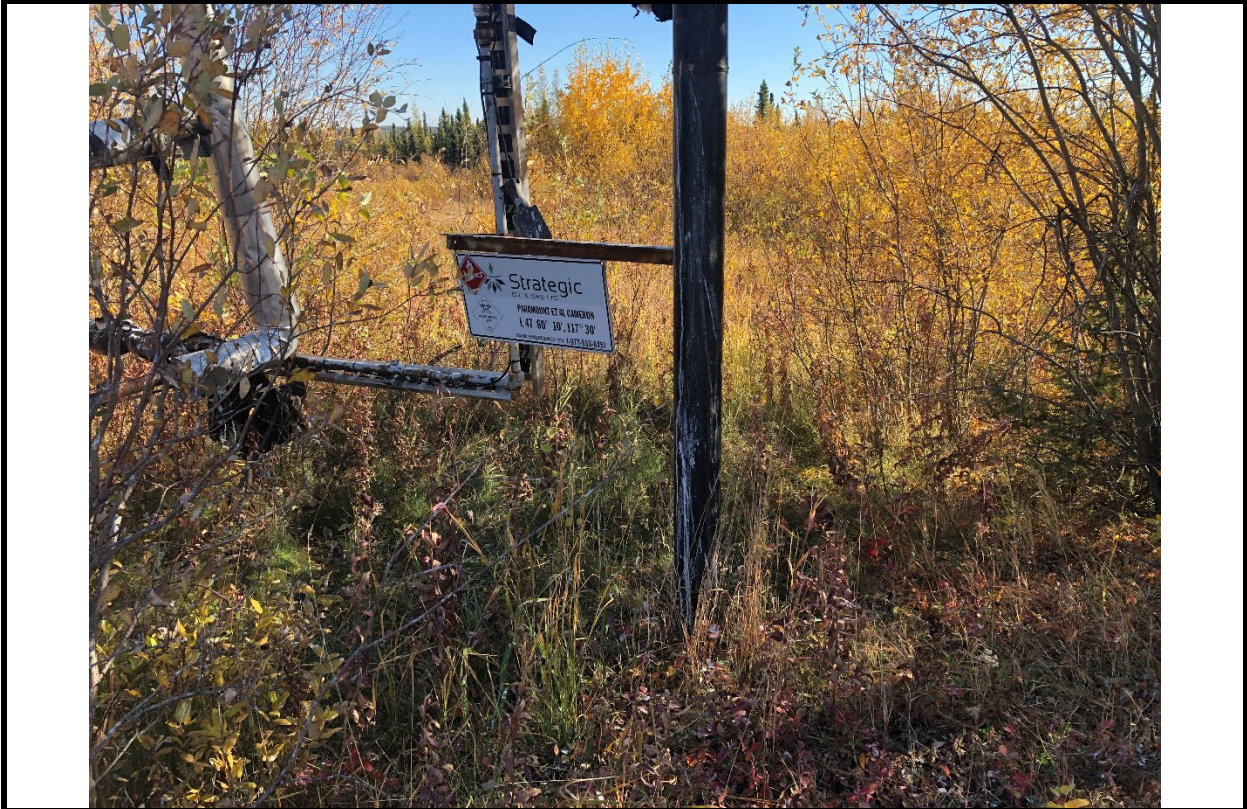
2) WELLHEAD SIGN: The current wellhead sign indicating the Well name and ID does not meet the requirements of Section 5A of the revised Guidelines issued in 2022. This sign does however meet the requirements of the Guidelines issued in 2017. During the next planned visit of SOG to this well, the sign will have to be updated to reflect the requirements of Section 5A of the Guidelines revised in 2022. (See Photo #3)

Photo #3: Cameron L-47 well sign.

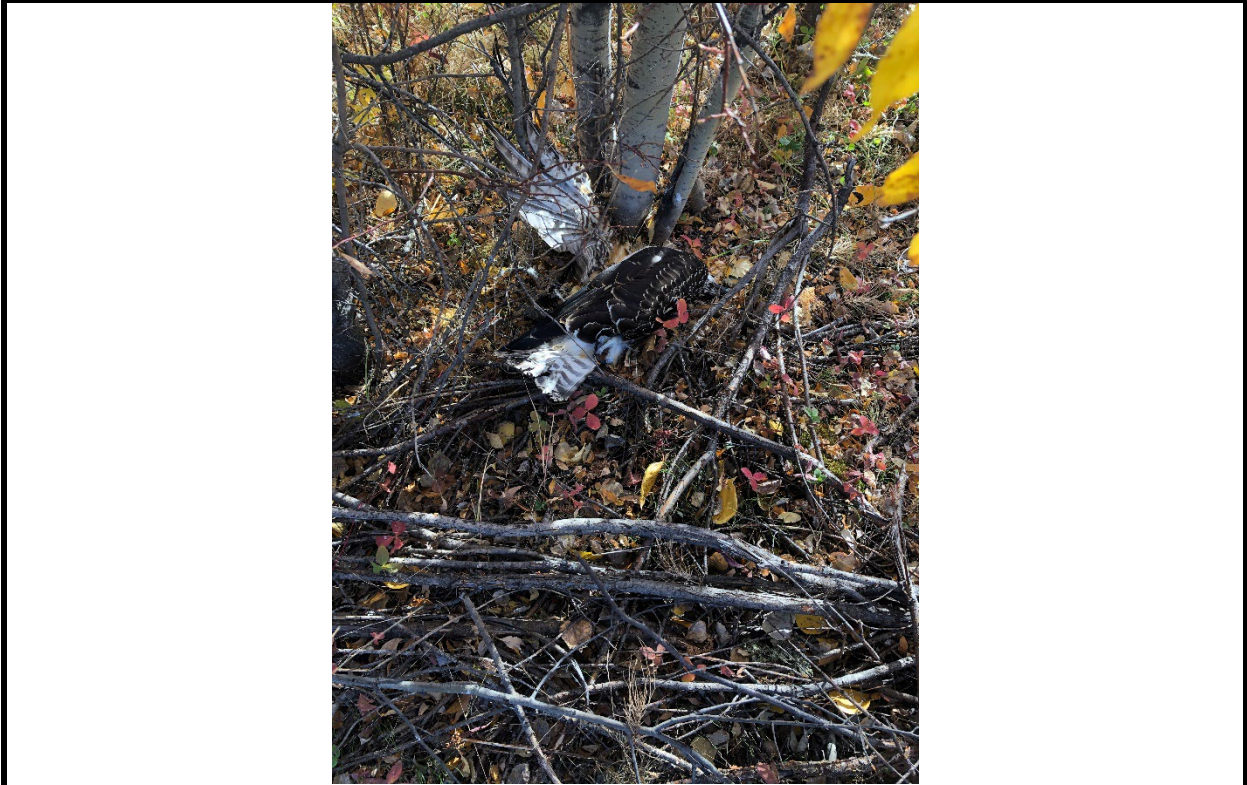
3) DECEASED WILDLIFE: During the inspection, a deceased raptor was found 7m to the south of the wellhead. In an email to SOG dated September 26, 2022, further investigation is required to ensure this well is secured and not a contributing factor to the death of this raptor. Results of this investigation are to be submitted to OROGO as well as the the Departments of Lands and Environment and Natural Resources South Slave Regional Offices no later than October 30, 2022. (See Photo #4 and attached email)

Photo #4: Dead raptor located 7m to the south of the wellhead.

The departments of Lands and Environment and Natural Resources (ENR) found a deceased raptor located 7m to the south of the wellhead under the flare stack line. This was reported to Kurt Hewitt on site on September 20, 2022.

During OROGO's inspection with Lands, we landed at the well site and there were no observable signs indicating a potential causes of death nor were there any signs of decomposition of the raptor. OROGO and Lands conducted a bubble test on the Surface Casing Vent and no bubbles were observed.

Given the proximity of the raptor to the well head, further investigation is required to ensure the well is secure and did not lead to the death of the raptor.

Please submit the results of the investigations for these two wells to OROGO, Lands and ENR on or before October 30, 2022.
