## WELL INSPECTION REPORT

Well Name: Paramount et al Liard F-25A

Current Inspection Date: 20-Aug-2021

**Paramount et al Liard F-25A WID #1621 Suspended Well Inspection Photos  
August 20, 2021**

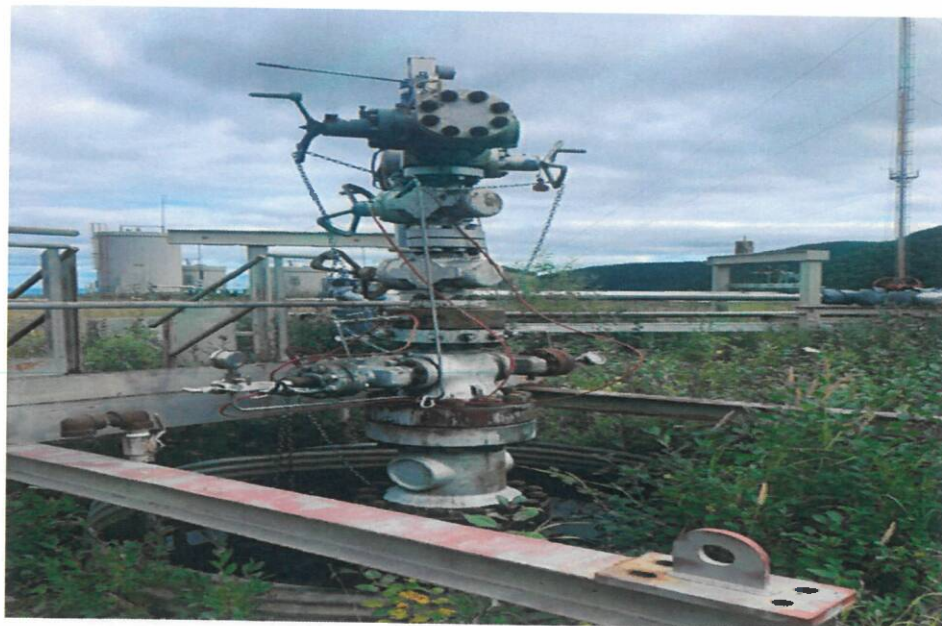
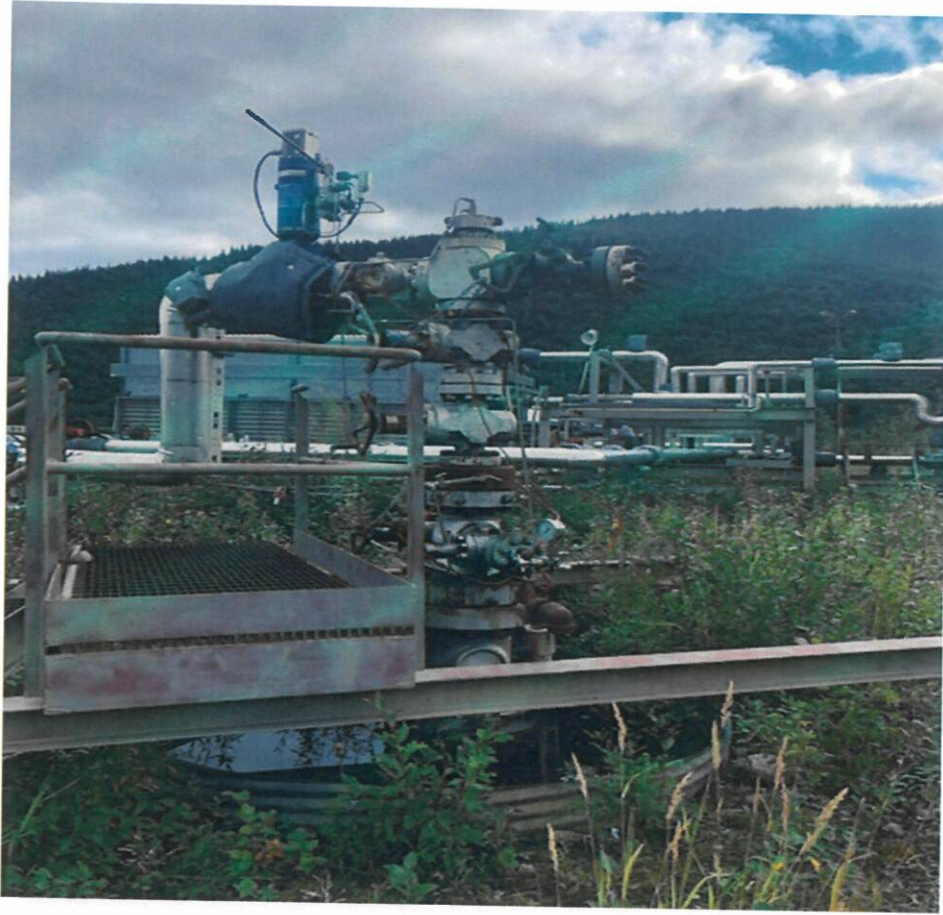
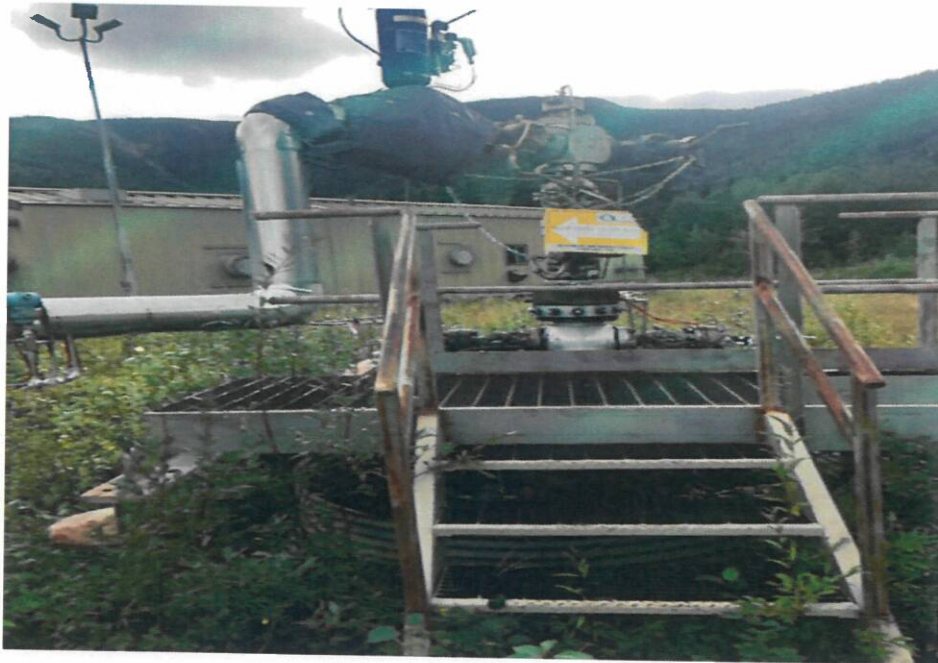
**Wellhead & valves:**

Unable to function intermediate casing valve. One is siezed open and other is closed.

Pressure test intermediate / surface casing seals to 19 MPa. Held 10 minutes. Intermediate spool seals held 19 MPa presssure.

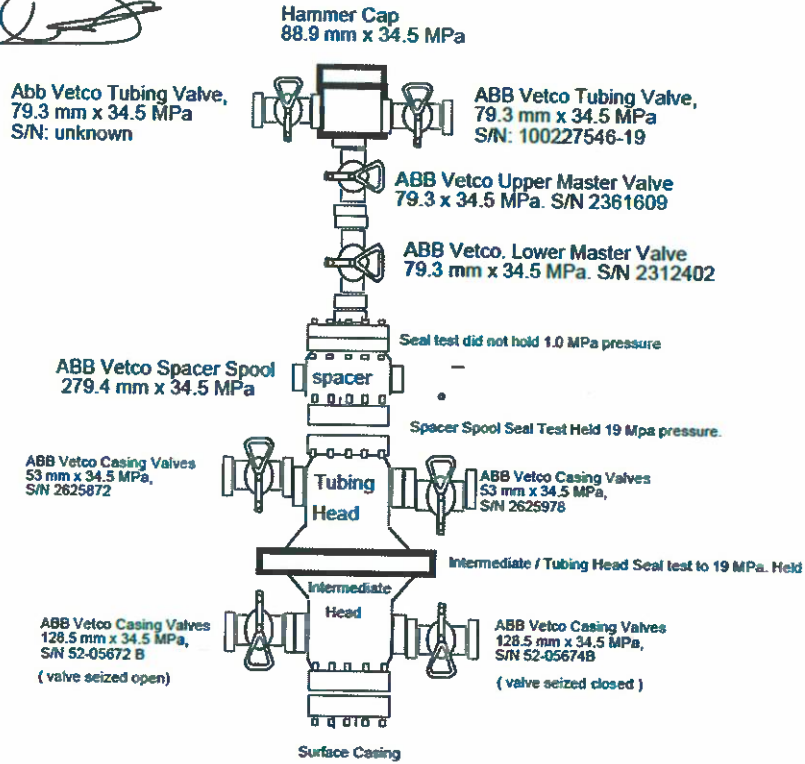
# Wellhead Schematic:

Paramount et al F-25 <sup>JEH</sup>

Inspected by Dusty Schneider

20-Aug-2021
