CITY OF YELLOWKNIFE

# 2011 INSPECTION OF DAMS 1, 2 AND 3 ON FIDDLER'S LAKE SEWAGE LAGOON, CONTROL STRUCTURE F9 AND OTHER TRAPPER'S LAKE OUTLET STRUCTURES

## REPORT

APRIL 2012  
ISSUED FOR USE  
Y14101405

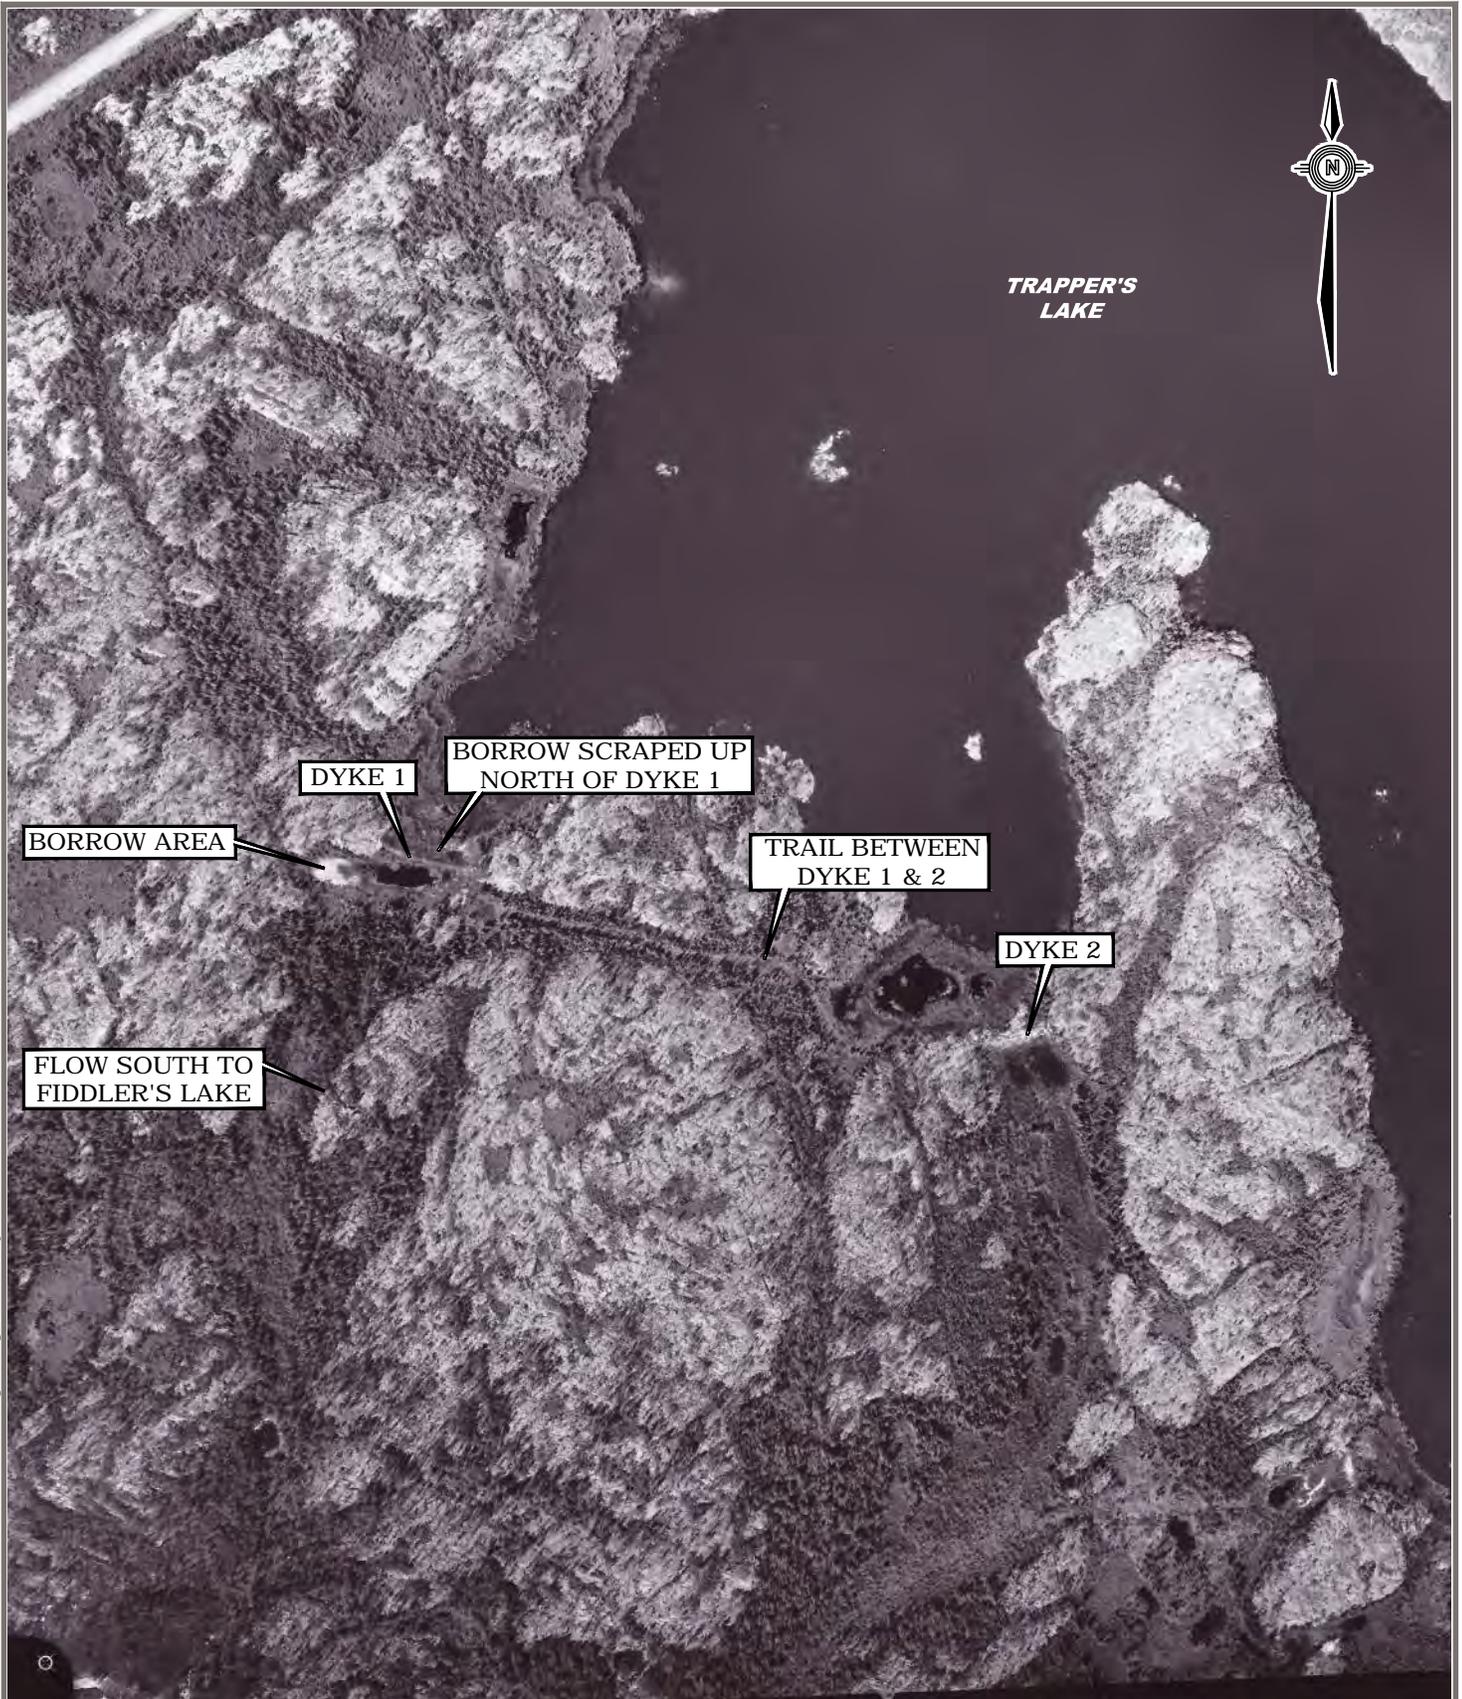
Figure 2

- The 1984 air photos indicate that Dyke 1 was created by blading up materials from north of the dyke location, as well as from a borrow area to the west of the south pond (Figure 2). That borrow area is now completely overgrown and is virtually indistinguishable from its surroundings on the 2008 ATLAS GIS imagery. The dyke crest appeared to be more-or-less level shortly after construction, with a slight increase in elevation at the abutments, especially at the east abutment. A relatively steep slope along the crest remains at the east abutment (Photo 20), likely due to this section of the dyke having been protected by being constructed over exposed or near-surface bedrock. It is only because of this well-preserved area that the dyke's location could be field-verified with confidence.

- The east and west ends of the dyke abut on local bedrock outcrops, and there is an intermediate bedrock outcrop as well. Looking east from the west abutment, the dyke is characterized by tall grasses on the untreed sections, and grasses, white birch and willow in treed areas, especially on the downstream side (Figure 2, Photos 24 and 25).

Of these trails, air photo observations suggest the most potential concern with the trail between Dyke 2 and Dyke 1 (Figure 2). Significant observations from the 1984 air photos, Google Earth (2004), ATLAS GIS (MACA, 2012, based on 2008 imagery), and the field reconnaissance include:

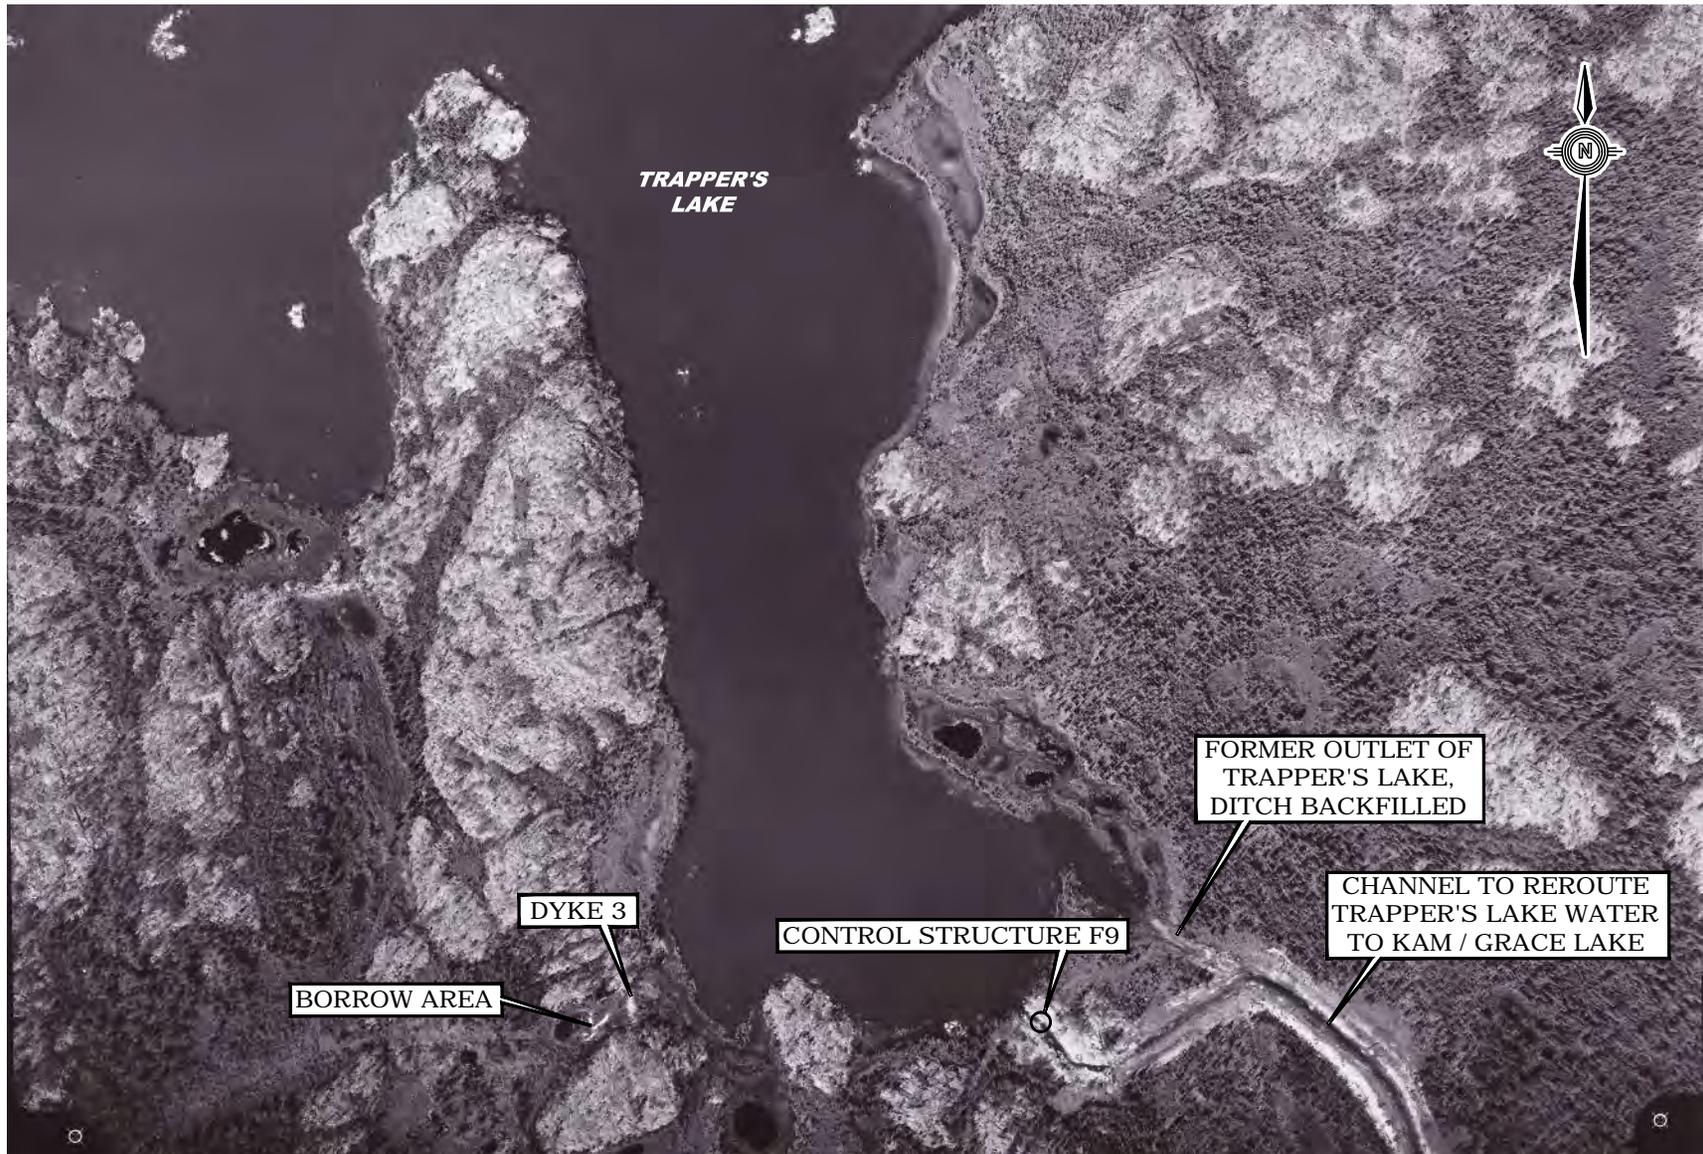
Figure 3

- Dyke 3 is a smaller north-south dyke located between bedrock outcrops on the southwest corner of the southeast leg of Trapper's Lake, west of F9 (Figure 3).

The former outlet of Trapper's Lake has not yet been located in the field (Figure 3). Significant observations from the air photos and ATLAS GIS include:

- Both the former outlet channel, and the newer one that leads to it from F9, are readily visible on the 1984 air photos and on the 2008 ATLAS GIS imagery. The ATLAS GIS imagery suggests that the backfill in the former outlet channel has now settled, and may no longer be effective in blocking drainage (Figure 3).
- The 1994 air photos, which extend further south than the 1984 airphotos, indicate that the ditch continuing south to the road has only intermittent water flow, since it is dry through most of its length in this set of photos.
