Our reference: DDMI Incident number 1000648218

Your reference: GNWT Spill 2023530

Subject: Follow-up to GNWT Spill report 2023530

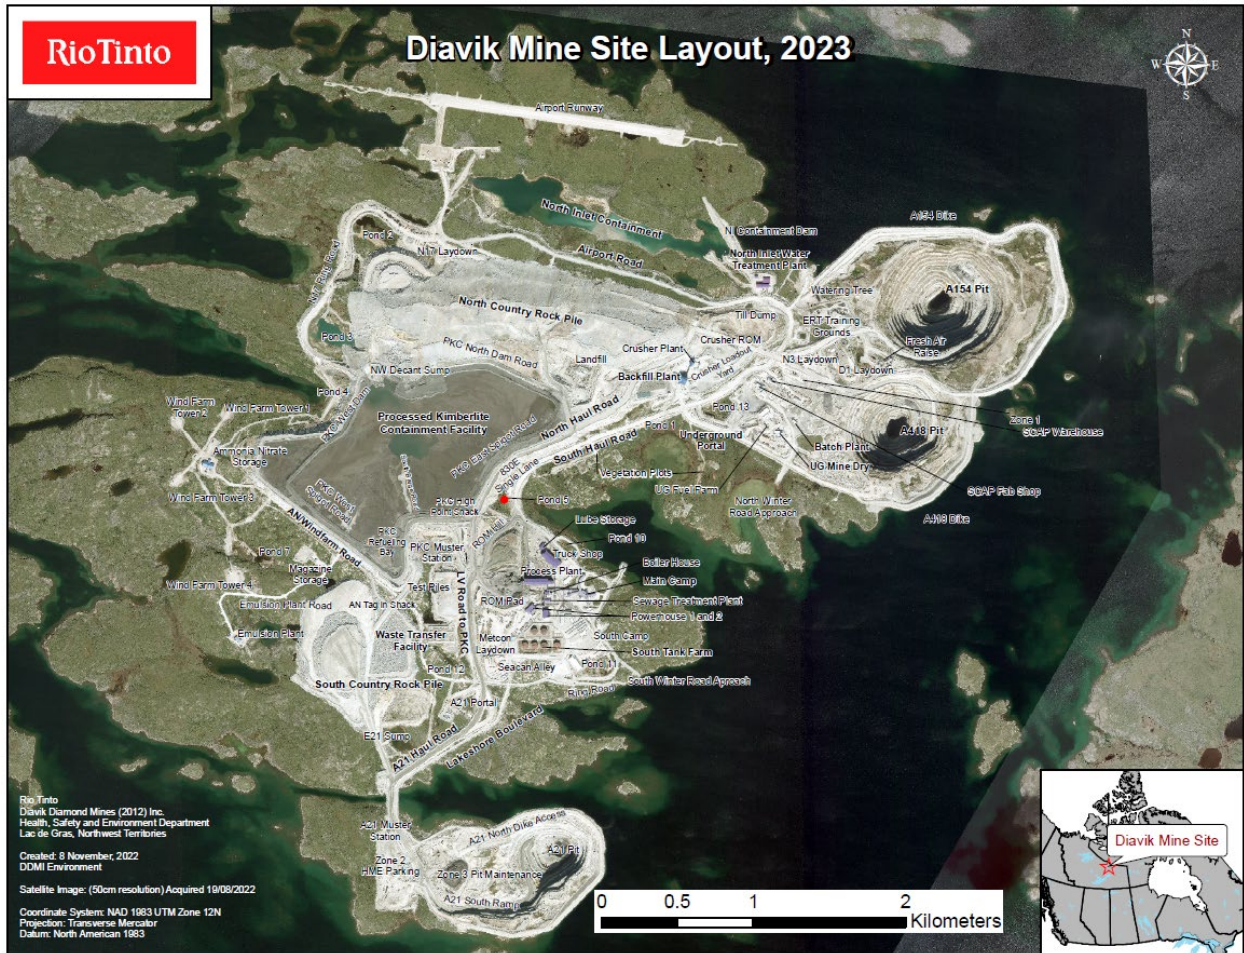
On December 27 at approximately 12:07pm a worker travelling on the South Haul Road reported a leak from the Processed Kimberlite to Mine Workings (PKMW) line 312 in Pond 5 (Figure 1). After reporting the leak, flow from the line was stopped and drained to allow for an investigation. The investigation showed a significant decrease in pressure in the line at 12:10am on December 27 from a burst drainage valve (Figure 2 and 3). An estimated 1,680 m³ was released into Pond 5 (Figure 4). No spilled material reached the receiving environment as it was all contained within Diavik's drainage and collection control system.

Figure 1 Spill 2023530 Location indicated by the red dot.
