Diavik Diamond Mines (2012) Inc.  
P.O. Box 2498  
Suite 300, 5201-50th Avenue  
Yellowknife, NT X1A 2P8 Canada  
T +1-867-669-6500 F +1-866-313-2754

Our reference: DDMI Incident number 2980687160\_40194  
Your reference: GNWT Spill 2024260

**Subject: Follow-up to GNWT Spill report 2024260**

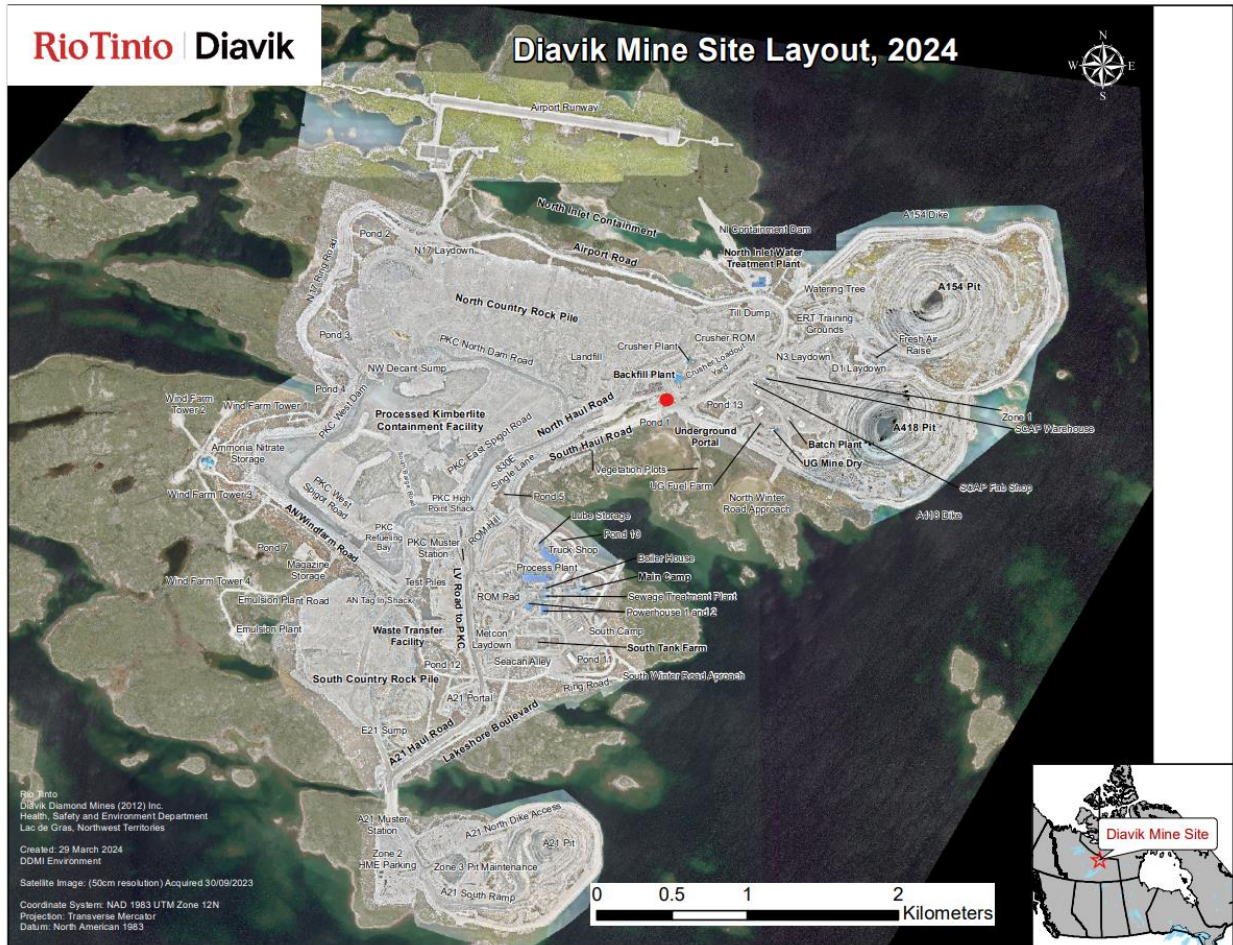
- On July 7<sup>th</sup>, 2024, at approximately 17:40, an employee driving on the South Haul Road reported a leak in the Process Plant Wet Well pipeline near Pond 1 (Figure 1).

Figure 1: Spill 2024260 Location indicated by the red dot.
