Diavik Diamond Mines (2012) Inc.
P.O. Box 2498
Suite 300, 5201-50th Avenue
Yellowknife, NT X1A 2P8 Canada
T +1-867-669-6500 F +1-866-313-2754

Our reference: DDMI Incident number 2982617045_40203
Your reference: GNWT Spill 2024261

Subject: Follow-up to GNWT Spill report 2024261

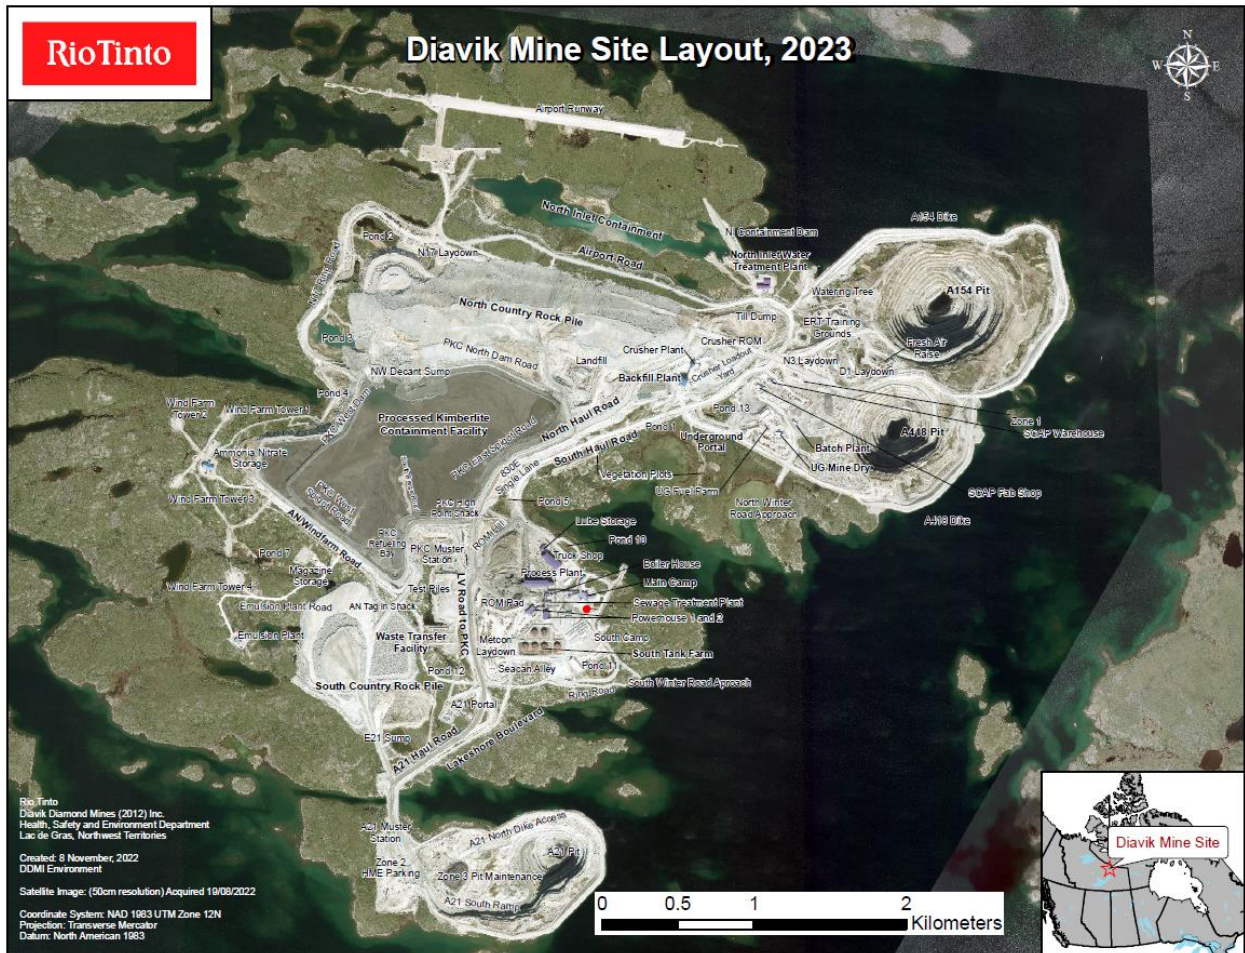
- On July 8th, 2024, at approximately 18:30, a smell of sewage was reported in the E-Wing Dormitory of the Main Accommodations Complex (Figure 1).
- Approximately 200L of sewage and grey water was found to have leaked under the dormitory (Figure 2).
- Upon investigation it was determined that the sewage/grey water effluent pipe had fractured due to a failed pipe hanger support (Figure 3).
- All spilled material was contained within the Drainage Control and Collection System (DCCS) and no material was released to the receiving environment.

Figure 1: Spill 2024261 Location indicated by the red dot.
