20 August 2024

Our reference: DDMI Incident number 4088576141_41971
Your reference: GNWT Spill 2024285

Subject: Follow-up to GNWT Spill report 2024285

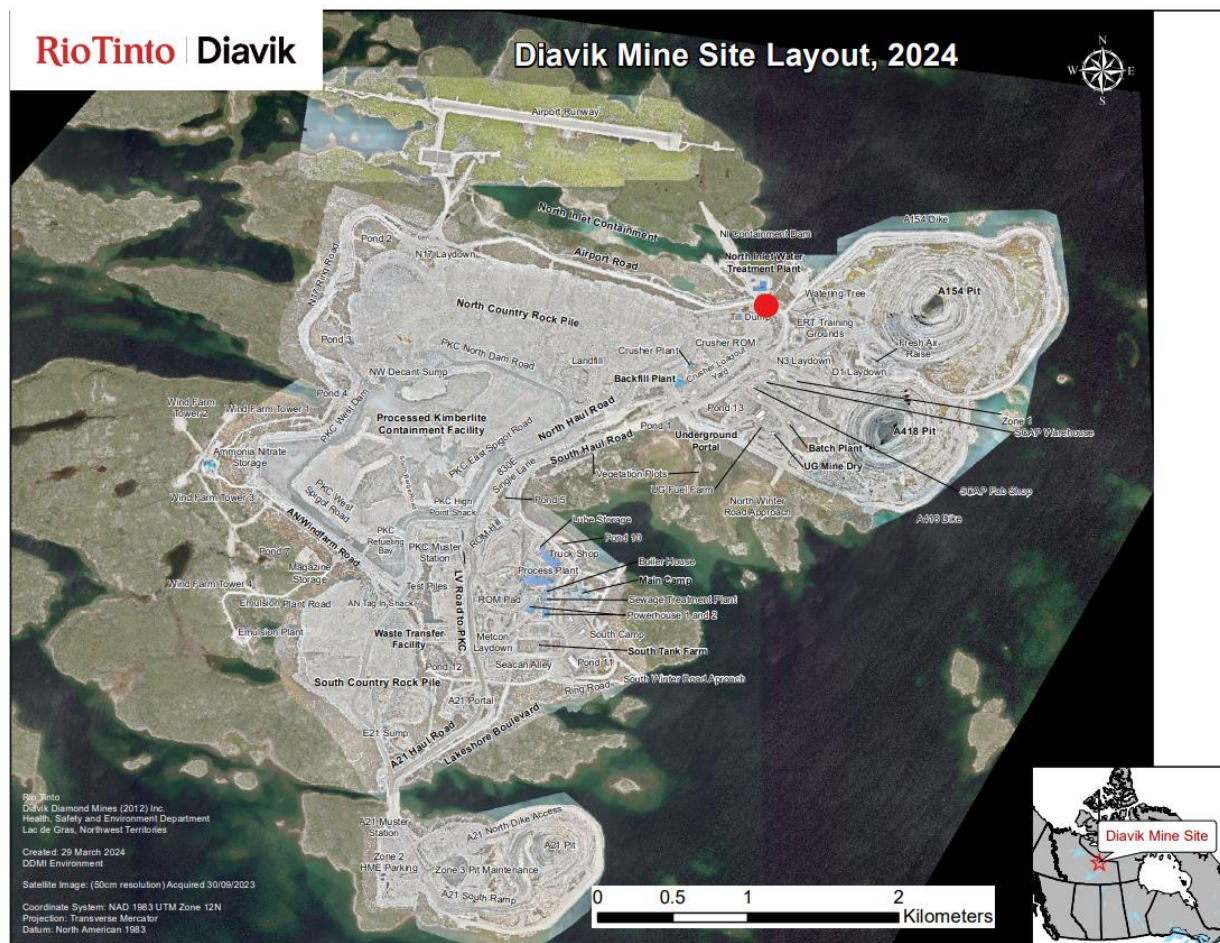
- On 23 July 2024, at approximately 3:30 pm, a Surface Geotechnical employee working in the area near the North Inlet Water Treatment Plant reported a leak in the Process Plant Wet Well pipeline (Figure 1).
- Upon further investigation, it is estimated the leak began at approximately 9:30 am on 21 July 2024.
- Approximately 2,800 m³ of mine contact water was released and pooled approximately 10 m away from pipeline failure (Figure 2). Leak occurred at a portion of pipeline that was enclosed in a berm, causing the spill to not be visible from regular operating areas.
- Initial investigation determined that the spill was a result of a blown gasket inside flange insulation (Figure 3) caused by an over-pressure in the line.
- All spilled material was contained within the Drainage Control and Collection System (DCCS) and no material was released to the receiving environment.

Figure 1: Spill 2024285 Location indicated by the red dot.
