November 15, 2019

Subject: W2017D0004: Spill 2019429 Report

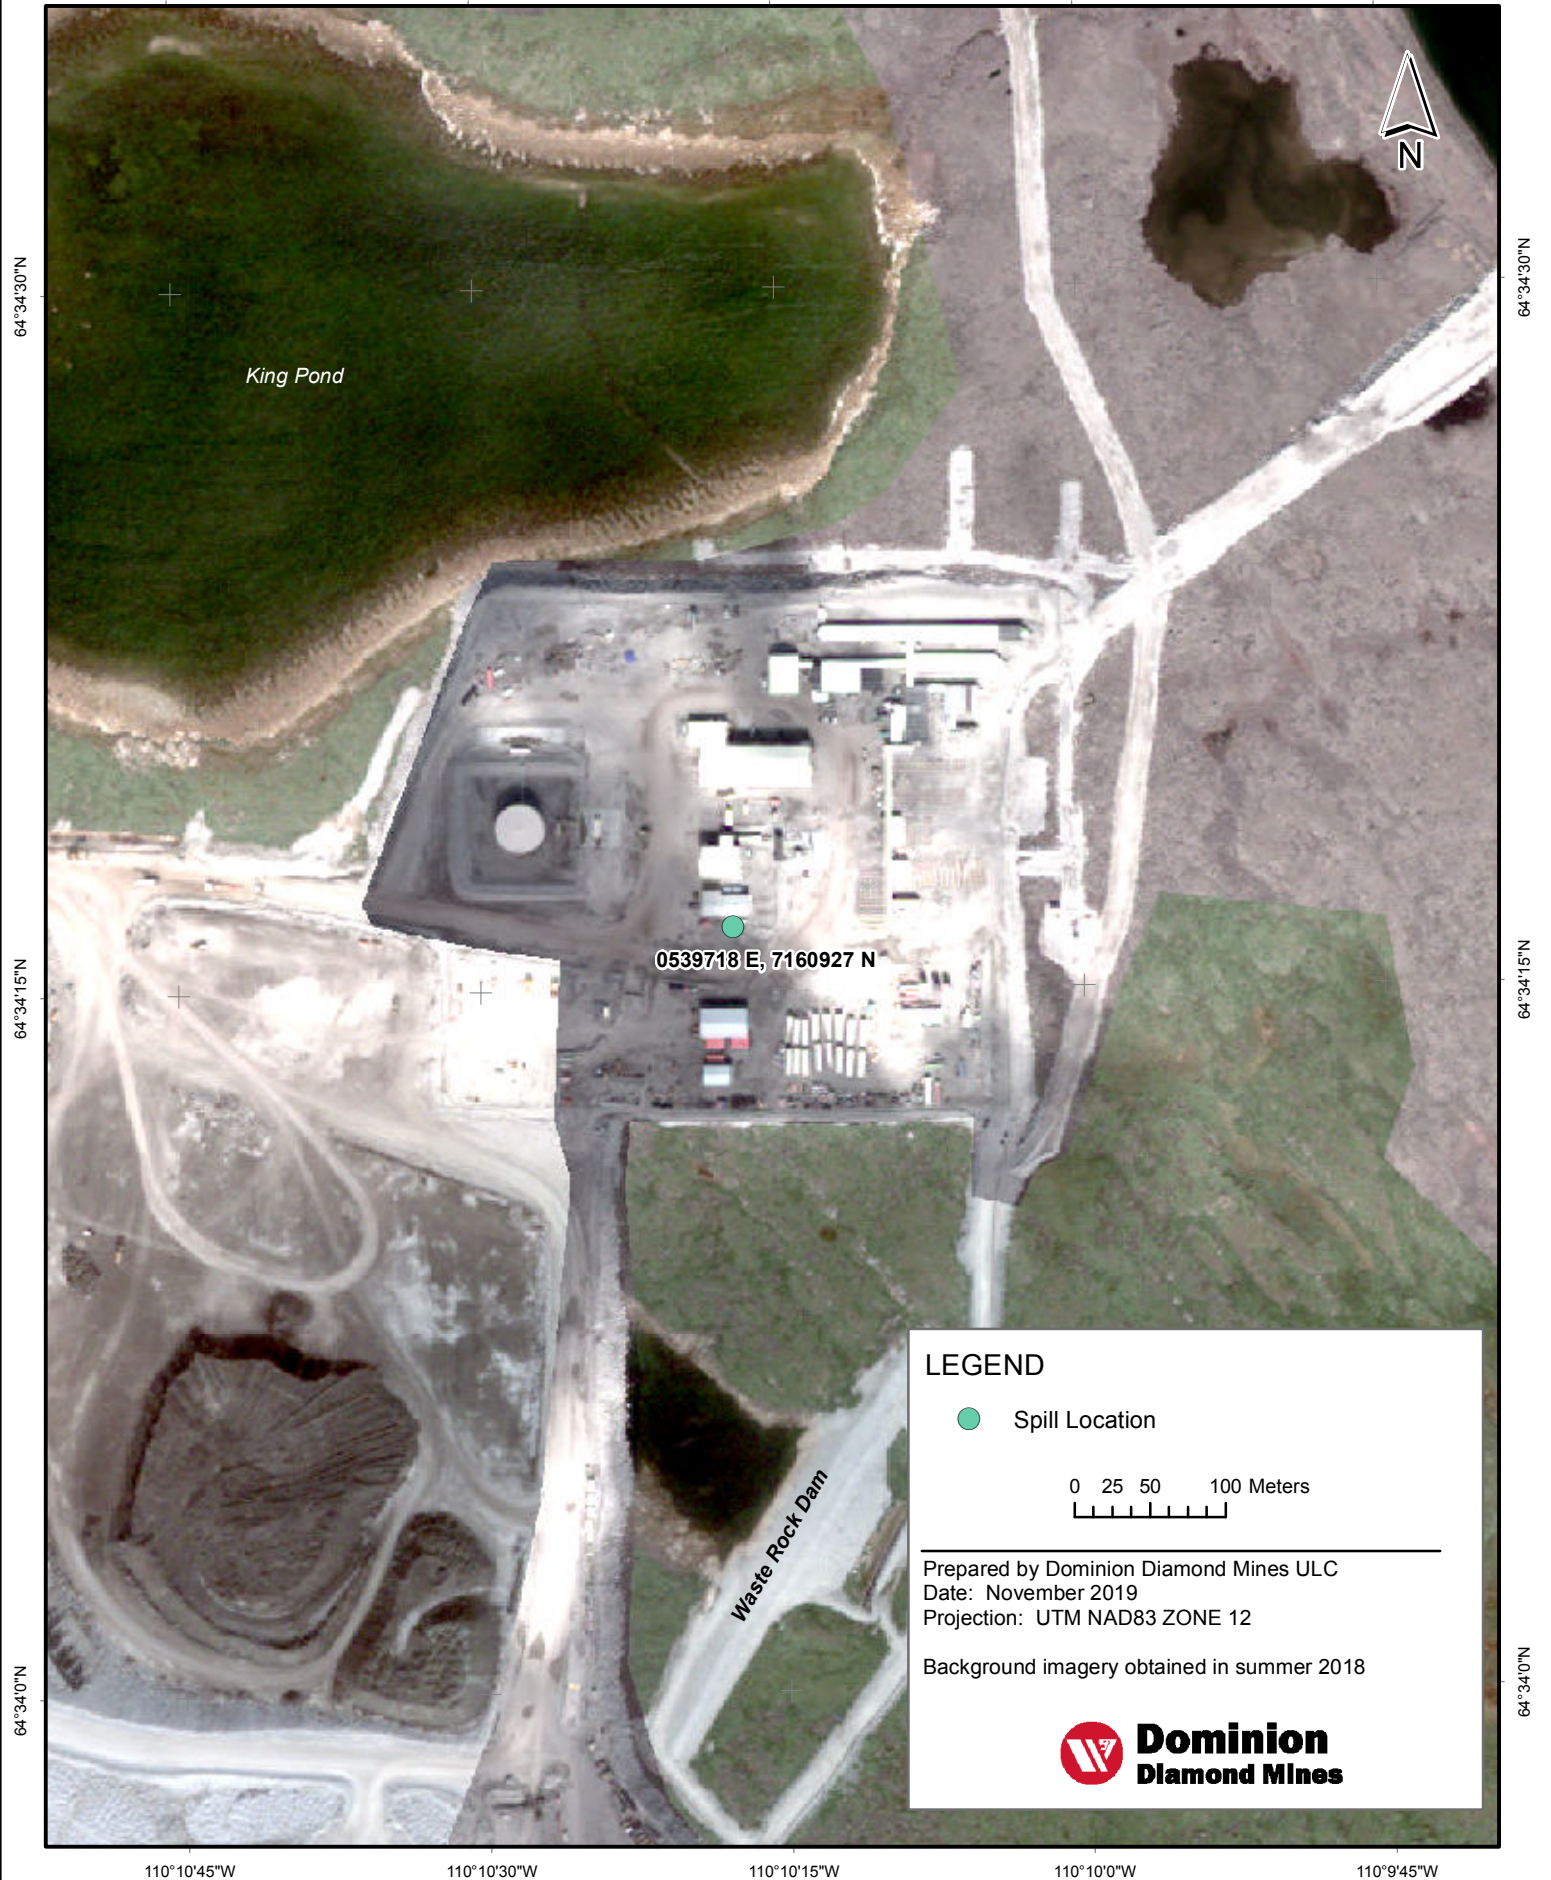
**Figure 1: Location of Spill 2019429
Misery Camp, Ekati Diamond Mine**

Pursuant to Part C Condition 18(c) of Land Use Permit W2017D0004, Dominion Diamond Mines ULC (Dominion) is providing a detailed report on Spill 2019429 which occurred on October 17, 2019 outside of the Misery Camp Light Duty Shop (see Figure 1 for location).
