Prairie Creek Project

MINEWATER TREATMENT CONTINGENCY PLAN FOR WATER LICENCE MV2019L2-0006

January, 2021

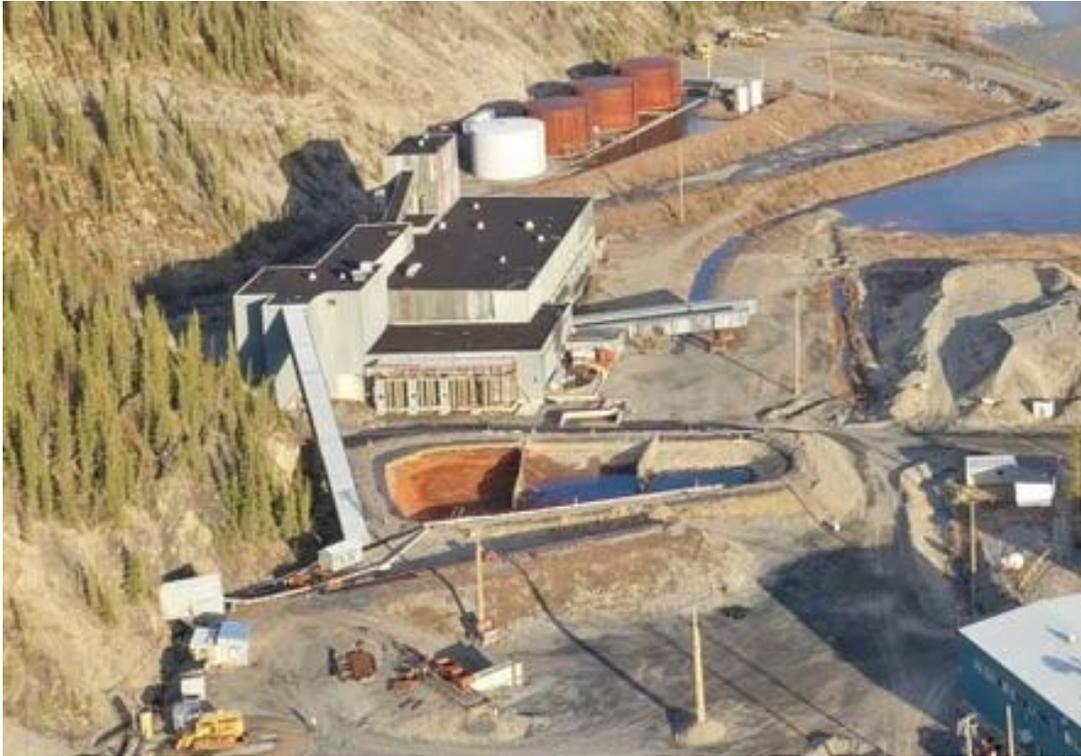
Apart from infiltration primarily during the summer months, the mine water management and treatment system is not affected by surface water runoff. Only mine water reports to the culvert where primary treatment occurs (see photo below). Treated water is then delivered to the Polishing Pond by a pipeline. The Polishing Pond is a raised structure with four berms. There is no run-on into the pond. The pond does receive incident precipitation, but this does not negatively affect pond function, which is the settling of sediment, and pond volume stays constant as inflows are matched by outflows which occur over a weir at a constant elevation below freeboard.

Mine water flows are monitored at SNP Station 3-4, Polishing Pond outflow, via a calibrated weir gauge and recorded daily when site is open.
