**Re: Colomac Monitoring Project
Type B Water Licence W2014L8-0003
PART B: Schedule 1 – Colomac 2018 Annual Report**

Water Licence W2014L8-0003 2018 ANNUAL REPORT Colomac Monitoring Project

**WATER LICENCE W2014L8-0003
 COLOMAC MONITORING PROJECT
 2018 ANNUAL REPORT**

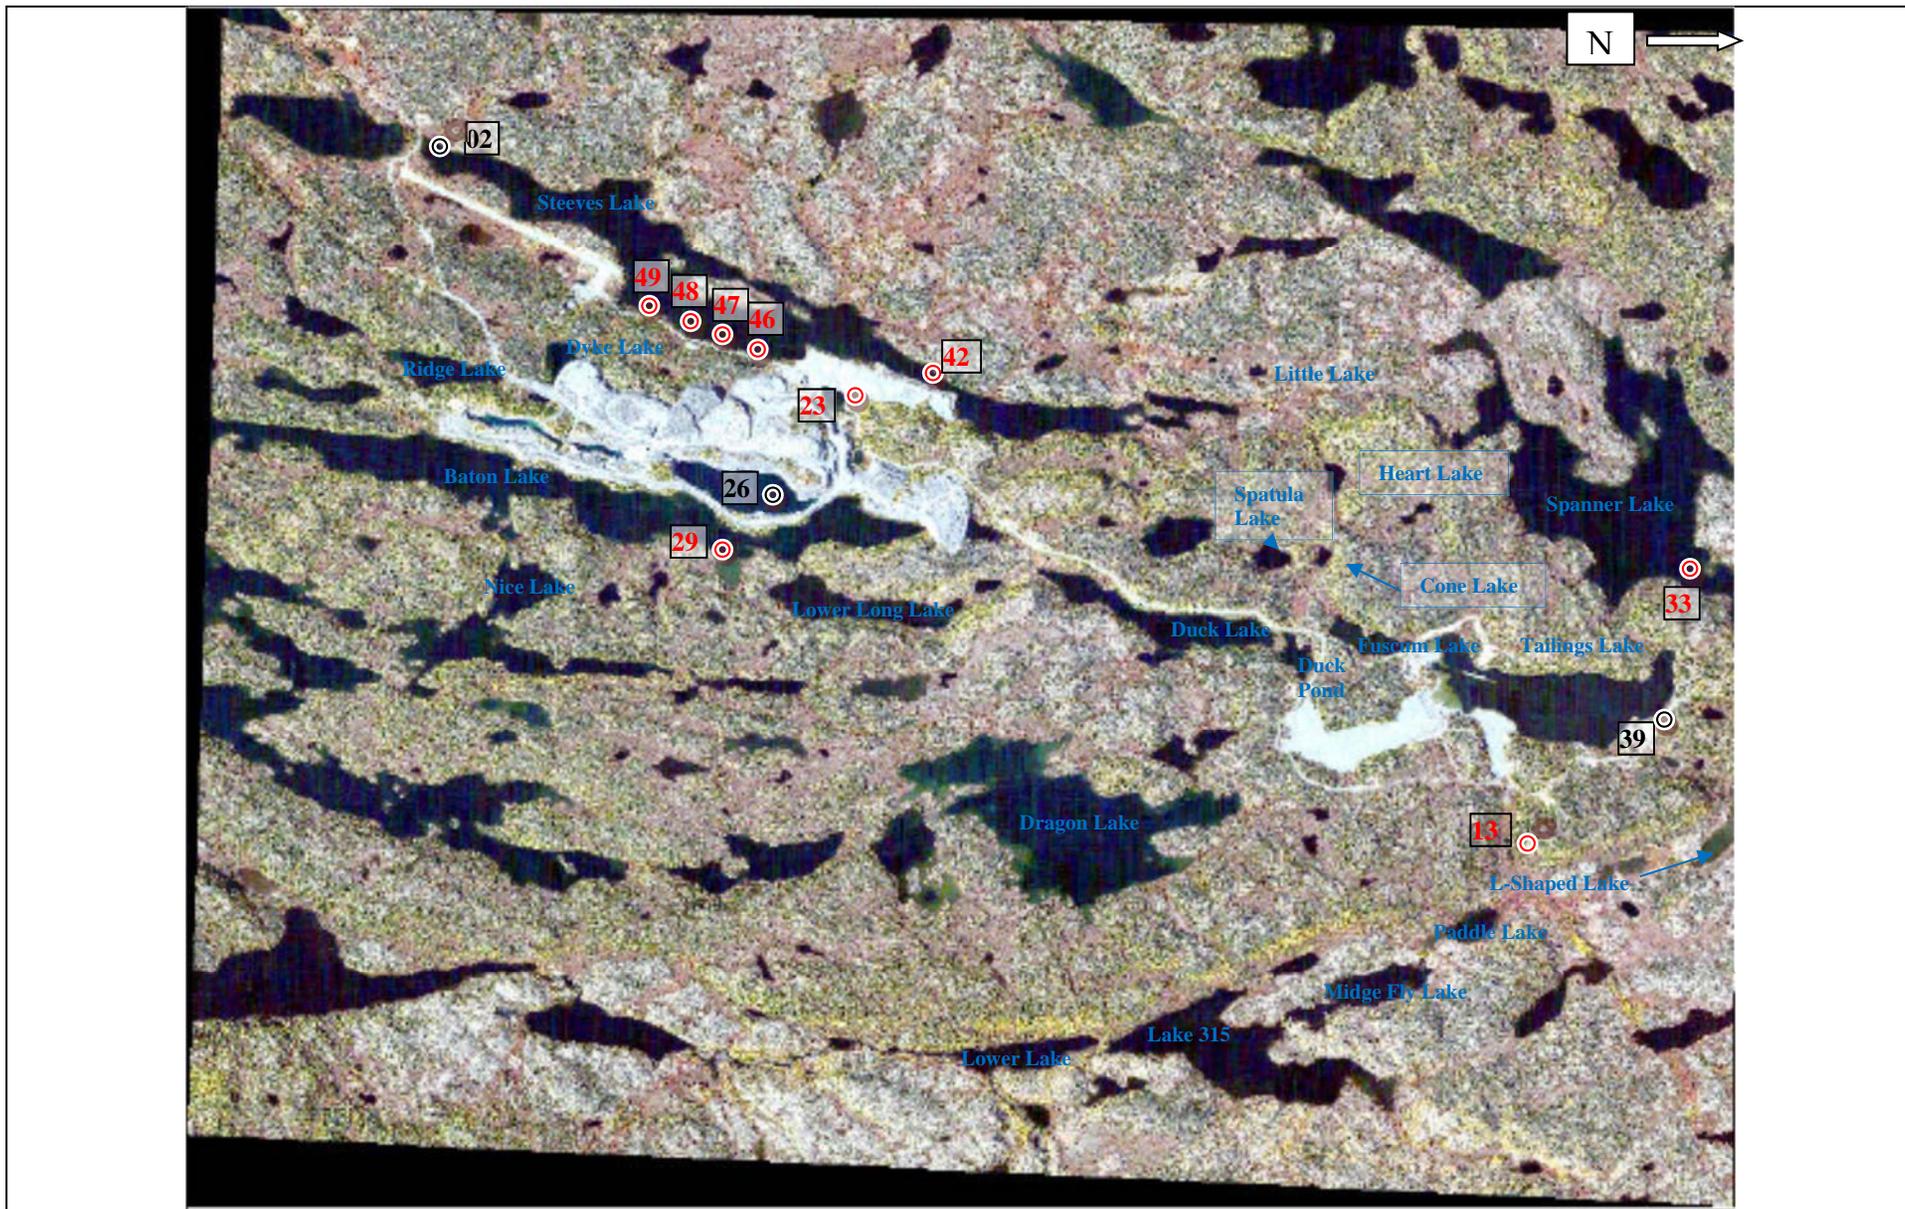
Figure 1 – Surveillance Network Program Sampling Site Locations - Colomac Mine8

The SNP (formally discussed together as the Surveillance Network Program and Enhanced Natural Recovery program) annually monitors surface water quality in strategic water bodies around the remediated former Colomac Mine. The SNP evaluates compliance for discharge from the TCA and monitor the decrease in chemicals of concern in Zone 2.0 Pit. The former Colomac Mine site includes two watersheds, Tailings Lake and Steeves Lake, which are within the Indin River watershed.
