Prairie Creek Project

MINEWATER TREATMENT CONTINGENCY PLAN FOR WATER LICENCE MV2019L2-0006

Submitted in Support of an Application to Amend
the Zinc EQC in the Licence from Total to Dissolved

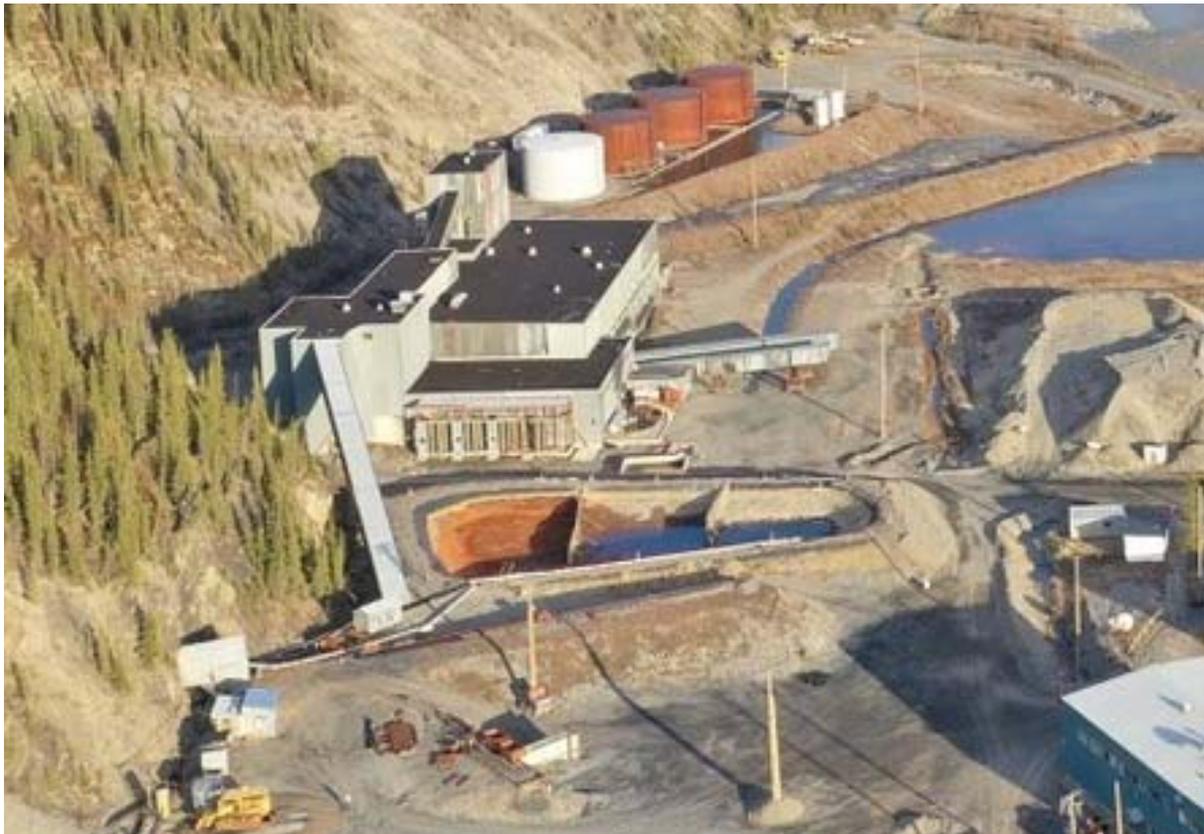
870 Portal (Left Foreground) and Polishing Pond

Apart from infiltration primarily during the summer months, the mine water management and treatment system is not affected by surface water runoff. Only mine water reports to the culvert where primary treatment occurs (see photo below). Treated water is then delivered to the Polishing Pond by a pipeline. The Polishing Pond is a raised structure with four berms. There is no run-on into the pond. The pond does receive incident precipitation, but this does not negatively affect pond function, which is the settling of sediment, and pond volume stays constant as inflows are matched by outflows which occur over a weir at a constant elevation below freeboard.
