DRAWING LIST

SHEET NUMBER	SHEET TITLE
00 - C - 000	COVER SHEET
00 - C - 001	GENERAL NOTES AND BORROW MATERIAL LOCATIONS
00 - C - 100	PROPOSED DIKE REPAIR, LOCATION 1
00 - C - 101	PROPOSED DIKE REPAIR, LOCATIONS 2
00 - C - 102	PROPOSED DIKE REPAIR, LOCATIONS 3 AND 4

2017 RAE LAGOON REPAIR

PROJECT
RAE LAGOON REPAIR
Behchokq, Northwest Territories

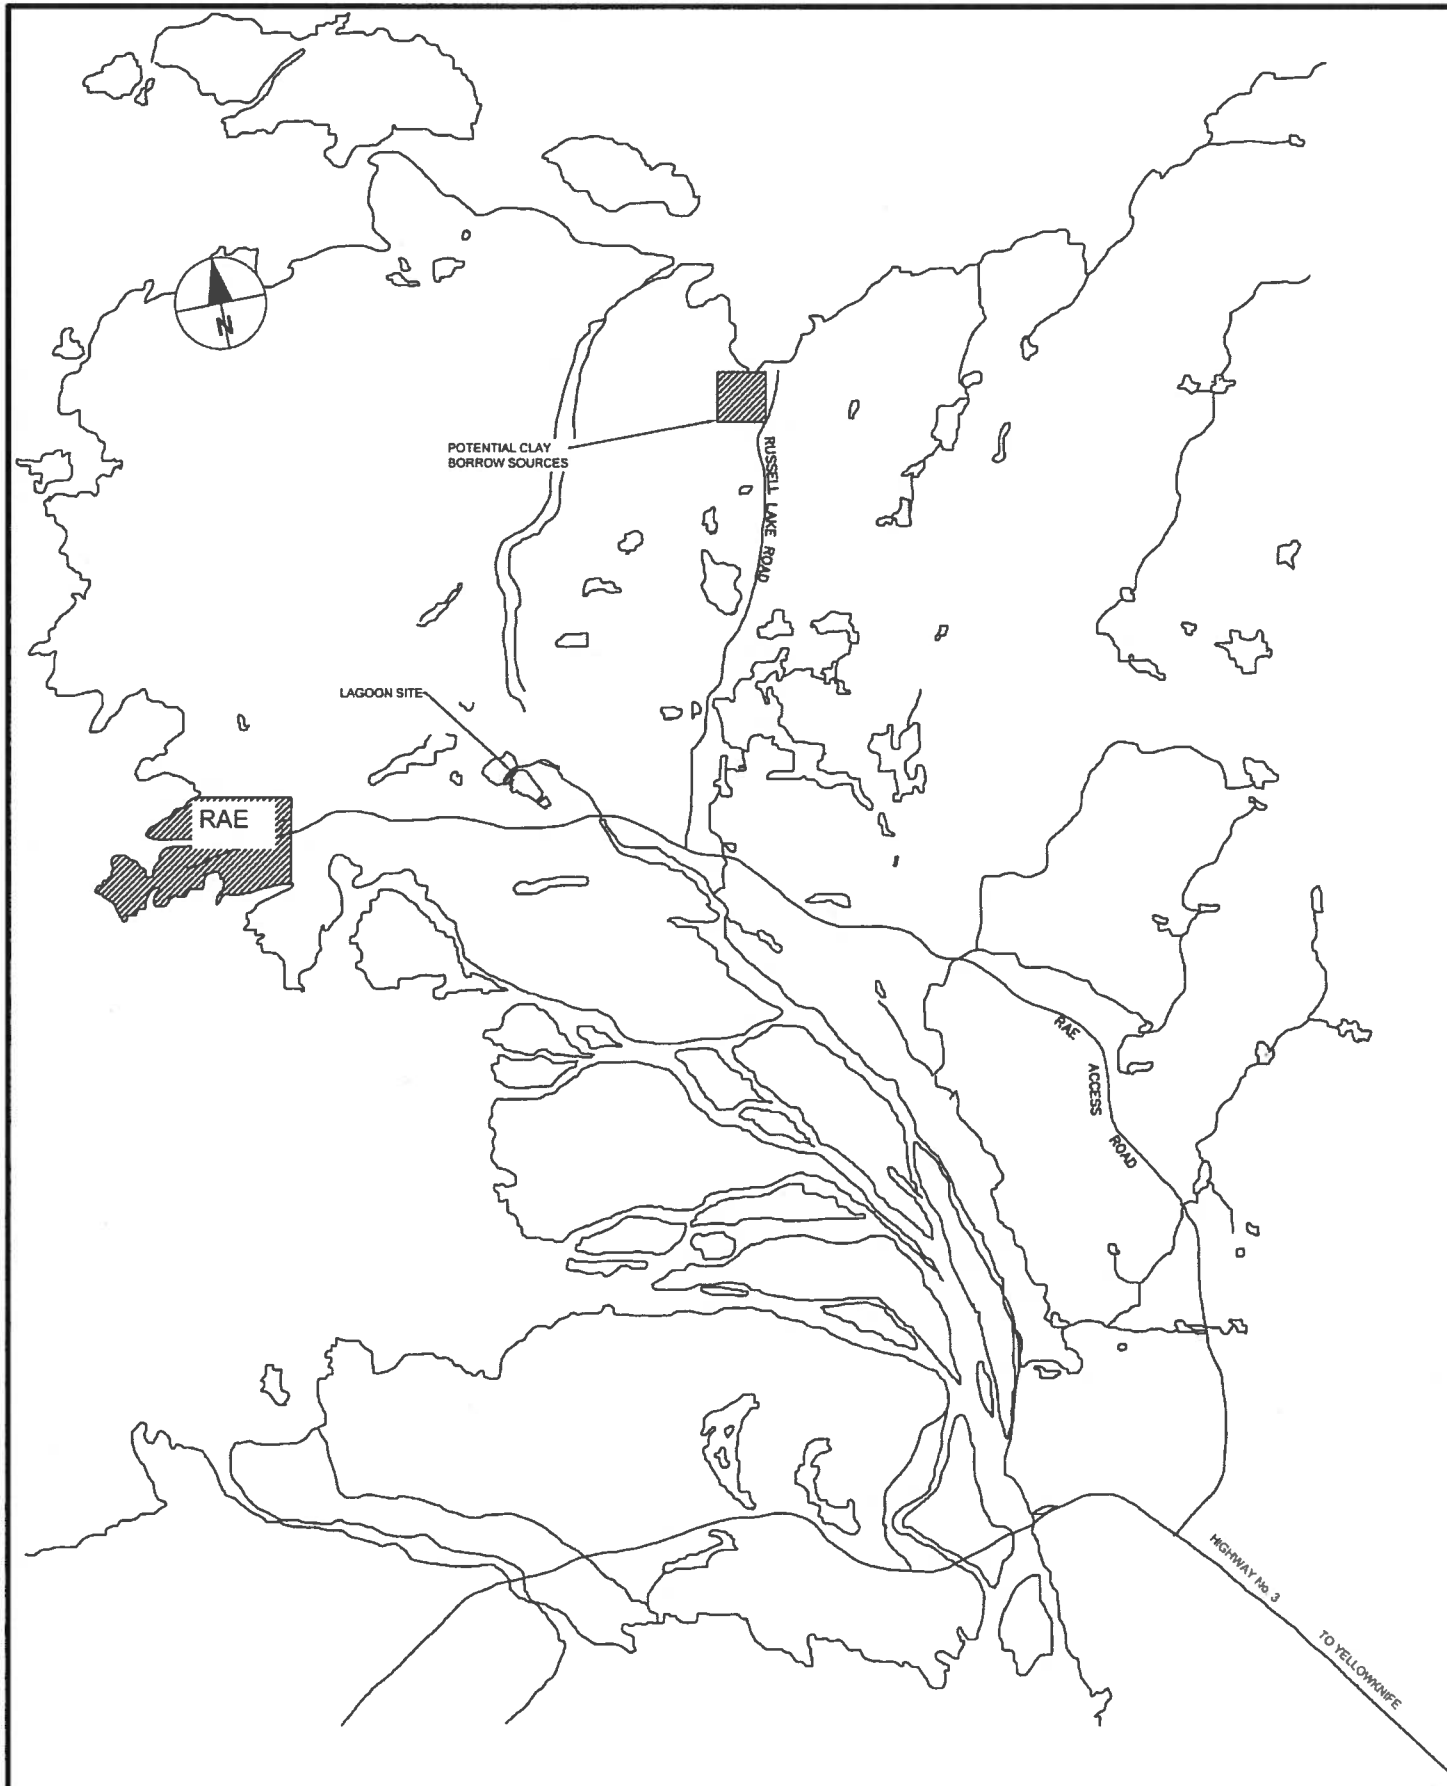
BORROW MATERIAL PLAN
SCALE 1:25000

1. THE CONTRACTOR IS RESPONSIBLE TO DIVERT ALL SEWAGE FROM REMOVE ORGANIC AND GRANULAR MATERIAL AND DISPOSE OF THIS MATERIAL AT THE LANDFILL AS DIRECTED BY THE SITE REPRESENTATIVE.
2. SPREAD EXISTING MATERIAL WITHIN THE REPAIR AREA OF THE DYKES TO WITHIN 400 mm ABOVE WATER LEVEL. IMPORT AND PLACE ADDITIONAL MATERIAL AS REQUIRED TO BUILD UP THE BASE OF THE DYKE TO 400 mm ABOVE WATER LEVEL.
3. COMPACT THIS MATERIAL AND CONTINUE BUILDING UP IN 200 mm LIFTS. COMPACTED TO 95% OF STANDARD PROCTOR DENSITY.
4. PLACE 100 mm LIFT OF GRANULAR SURFACING MATERIAL.

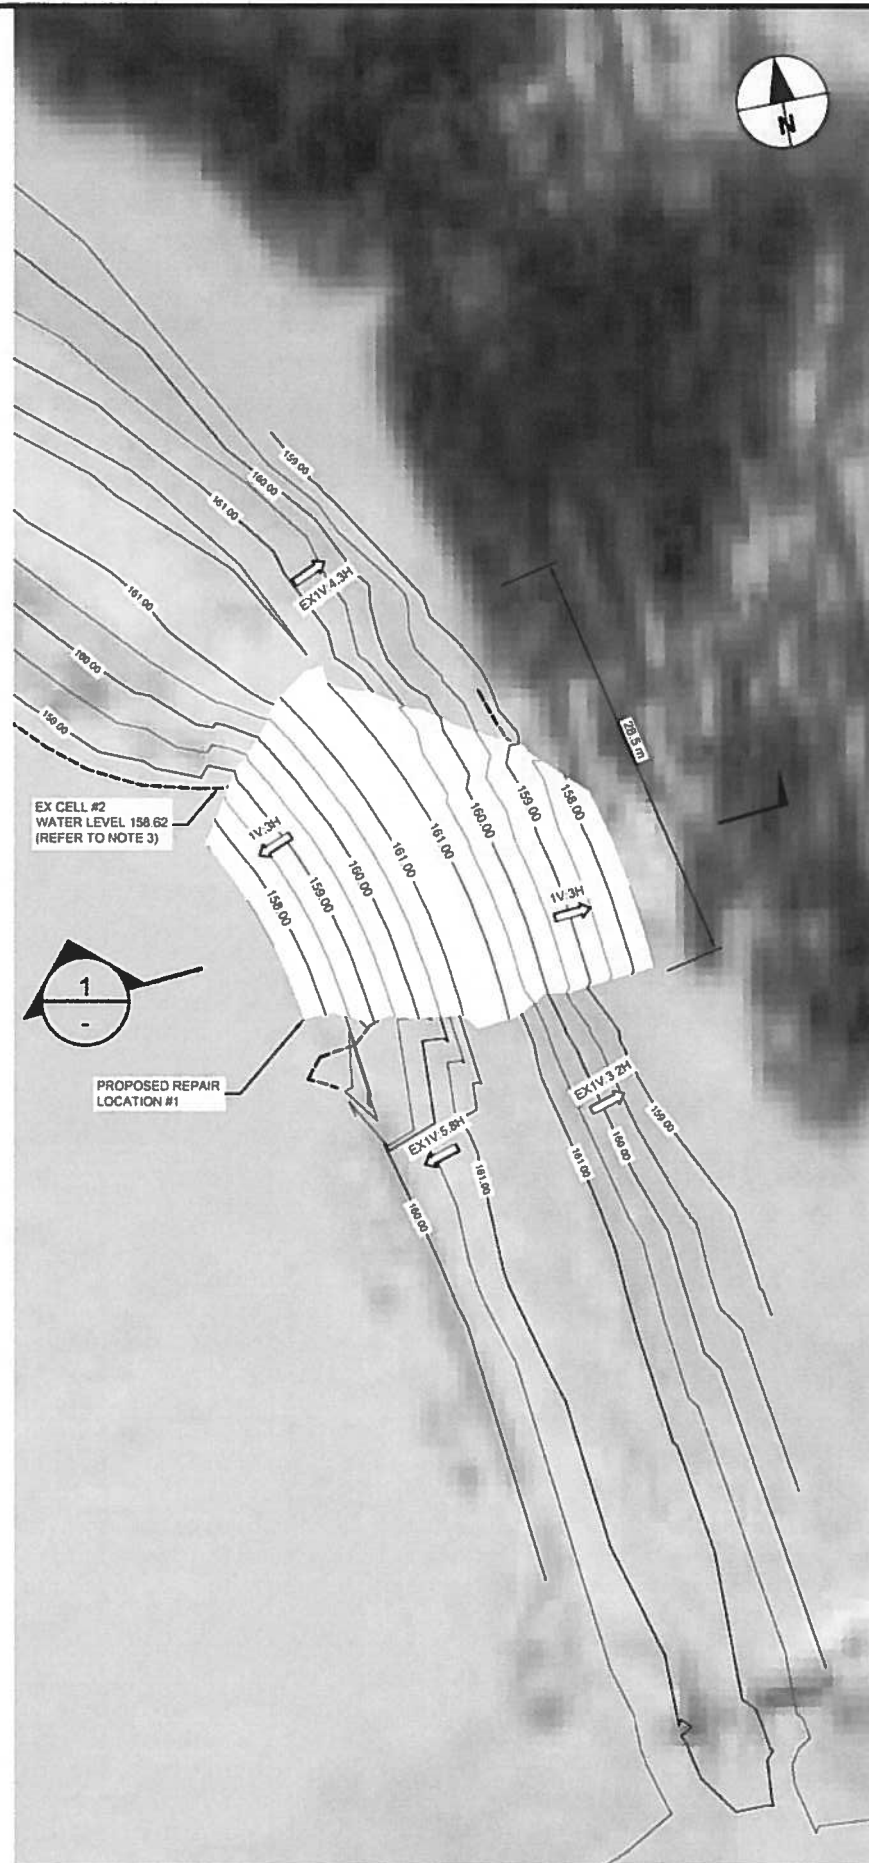
DIKE REPAIR - LOCATION 1
 SCALE 1:250
 PROPOSED REPAIR

1. REFER TO DRAWING C-001 FOR GENERAL NOTES.
2. DIMENSIONS ARE IN METERS UNLESS STATED OTHERWISE.
3. WATER LEVELS RECORDED DURING SURVEY JUNE 2017. SUBJECT TO CHANGE.
4. PROPOSED TOE OF SLOPE BASED ON ASSUMED EX CELL LEVEL OF 157.50. TO BE CONFIRMED ON SITE.
5. AERIAL IMAGE SHOWN FOR INFORMATION ONLY.
6. CONTOUR INTERVALS 0.50 m

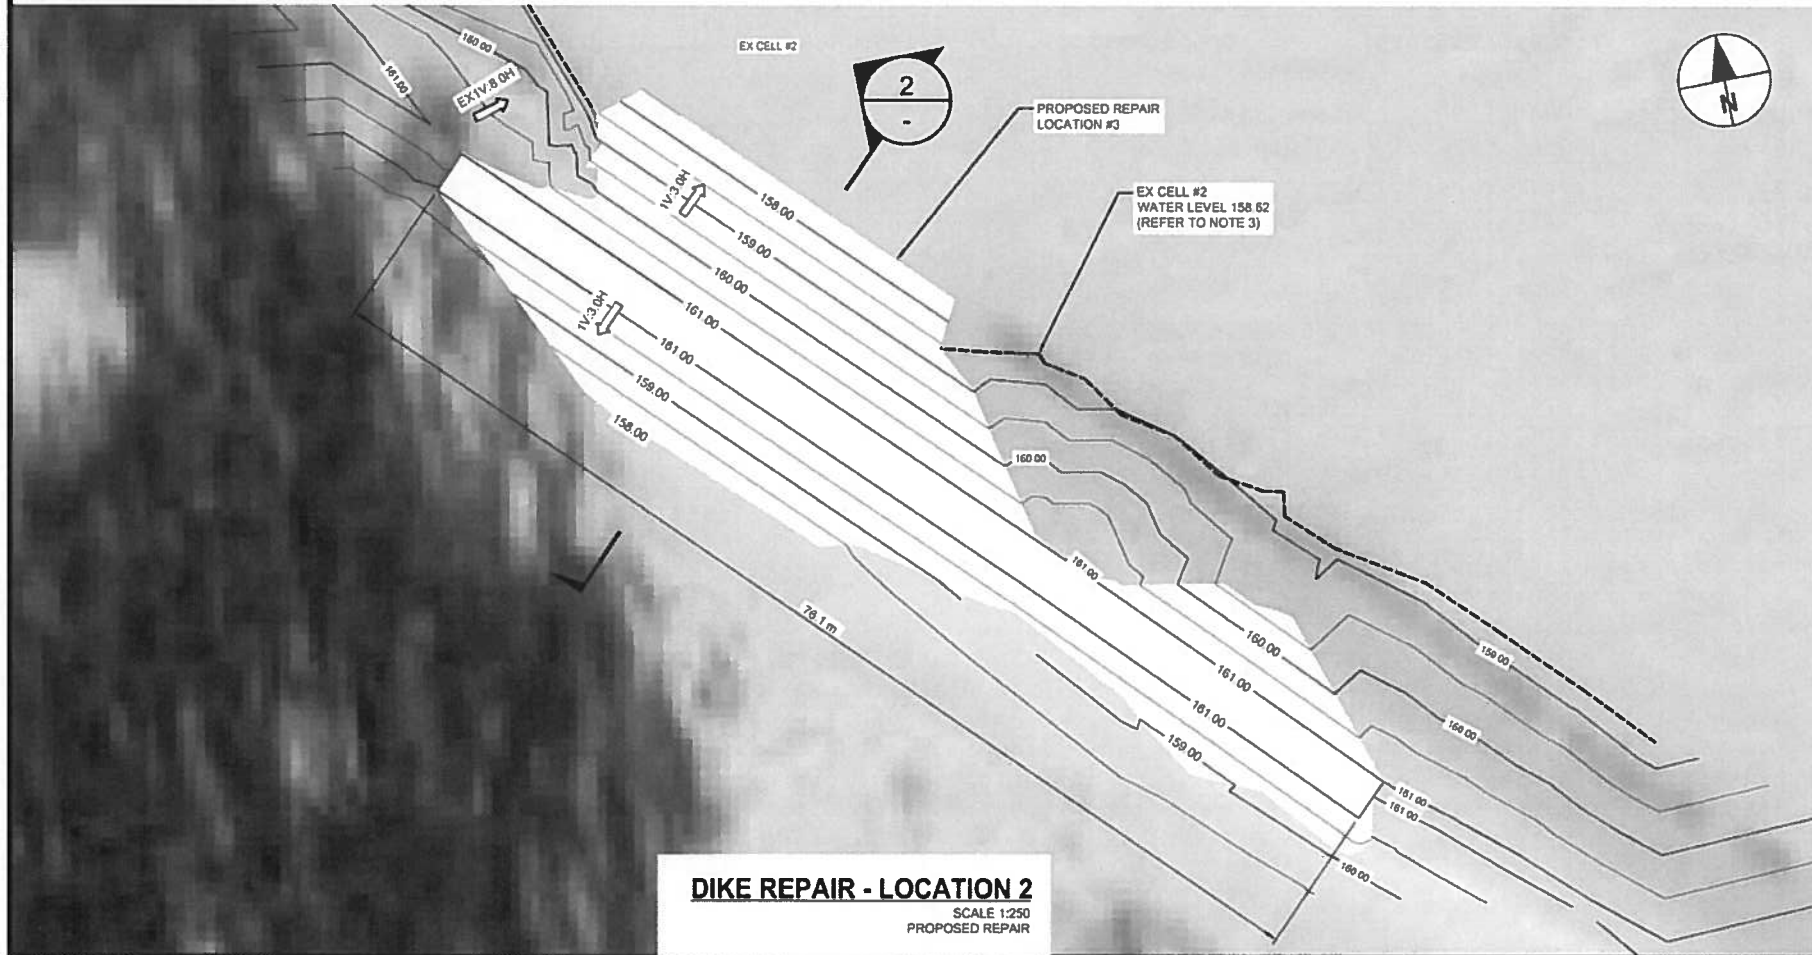
DIKE REPAIR - LOCATION 2
SCALE 1:250
PROPOSED REPAIR

1. REFER TO DRAWING C-001 FOR GENERAL NOTES.
2. DIMENSIONS ARE IN METERS UNLESS STATED OTHERWISE.
3. WATER LEVELS RECORDED DURING SURVEY JUNE 2017. SUBJECT TO CHANGE.
4. PROPOSED TOE OF SLOPE BASED ON ASSUMED EX CELL LEVEL OF 157.50. TO BE CONFIRMED ON SITE.
5. AERIAL IMAGE SHOWN FOR INFORMATION ONLY.
6. CONTOUR INTERVALS 0.50 m

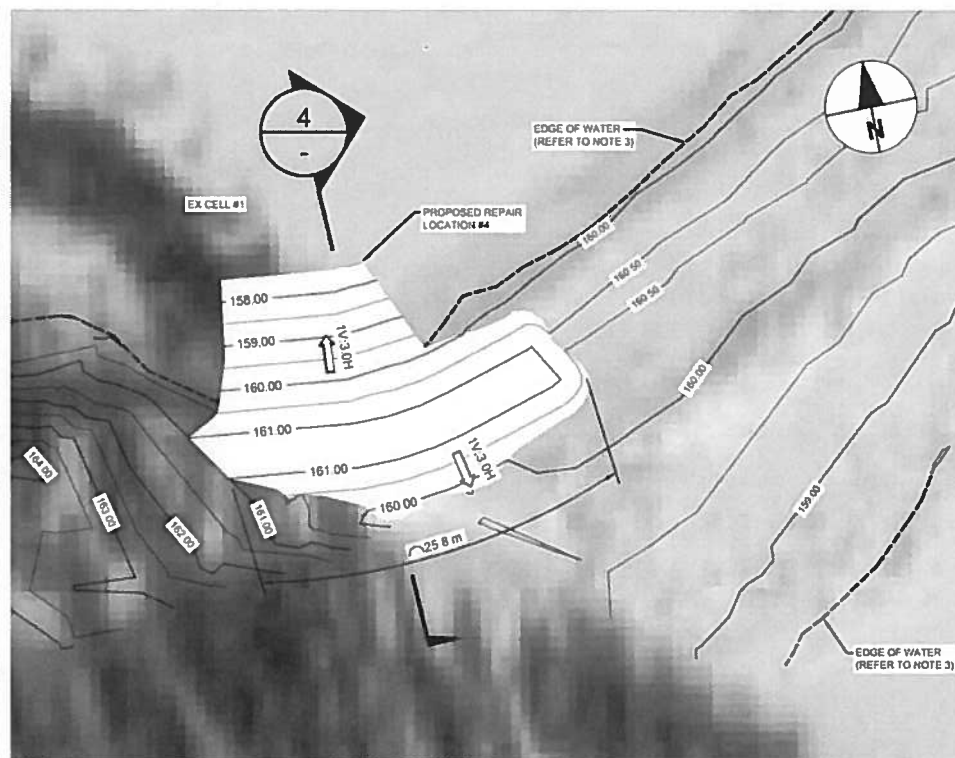
DIKE REPAIR - LOCATION 4
SCALE 1:250
PROPOSED REPAIR

- NOTES:
- REFER TO DRAWING C-001 FOR GENERAL NOTES.
 - DIMENSIONS ARE IN METERS UNLESS STATED OTHERWISE.
 - WATER LEVELS RECORDED DURING SURVEY JUNE 2017, SUBJECT TO CHANGE.
 - PROPOSED TOE OF SLOPE BASED ON ASSUMED EX CELL LEVEL OF 157.50 TO BE CONFIRMED ON SITE.
 - AERIAL IMAGE SHOWN FOR INFORMATION ONLY.
 - CONTOUR INTERVALS 0.25 m
