<b>File Number</b>	<b>G16Q004</b>
<b>Type of Operation</b>	<b>QUARRY SITE - Existing</b>
<b>Location</b>	<b>KM 251 Quarry</b>

## ENVIRONMENTAL INSPECTION REPORT

<b>Permittee:</b>	Bob's Welding Ltd.	<b>Permit Expiry Date:</b>	May 25, 2021
<b>Land Use Permit No.</b>	G16Q004	<b>Previous Inspection:</b>	July 11, 2017
<b>Quarrying Permit No.</b>		<b>Inspection Date:</b>	August 09, 2017
<b>Contractor:</b>	Bob's Welding Ltd.	<b>Subcontractor:</b>	
<b>Location(s) Inspected:</b>	KM 251 Quarry		
<b>Current Stage of Operation:</b>	Ongoing		
<b>Program Modifications Approved:</b>	NIL

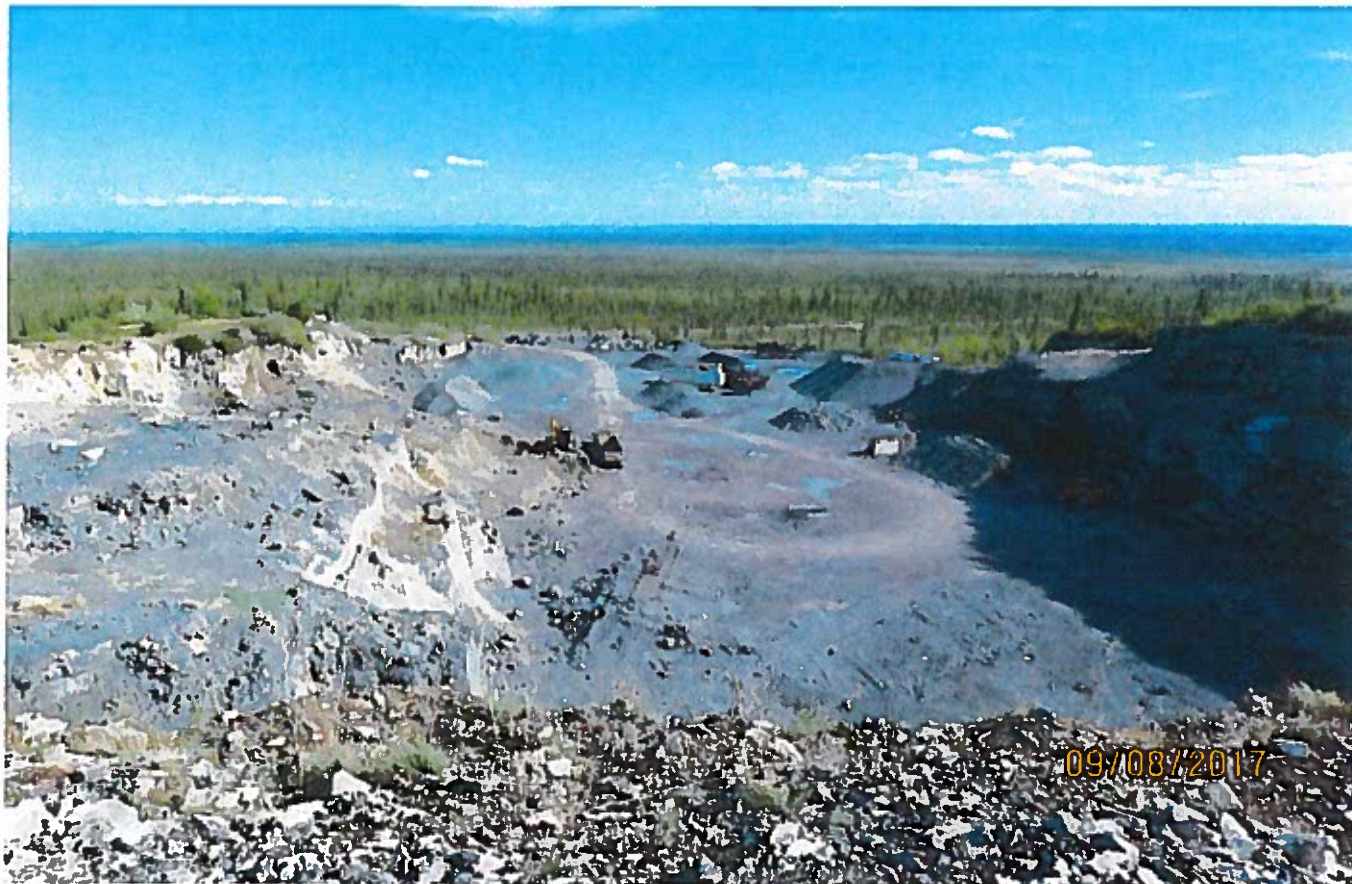
**Figure 1**

During the inspection it was observed that there are 12 stockpiles of crushed material that still need to be removed from the quarry. The last two inspection reports dated June 27, 2017 and July 12, 2017 requested the crushed material to be removed as this is a multi-user pit. A new permit will not be issued until all the material has been removed from the quarry. It was also observed that the burn barrel in the south-east corner of the pit has some burnt oil/fuel filters and a small pail of a hydrocarbon substance about 3/4 full near the burn barrel which needs to be removed and disposed of properly. This quarry permit, issued by the Gwich'in Land and Water Board (GLWB) in accordance with the Mackenzie Valley Resource Management Act (MVRMA) do not allow the incineration or improper storage of oil/fuel lubricants.

**A picture of the pit with all the stockpiles.**

Ensure the stockpiles are removed.

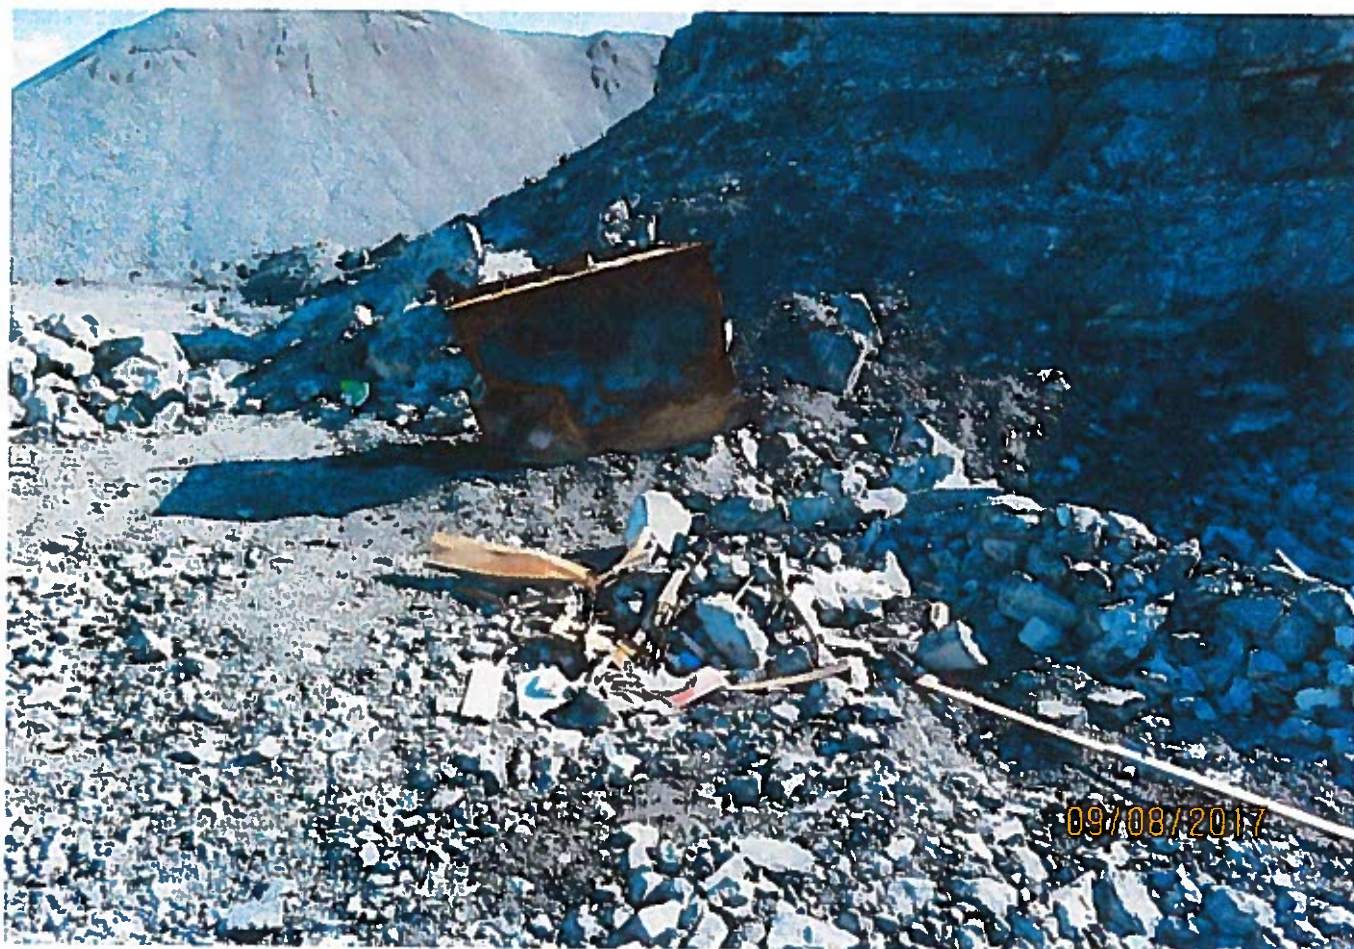
**Figure 2**

**The burn barrel in the south-east portion of the pit. Notice the small green pail to the left of the burn barrel and some metal debris in front.**

Ensure the metal/garbage debris and small pail of hydrocarbon is cleaned up properly.

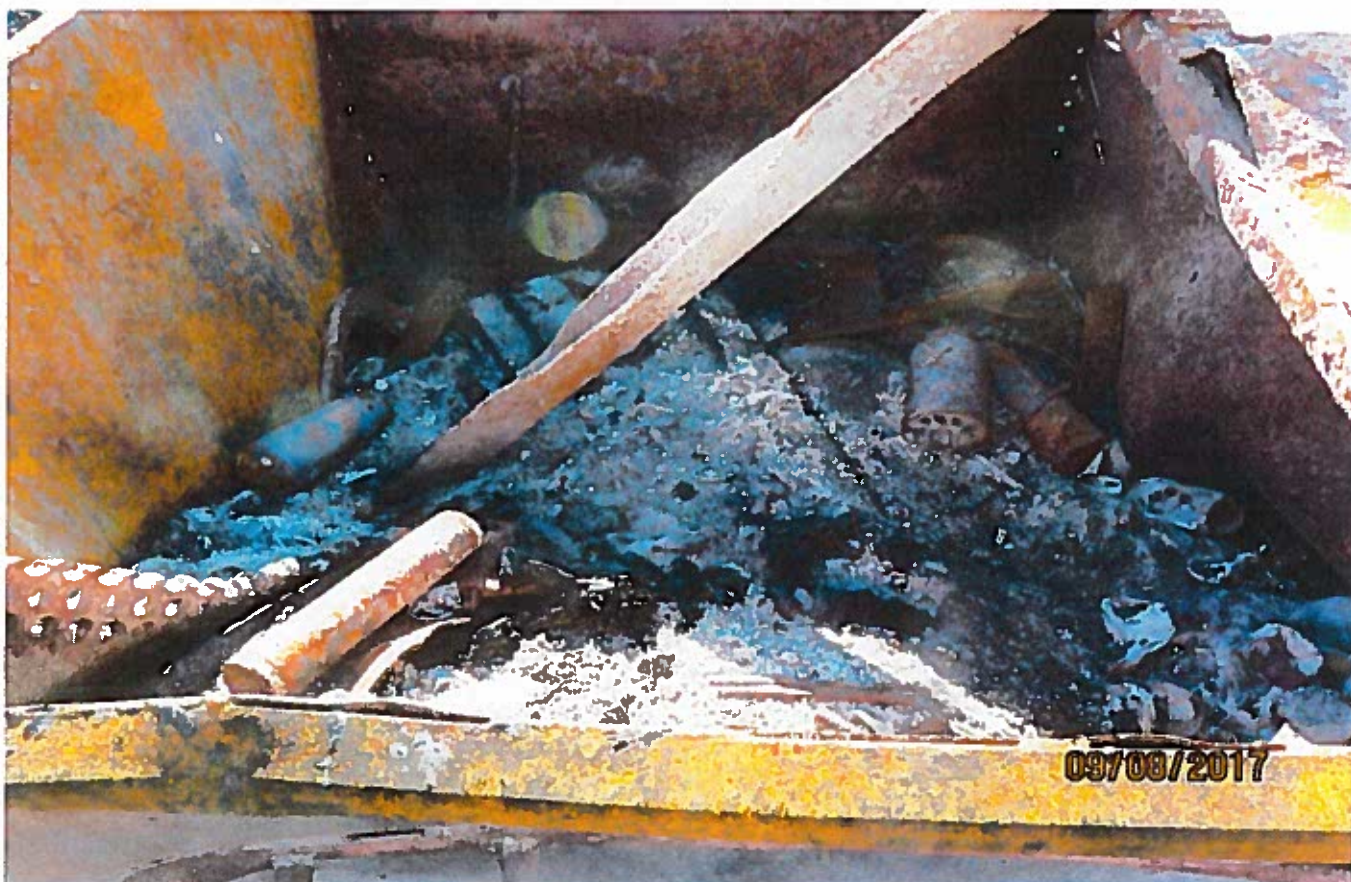
Figure 3

Inside the burn barrel among the ashes are some oil/fuel filters and grease-gun tubes.

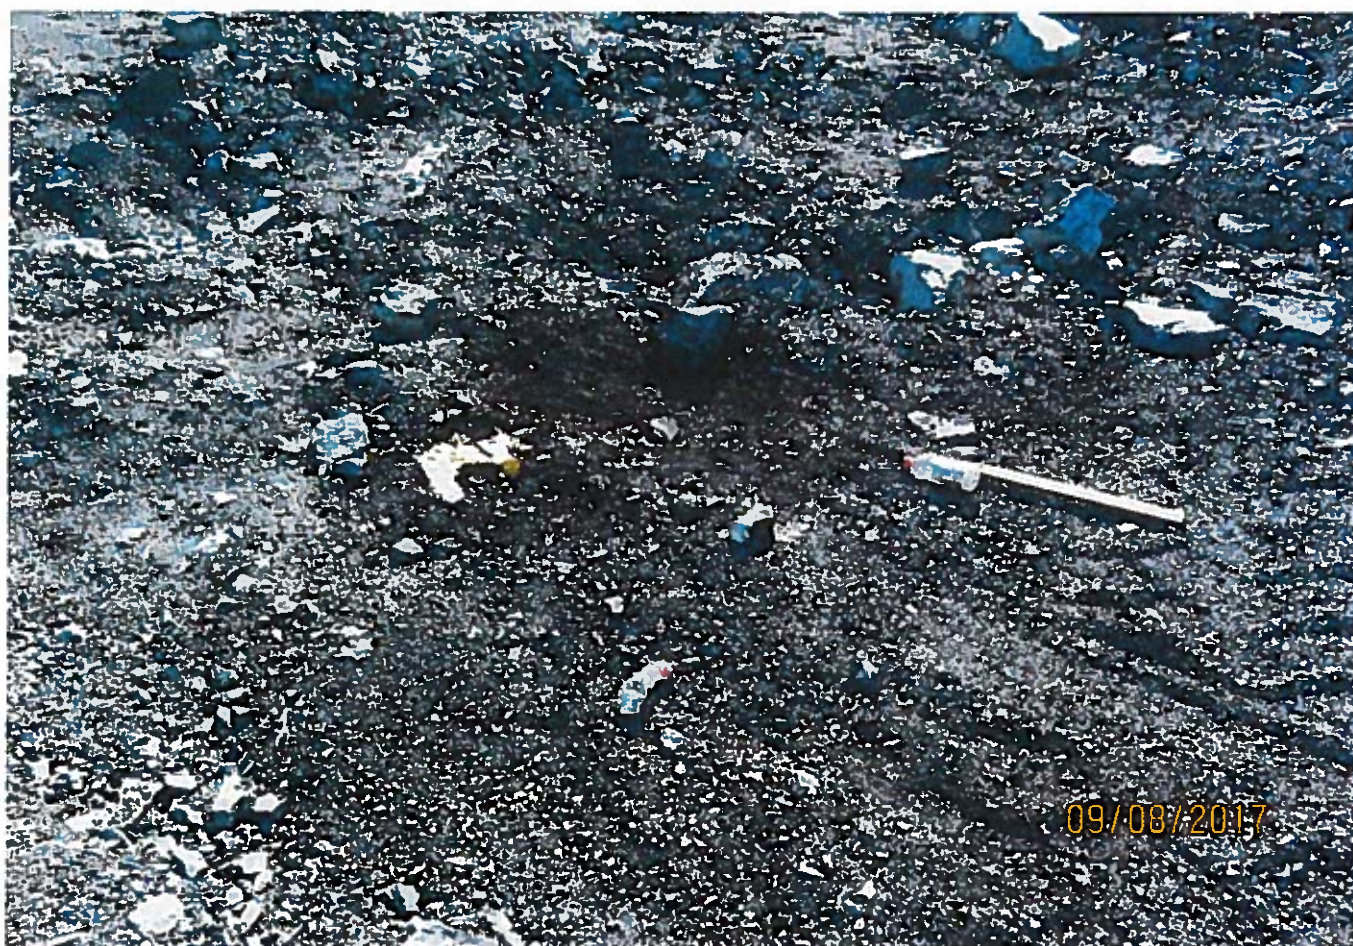
Figure 4

Some garbage debris scattered near the burn barrel.
