2010 – 2012 Water Quality Results for SNP Station 43-1
Treated Minewater Discharged from the Giant Mine Polishing Pond to Baker Creek

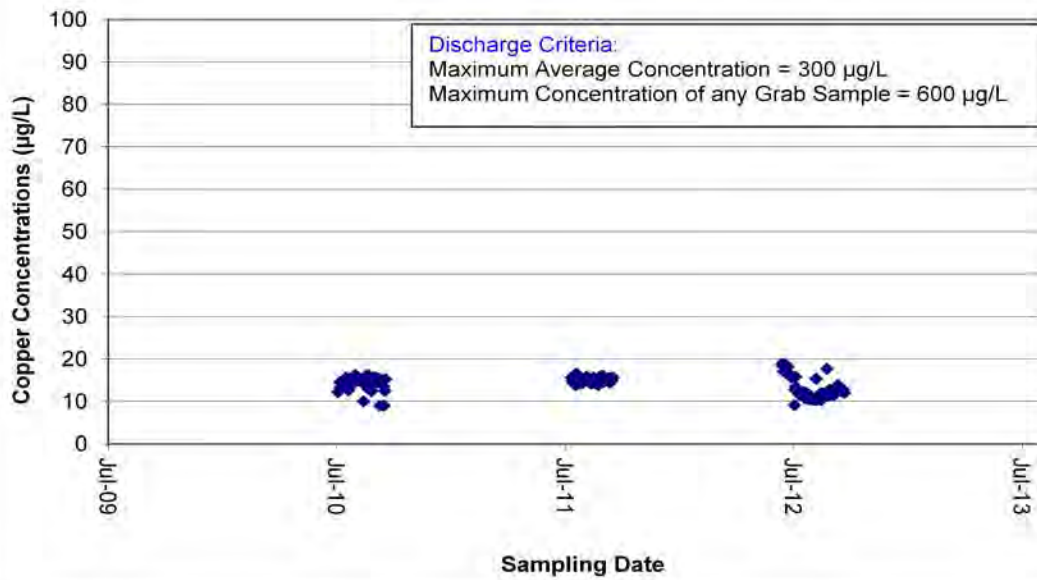
Total Copper Concentrations at SNP 43-1 (2010 to 2012)

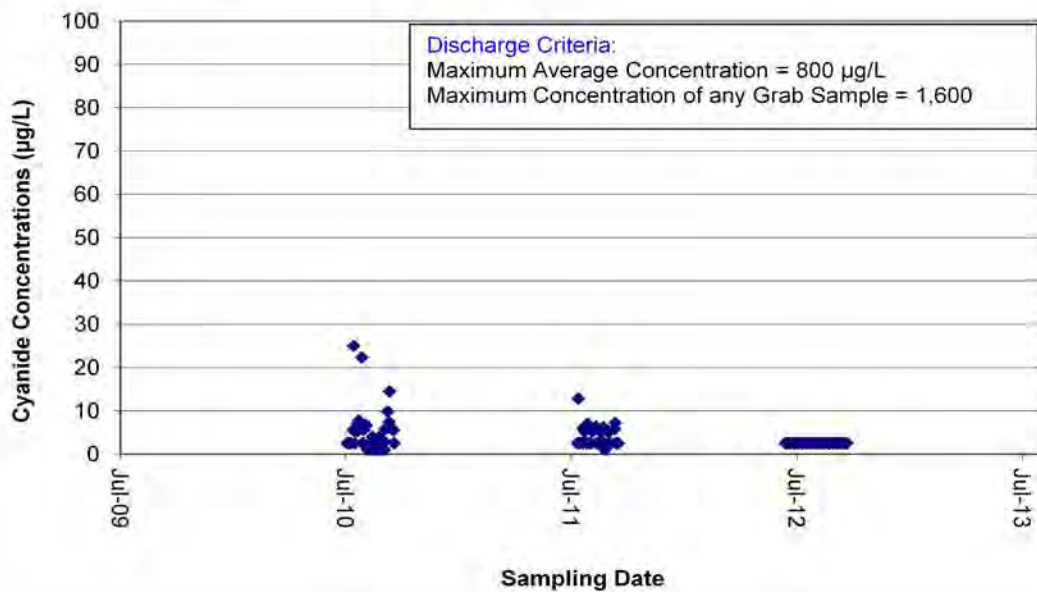
Cyanide Concentrations at SNP 43-1 (2010 to 2012)

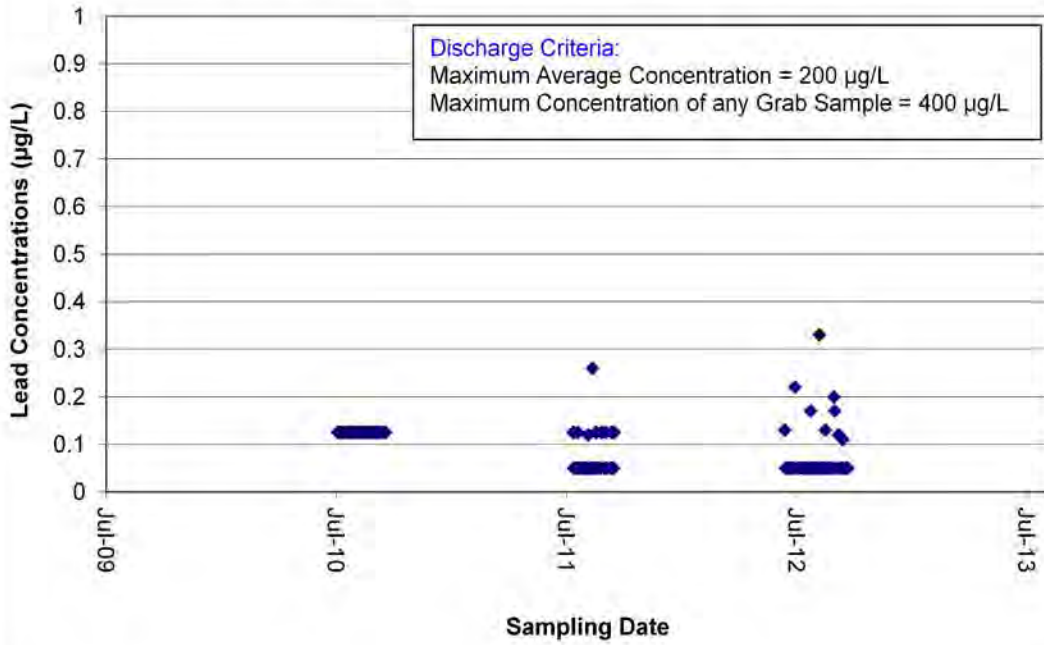
Total Lead Concentrations at SNP 43-1 (2010 to 2012)

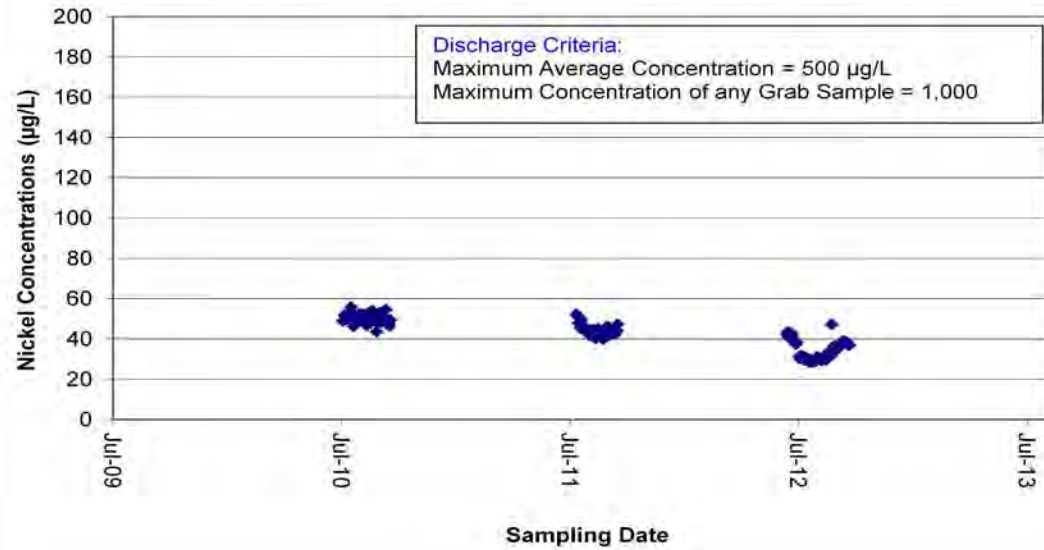
Total Nickel Concentrations at SNP 43-1 (2010 to 2012)

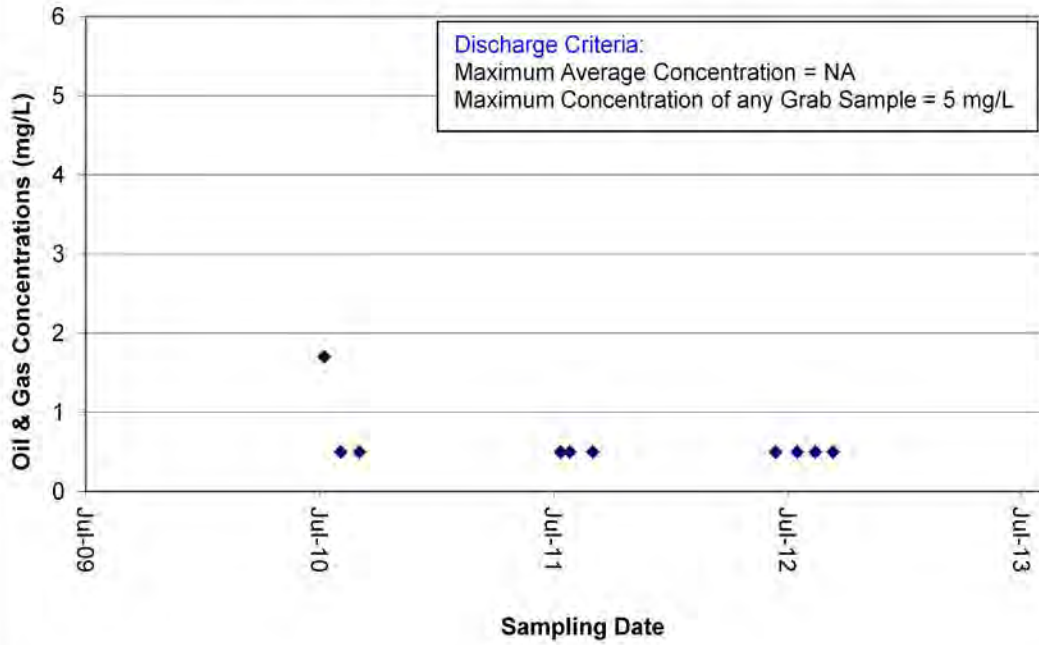
Oil & Gas Concentrations at SNP 43-1 (2010 to 2012)

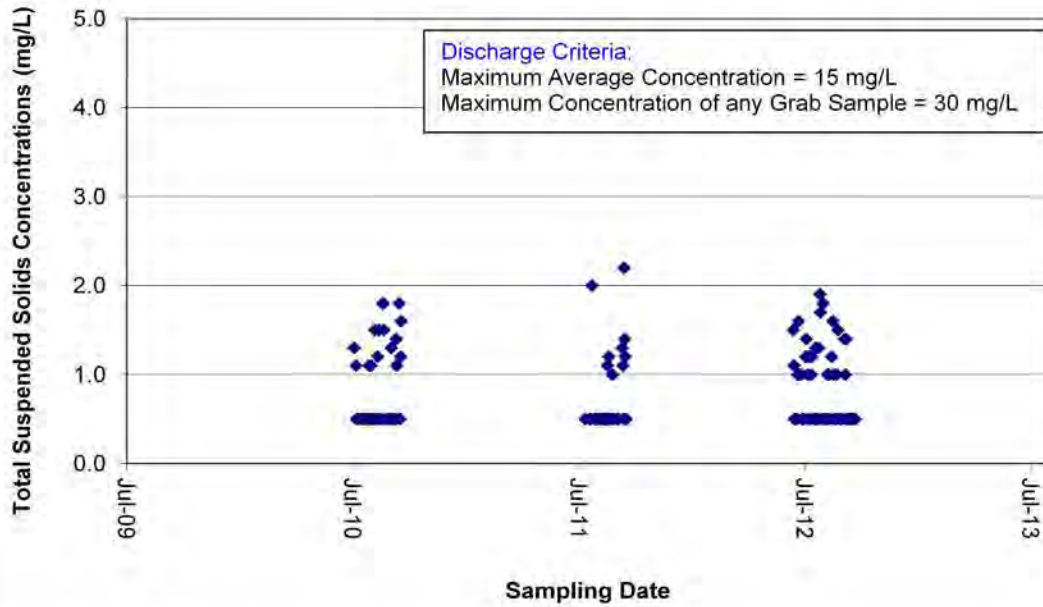
Total Suspended Solids (TSS) at SNP 43-1 (2010 to 2012)

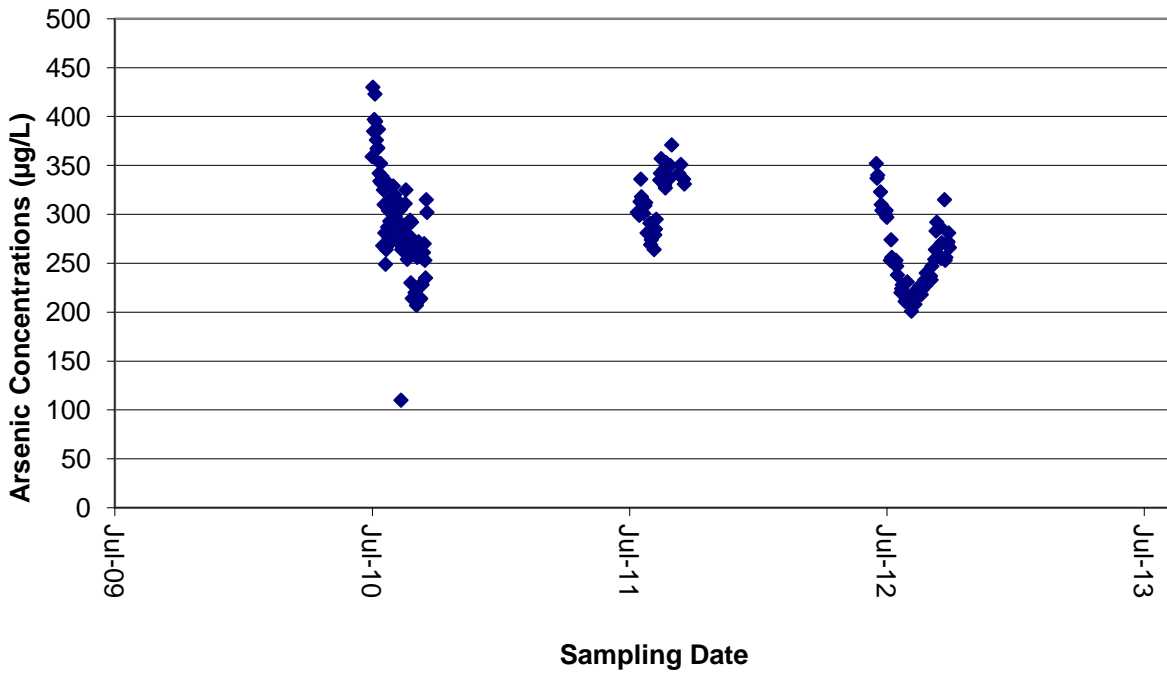
Dissolved Arsenic Concentrations at SNP 43-1 (2010 to 2012)

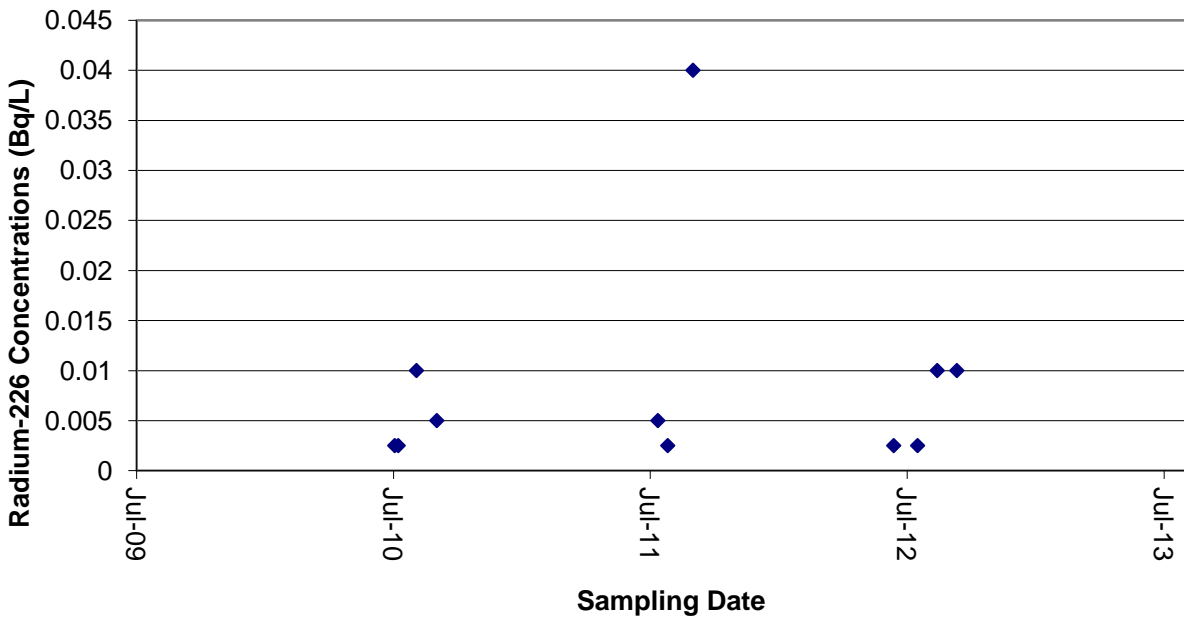
Radium-226 Concentrations at SNP 43-1 (2010 to 2012)

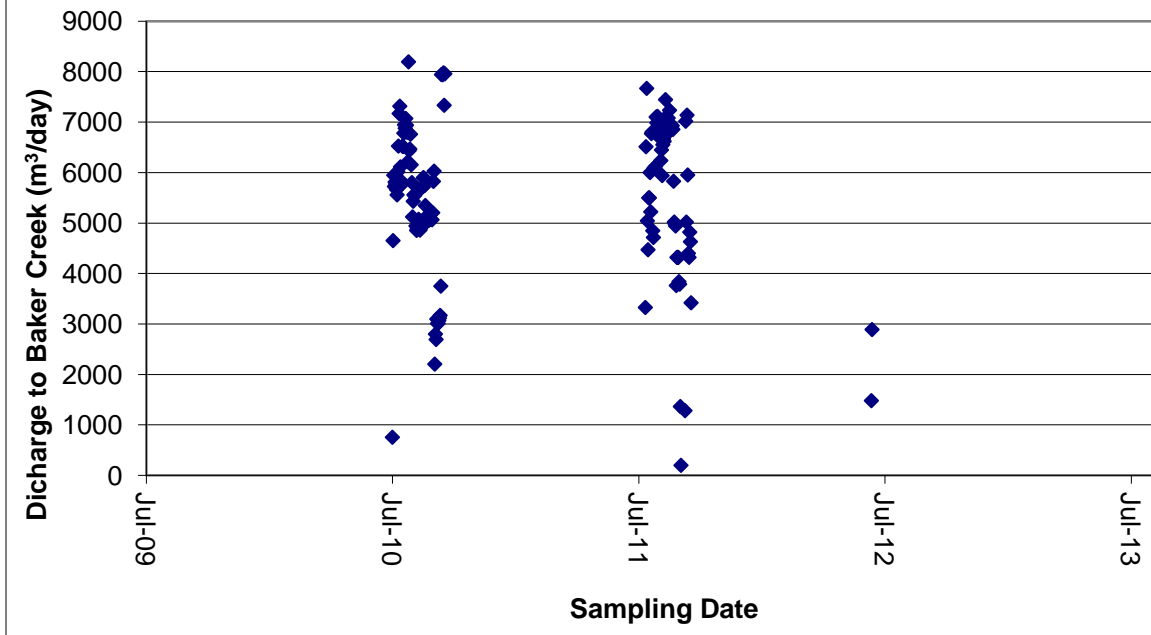
Discharge to Baker Creek at SNP 43-1 (2010 to 2012)
