Re: **Land Use Permit G02A011  
Drilling Program, Tree River C-36**

## ENVIRONMENTAL INSPECTION REPORT

Location(s) Inspected:	Tree River Sump C36
------------------------	---------------------

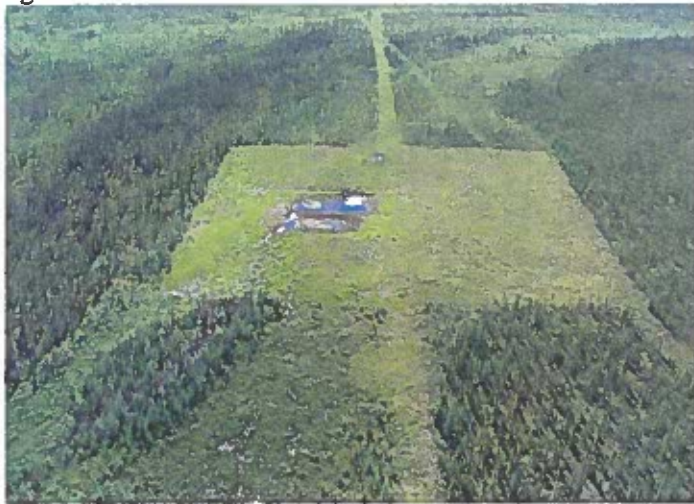
Figure 1:

Please note that a previous inspection in 2003 and 2006 indicated that the cap was settling. In the above noted Inspection Report and photos, indications are that further subsidence has occurred to the point that it is causing significant volumes of water to pool on the sump cap. The integrity of the sump and its contents will be at risk should this be allowed to continue without remediation. Please provide our office with a timeline for these issues to be evaluated and ultimately rectified.
