File Number G21E001
Type of Operation HWY MAINTENANCE & OPERATIONS
Location KM 235 (Follow-up inspection from 2022 season)

ENVIRONMENTAL INSPECTION REPORT

Permittee:	Department of Infrastructure	Permit Expiry Date:	June 27, 2026
Land Use Permit No.	G21E001	Previous Inspection:	October 18, 2022
Quarrying Permit No.		Inspection Date:	May 19, 2023
Contractor:	LJ's Contracting	Subcontractor:	
Location(s) Inspected:	KM 235 (Follow-up inspection from 2022 season)		
Current Stage of Operation:	Inactive		
Program Modifications Approved:

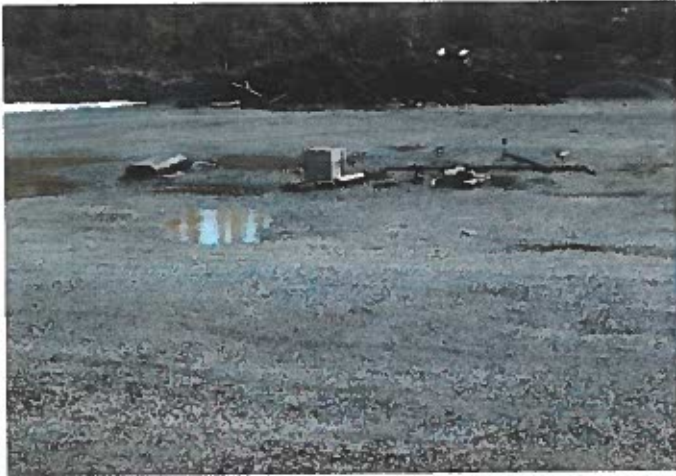
Figure 1

A follow up inspection from issues arising from an inspection done on October 18, 2022 at KM 235 found that clean up of the location did not occur. This site had a temporary camp situated on this site for Infrastructure projects in 2022 and debris and garbage was left on site and has yet to be cleaned up and disposed of to a proper facility.

It is highly recommended that the debris and garbage previously identified to the permit holder, be cleaned and hauled to a proper facility for disposal. Possible legislative actions may be considered by the Department of Environment and Climate Change if this is not rectified as soon as possible.
