Prairie Creek Project

MINEWATER TREATMENT CONTINGENCY PLAN FOR WATER LICENCE MV2019L2-0006

April, 2020

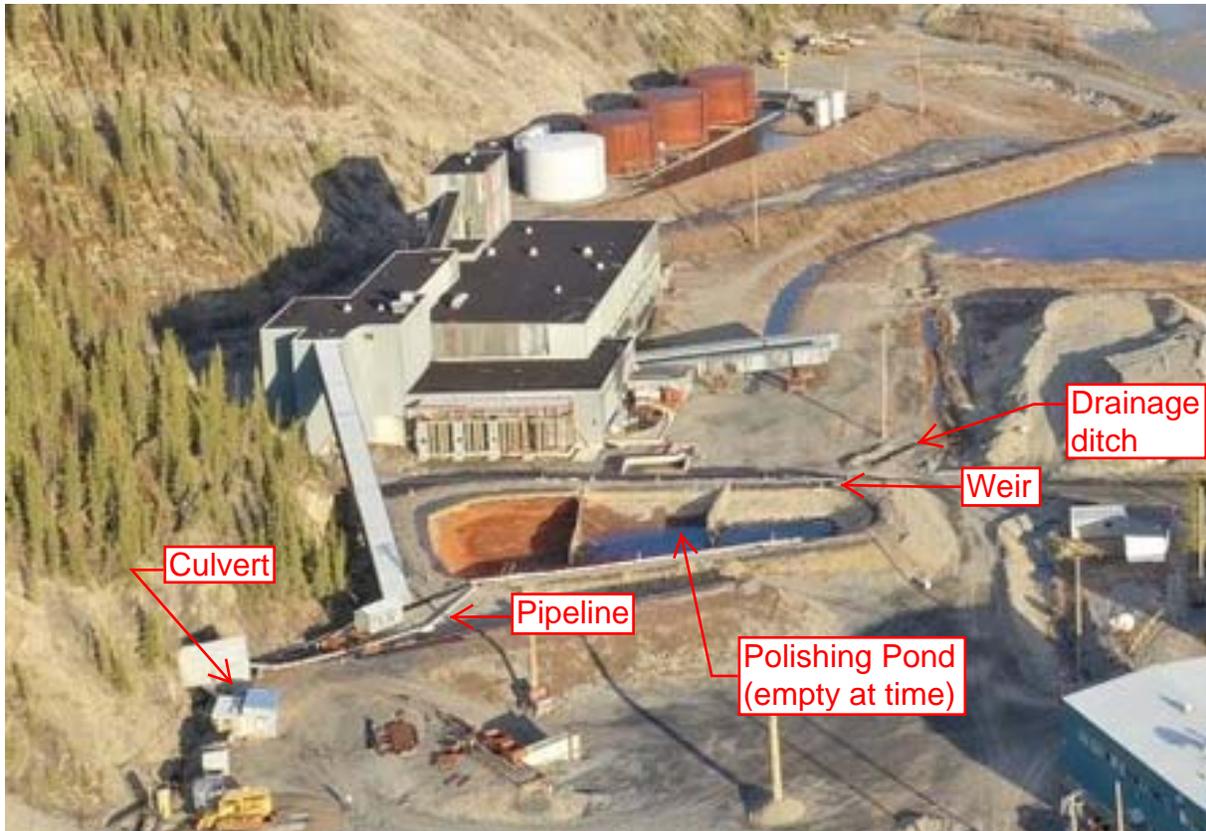
Apart from infiltration primarily during the summer months, the mine water management and treatment system is not affected by surface water runoff. Only mine water reports to the culvert where primary treatment occurs (see photo below). Treated water is then delivered to the Polishing Pond by a pipeline. The Polishing Pond is a raised structure with four berms. There is no run-on into the pond. The pond does receive incident precipitation, but this does not negatively affect pond function, which is the settling of sediment, and pond volume stays constant as inflows are matched by outflows which occur over a weir at a constant elevation below freeboard.

CZN treats mine water at a culvert which receives mine water from the 870 portal. Secondary treatment of the culvert stream is integrated with a connected delivery line to the Polishing Pond.
