**Subject: W2016D0003 – Spill 2023147**

Pursuant to Part C Condition 18(c) of Land Use Permit W2016D0003, Arctic Canadian Diamond Company Ltd. (Arctic) is providing a detailed spill report on Spill 2023147 which occurred on April 13, 2023, inside Sable Pit.

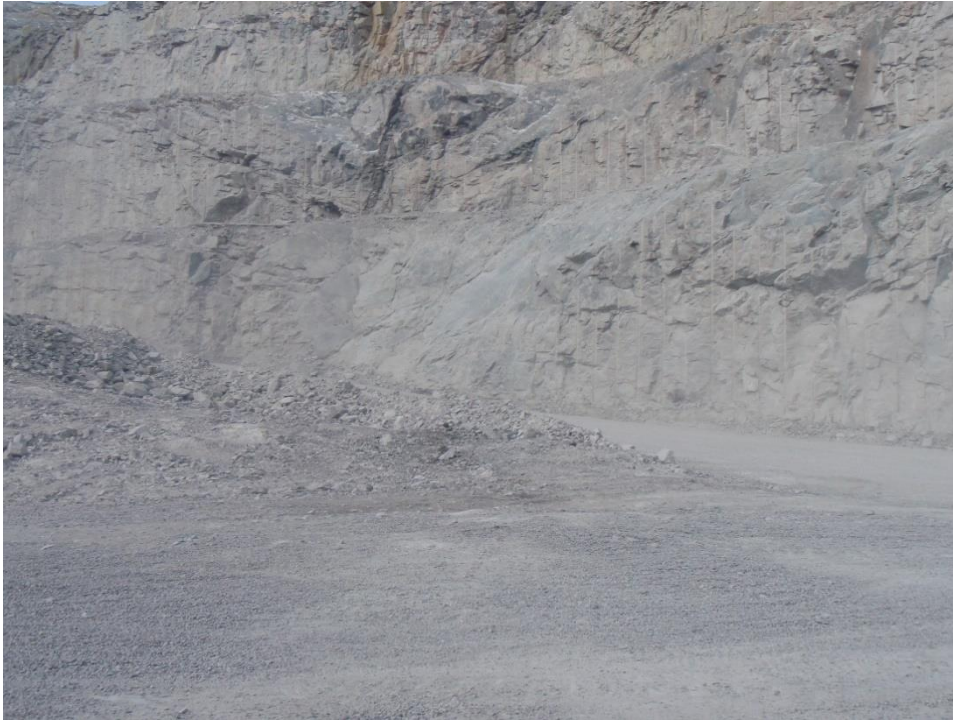
While operating down in Sable Pit, the O-ring on shovel 2567 failed on the right final drive motor and resulted in a spill of 800L petroleum- hydraulic oil.

*Photo 1: Spill 2023147 area after cleaning up and removal of contaminated material.*

On April 13<sup>th</sup>, 2023, a total of 15 m<sup>2</sup> of rock were blasted and 27 tons of rock disposed at Panda/Koala, Zone S by surface mining department.
