Subject: W2016D0003: Spill 2019127 Report

Pursuant to Part C, Condition 18(c) of Land Use Permit W2016D0003, Dominion Diamond Mines ULC (Dominion) is providing a detailed report on Spill 2019127 which occurred on March 20, 2019 at the Sable Fuel Tank Farm.

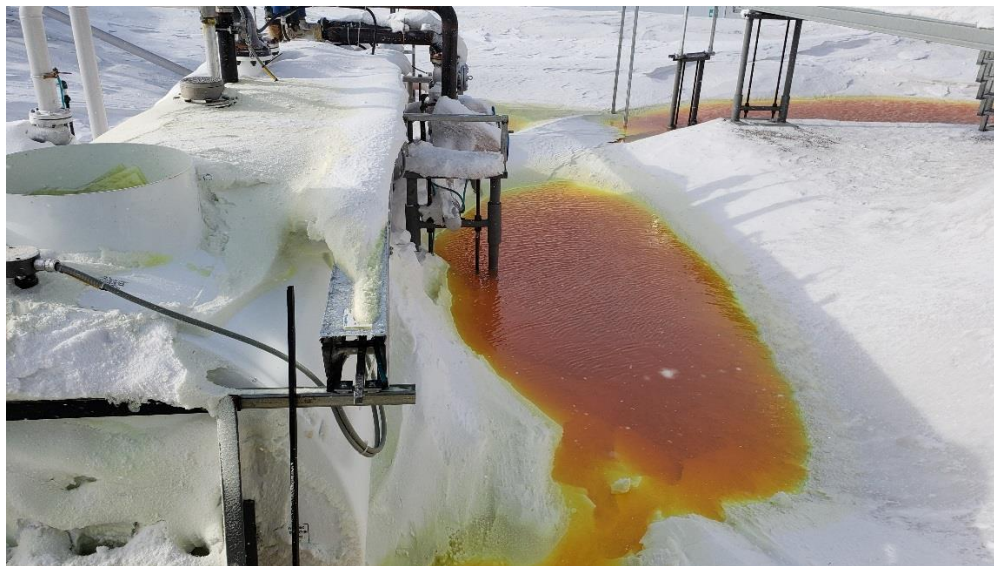
The failure was caused by the High Level and High High Level switches freezing due to condensation from the temperature changes at the Ekati mine. The level floats were not able to move up and down because they were frozen.

Figure 2. Pooled Diesel near Generator Day Tank (March 21, 2019)

- The Hydrocarbons Department have recovered 51,000 L of the spill from the containment berm and pumped it directly back into the bulk tank it drained from. Currently, more pooled diesel is under a layer of snow within the berm, and Dominion will attempt to recover more once the snow begins melting. Once all recoverable diesel has been pumped back into the tank, that bulk tank will be closed off until summer, at which time a contractor group will come to site, drain the water off the bottom, and filter any remaining fuel so that the product can still be used in the future.

- The Instrumentation Department has programmed timers into the PLC that will limit how much fuel can be pumped from the bulk tanks to each day tank. The PLC has been programmed to only allow filling of each day tank for the amount of time it takes to fill it. With this addition, even if the High and High High Level sensors fail the pump will only feed fuel to the day tanks for the set amount of time before kicking out.

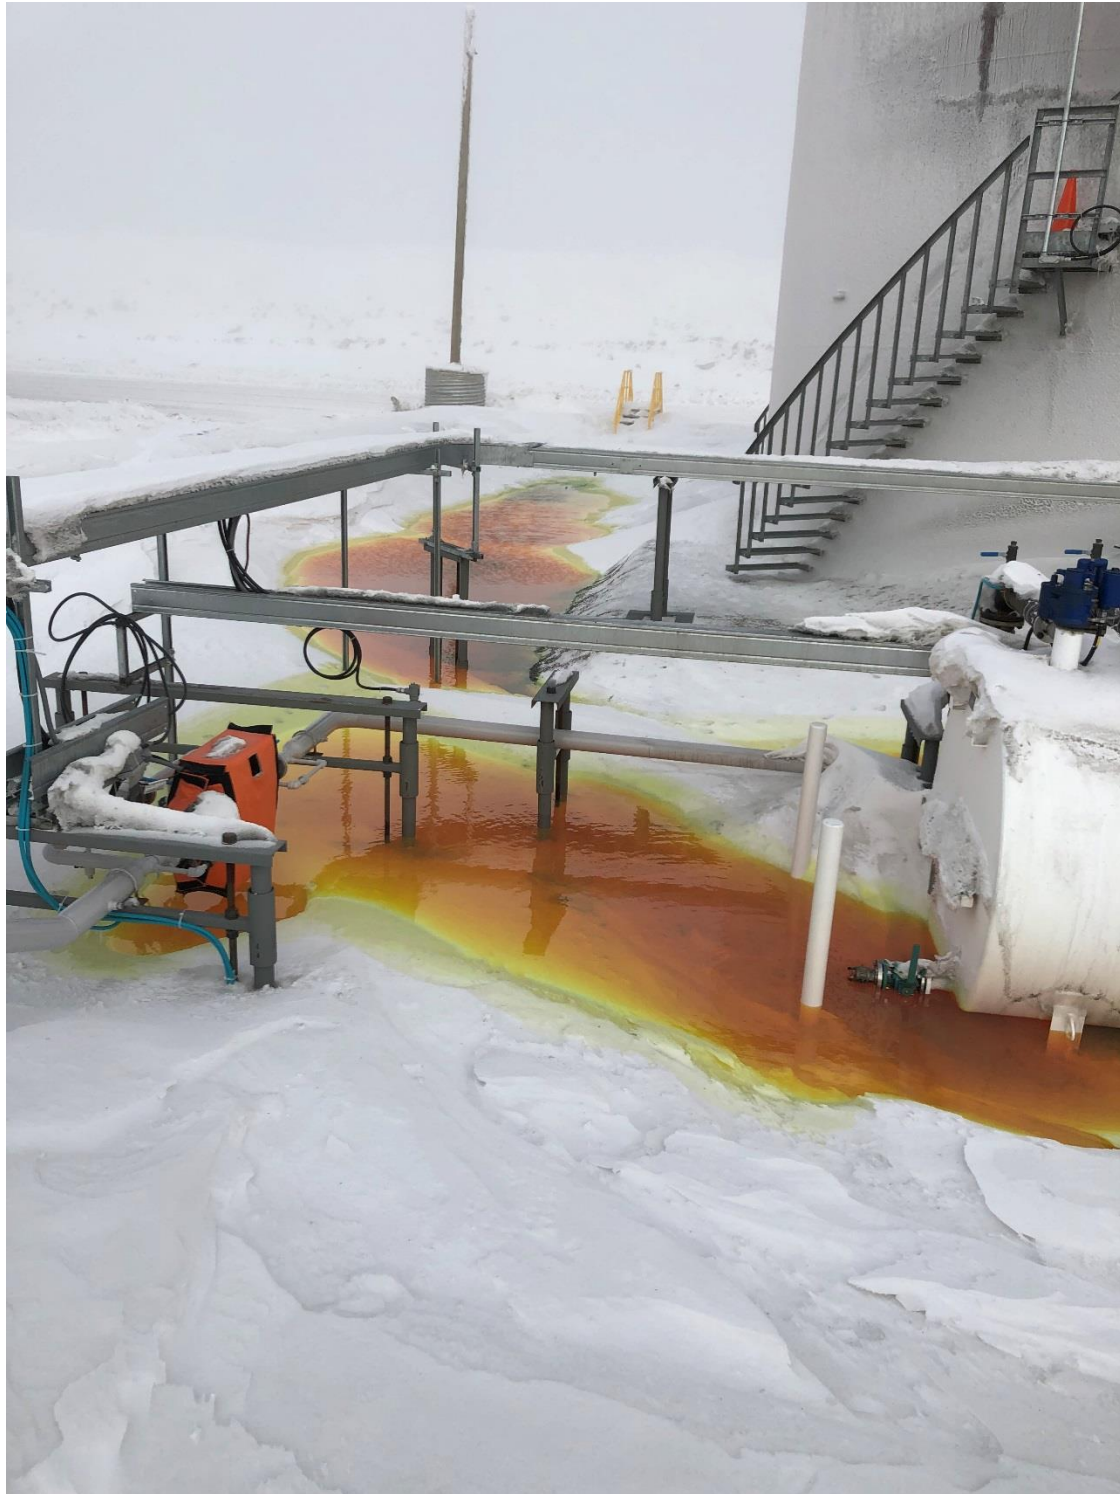
Figure 3. Pooled Diesel within Sable Fuel Tank Farm Containment Berm (March 21, 2019)
