Subject: W2016D0003: Spill 2020022 Report

Pursuant to Part C Condition 18(c) of Land Use Permit W2016D0003, Dominion Diamond Mines ULC (Dominion) is providing a detailed report on Spill 2020022 which occurred on January 15, 2020 within Sable Pit.

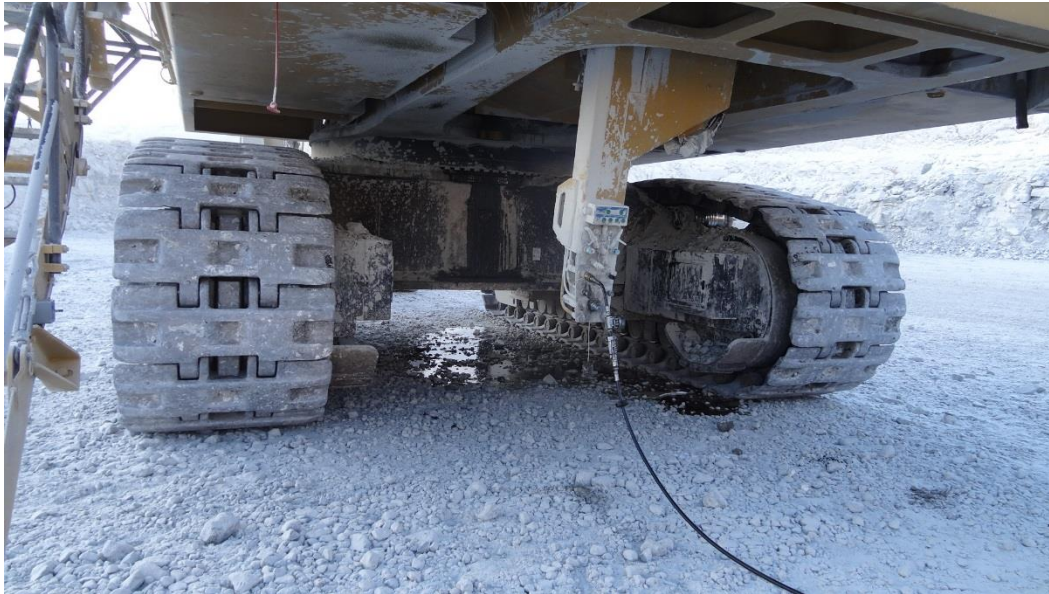
Figure 2. Spill 2020022 before clean-up

At 11:30 am on January 15, 2020 the swing drive hydraulic T-fitting failed on the CAT Shovel (Unit 2569) causing a 300 L hydraulic oil spill within Sable Pit. The spill took place at the following location:

Vibration and extreme cold temperatures are thought to have caused to the T-fitting failure.

The operator shut down the equipment, contacted their Team Leader, and deployed absorbent pads to retrieve some of the free-standing diesel. The Surface Mining team arranged for the unit to be repaired and move aside so the spill could be cleaned-up.

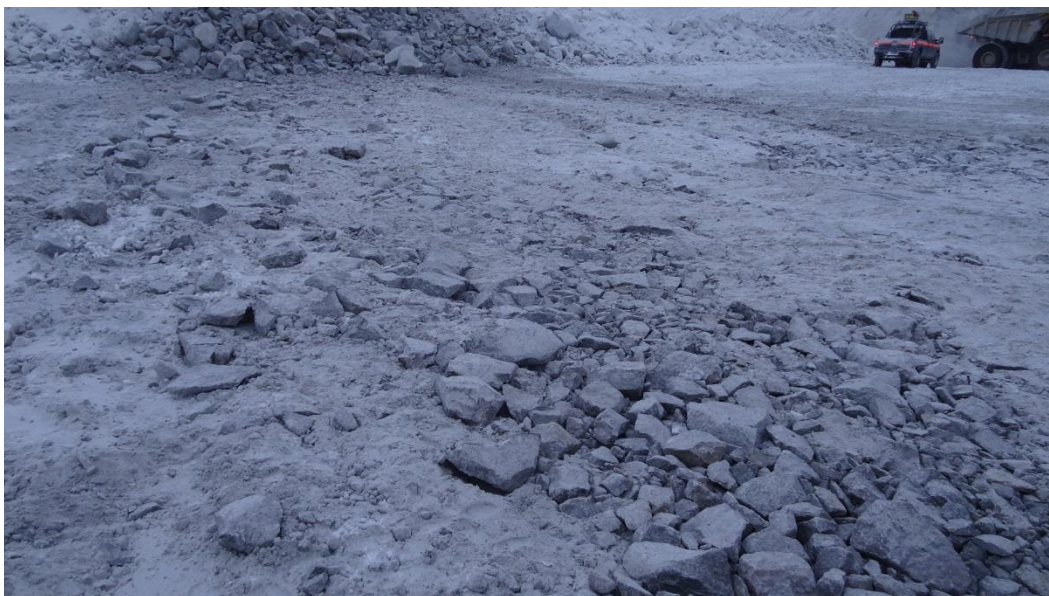
Figure 3. Spill 2020022 after clean-up

Once the Shovel was repaired and moved, the clean-up was fully completed. The contaminated soil was scraped up using a Grader and CAT 992 Loader and hauled to Zone S. The contaminated absorbent pads were taken to the Waste Management Building for proper disposal.
