Subject: W2016D0003: Spill 2022476 Report

Pursuant to Part C Condition 18c of Land Use Permit W2016D0003, Arctic Canadian Diamond Company Ltd. (Arctic Canadian) is providing a detailed report on Spill 2022476 which occurred on September 25, 2022, in Sable Pit.

Summary

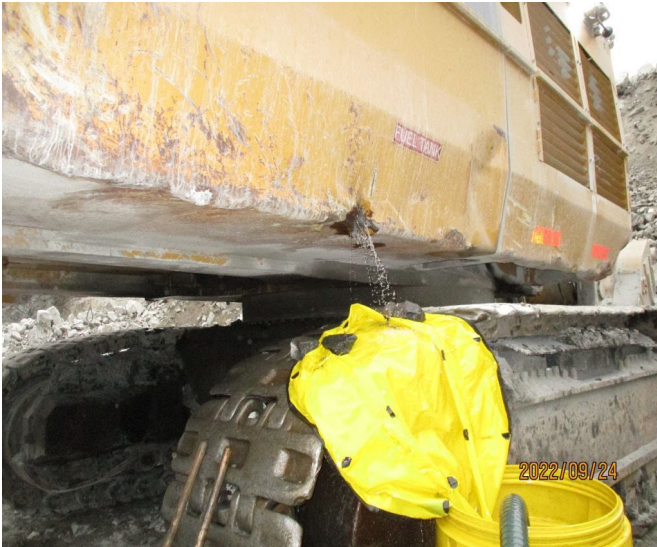
At 10:10 AM on September 25, 2022, a shovel working in Sable Pit collided with a rock. The impact caused a leak in the fuel tank and 120L of diesel spilled into Sable Pit. The affected area was 3m².

A collision with a rock caused the fuel tank to be punctured on heavy equipment.

Photo 1: Sable Pit – Containment barrel with vacuum pump to catch leaking diesel from impact site on shovel.

Containment barrel with vacuum pump was placed to prevent further leakage. The remaining fuel was then drained from the fuel tank.

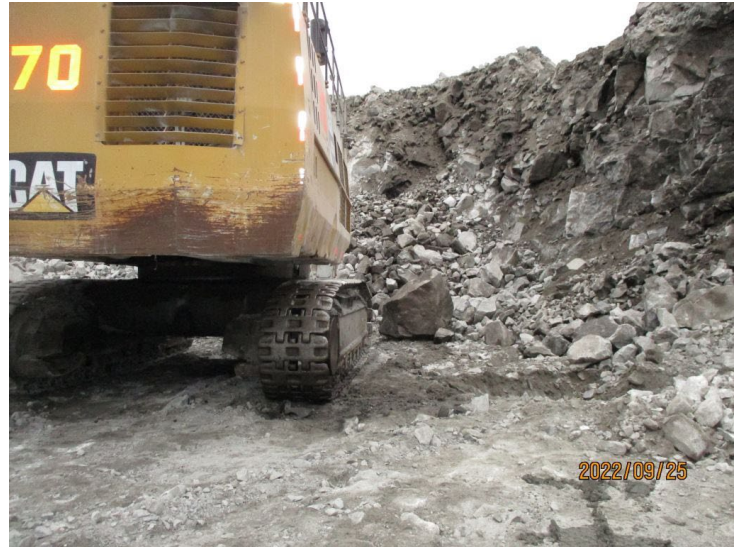
Photo 2: Sable Pit – Spill area next to shovel after the fuel tank had been drained.

Once the shovel was moved, the affected soil and rock was excavated and moved to a contaminated soil disposal area. The shovel is now undergoing repairs.
