Subject: W2016F0006: Spill 2019275 Report

Pursuant to Part C, Condition 17(c) of Land Use Permit W2016F0006, Dominion Diamond Mines ULC (Dominion) is providing a detailed report on Spill 2019275 which occurred on July 6, 2019 on the Pigeon and Sable Haul Road (see Figure 1 for locations).

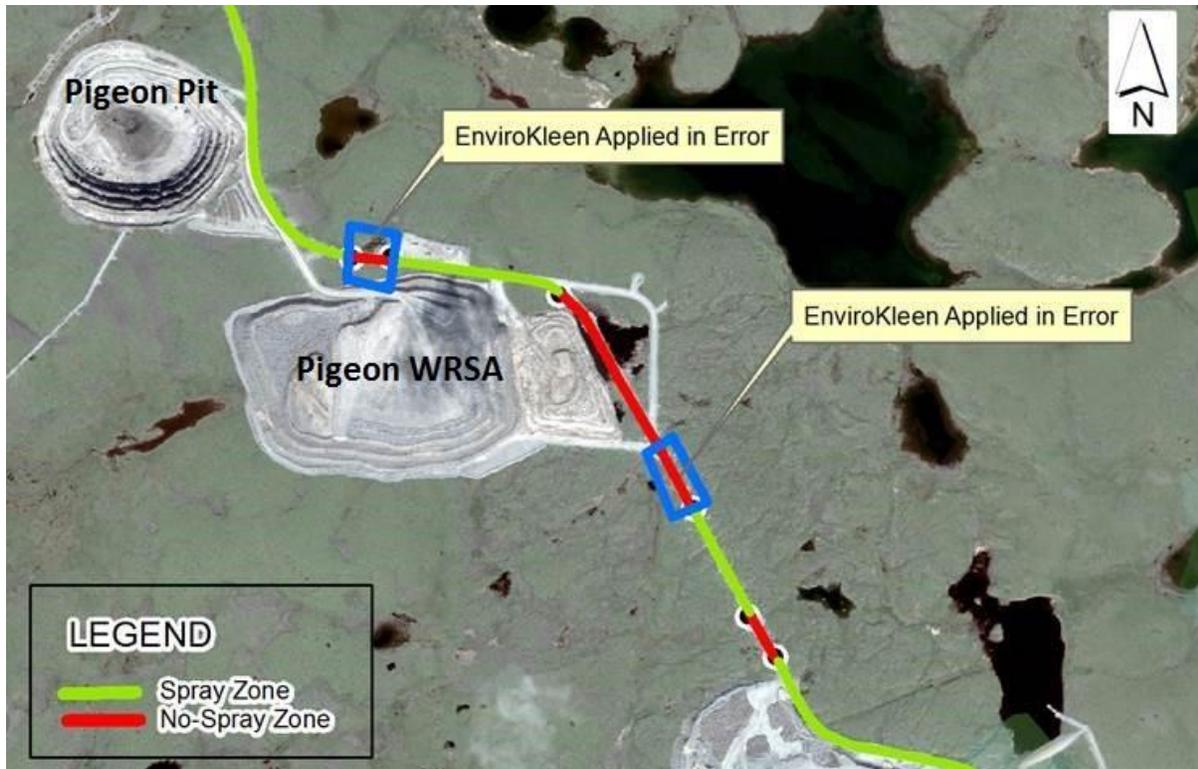
On July 6, 2019 approximately 170 L of a dust suppressant (Envirokleen) was applied to two areas (4,000 m² total area) which had been marked as no-spray zones. The areas had been marked as no-spray zones due to close proximity (within 15m) with non-fish bearing water bodies along the haul road. Dominion Environment Department learned of the misapplication on July 10, 2019 and notified the Inspector immediately.

Figure 1. Locations involved with Spill 2019275

Based on feedback received from Site Services, Environment personnel repainted all of the stakes and applied flagging tape to greatly increase visibility for the driver while applying EnviroKleen. Environment staff is now driving the route prior to any additional applications to ensure that all stakes are in the correct locations and highly visible to the Site Services team. These actions were put into place prior to a subsequent EnviroKleen treatment on July 30, 2019 and the application went well with no errors noted.
