RE: W2017D0004 – Spill-2024114

Pursuant to Part C Condition 18(c) of Land Use Permit WL2017D0002 - Ekati, Burgundy Diamond Mines Ltd. (Burgundy) is providing a detailed report on Spill-2024114 which occurred April 20th, 2024, at 07:00.

Summary

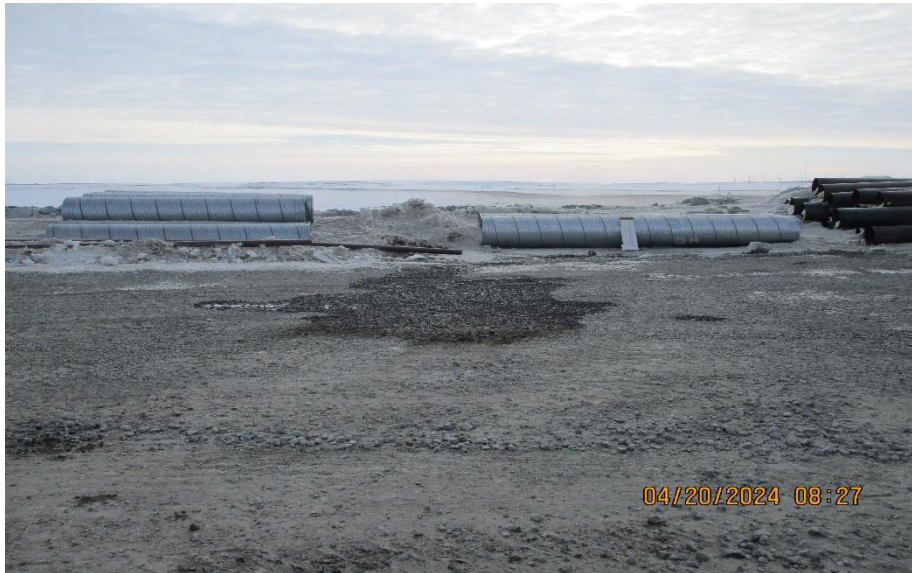
At 07:00 on April 20th a lube truck was filling up a haul truck at the Misery crusher pad when the automatic kick off didn't initiate causing a 150L diesel fuel spill.

Photo 1: Before photo of Spil-2024114 at Misery Crusher Pad.

The lube truck operator noticed the overflow occurring and immediately stopped the fueling process. The Mobile Maintenance team lead was notified, and cleanup efforts commenced.

The contaminated soil was scraped up and hauled to Misery Zone S for disposal. Operators were reminded of the importance of being diligent while refueling and to check on the breathers regularly.

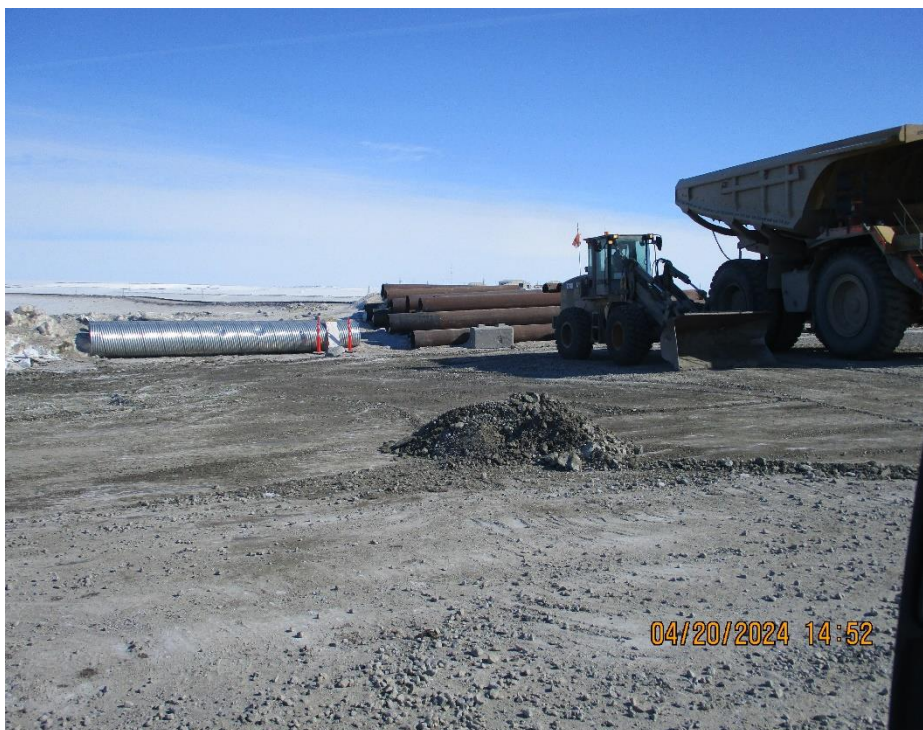
Photo 2: After photo of Spil-2024114 at Misery Crusher Pad.
